# Technical report

## A-001/2021

Accident on 12 January 2021, involving a SOCATA TB-10 aircraft operated by Adventia European Aviation College S.A., registration EC-FTJ, at Salamanca Airport (Spain)

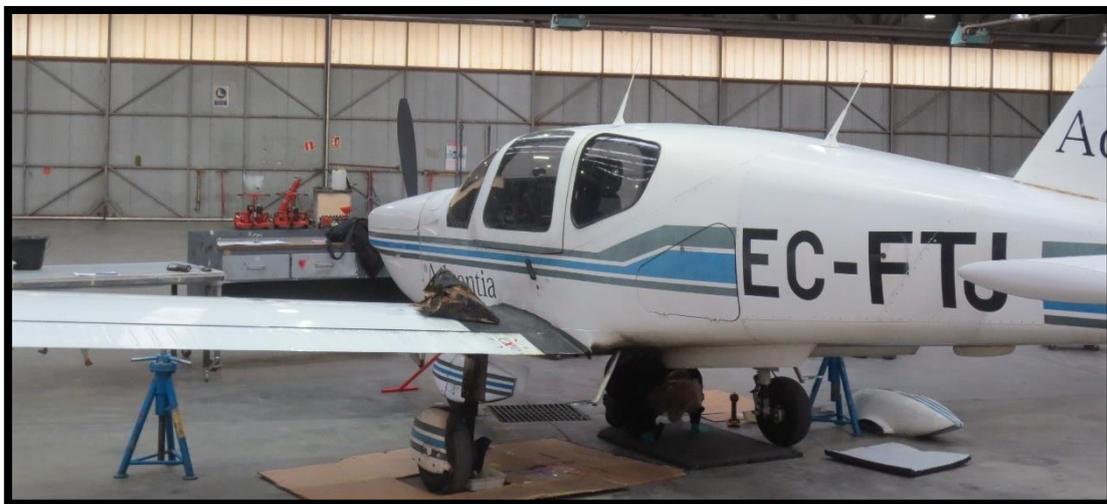
*Figure 11: Aircraft EC-FTJ after the accident.*

The fire caused significant damage to the brakes, the tyre, and the left main landing gear leg and fairing.

The left intrados wing skin and the ventral skin were also affected.

The structure and characteristics of the rest of the aircraft remained intact, with no apparent damage.

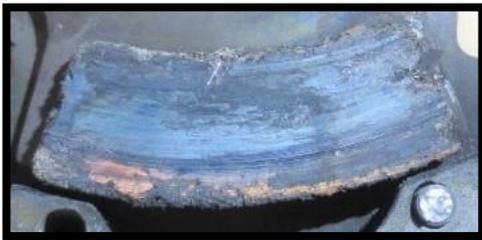
*Figure 12: Moving pad after the accident.*

- The LH brake pads were extremely worn and deteriorated throughout. They were badly damaged and partially charred, with material loss and additional adhered materials, evidenced by traces of orange.
- Some difficulty was encountered when removing the pressure plate (which contains the moving pad) from the brake calliper because it was stuck on the calliper anchor bolts.
- The back plate (which holds the fixed pad) was considerably deformed, while the pressure plate was slightly deformed.

As explained in point 1.16, the inspection of the aircraft's left brake components found that the surfaces of the LH brake pads were extremely worn and deteriorated. In addition, deep grooves and adhered melted material were observed on both sides of the LH disc surface. The evidence, therefore, suggests that there was considerable friction between these components, which generated a large amount of heat and exposed the brakes to very high temperatures.

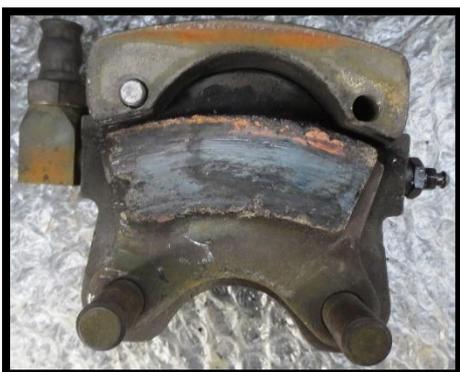
*Figure 14: Brake calliper after the accident.*

- No obstructions were found in the hydraulic line running inside the brake calliper to the actuator piston.
- The actuator piston was not seized inside the cylinder and moved freely.
- No trace of the actuating brake piston O-Ring was found.
- On removing the calliper, some resistance was encountered when sliding the calliper anchor bolts through the torque plate bushings.

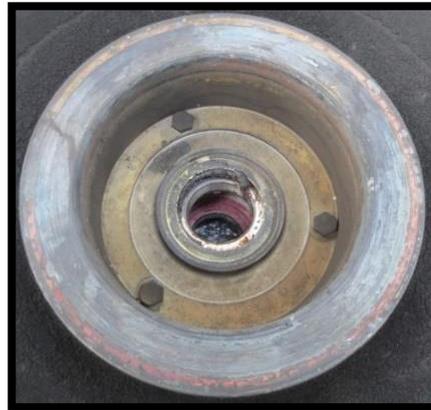
*Figure 15: Brake disc after the accident.*

- Deep grooves and traces of adhered melted orange material were found on both sides of the LH brake disc.

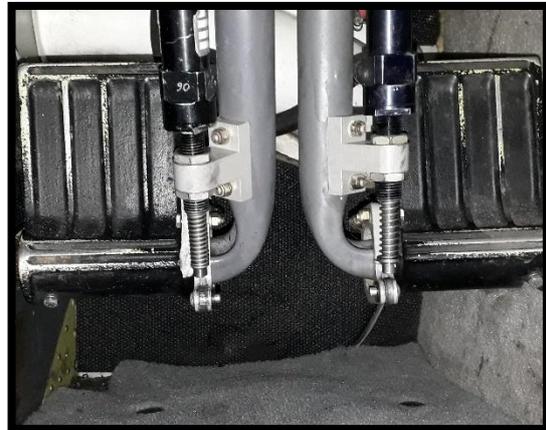
*Figure 16: Master actuator pistons of the co-pilot's brake pedal.*

- The master actuator pistons on the co-pilot's side of the aircraft were found as shown in the image. On the left side, the coils of the return spring are slightly closer together than on the right side.

- The master actuator pistons of both the pilot's and co-pilot's left pedal were disassembled and inspected, confirming that, while a little stiff, they returned to their natural position and functioned correctly.

It should be noted that, although it was considered possible that the condition of the brake master actuator piston of the left-hand pedal in the co-pilot's seat (shown in figure 16) could be responsible for the calliper not returning to its resting position, this hypothesis was deemed less likely than the previous due to the following factors:

- We could not confirm that the brake pads and brake disc were in contact with the brake master actuator piston in this position.
- The brake master actuator piston was disassembled, tested and found to be working correctly.
- The master actuator piston in question corresponded to the co-pilot's seat, which would imply that the brake pads and the brake disc had been in permanent contact since 15-12-2020 (the last time the aircraft was flown with a co-pilot, two flights before the accident flight). If this was the case, we believe it highly likely that either one of the crews of the two previous flights (one of them with an instructor), or the student pilot himself, would have noticed something unusual during one of the phases of their respective operations, particularly while taxiing at a low speed.

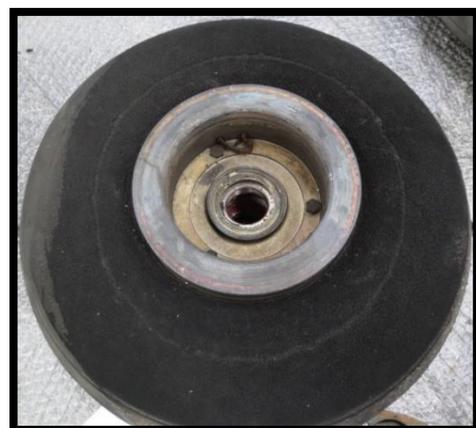
*Figure 17: Tyre after the accident.*

- The LH tyre displayed uniform deterioration on its inner side. There were no breakages, and it had pressure. No scuffing was observed on the tread.

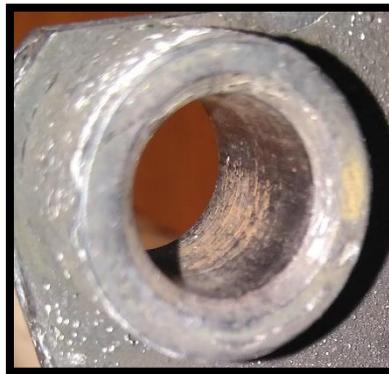
Figure 18: Detail of a guide pin hole.

- Staggered grooves and corrosion could be seen inside the torque plate bushings.

*The torque plate bushing I.D. (anchor bolt holes) are corroded. The surface finish also looks to be have been compromised in addition to the lack of cadmium plating. It is important that the anchor bolts are lubricated with a dry film lube and that the torque plate bushings are free of corrosion.*

- The conicity observed in the brake calliper anchor bolts and the corroded grooves found in the torque plate bushings through which they slide suggest the calliper anchor bolts were meeting resistance during the movement (based on the information in points 1.6.3 on "off-aircraft" maintenance guidelines and 1.18 on the brake manufacturer's instructions). However, it has not been possible to determine to what extent the fire that broke out and the subsequent removal of the brake from its housing in the aircraft leg contributed to these damages and deformities.
- The acceptable condition of the other brake system components that could have prevented the calliper from returning to its resting position, such as the brake master actuator pistons for the left-hand brake pedals and the brake calliper actuator piston.

We have concluded the most likely explanation for the calliper failing to return to its resting position is that the calliper anchor bolts were not sliding smoothly through the torque plate bushings. Furthermore, we believe this phenomenon could occur randomly; in other words, it may not have happened every time the brakes were applied, depending, for example, on the extent to which the calliper inclined when the brakes were applied.
