Report

A-002/2019

Accident involving a PIPER PA-28R-201 (Arrow III) aircraft, registration G-OARI, on Mount Ernio in Errezil (Gipuzkoa) on 9 January 2019

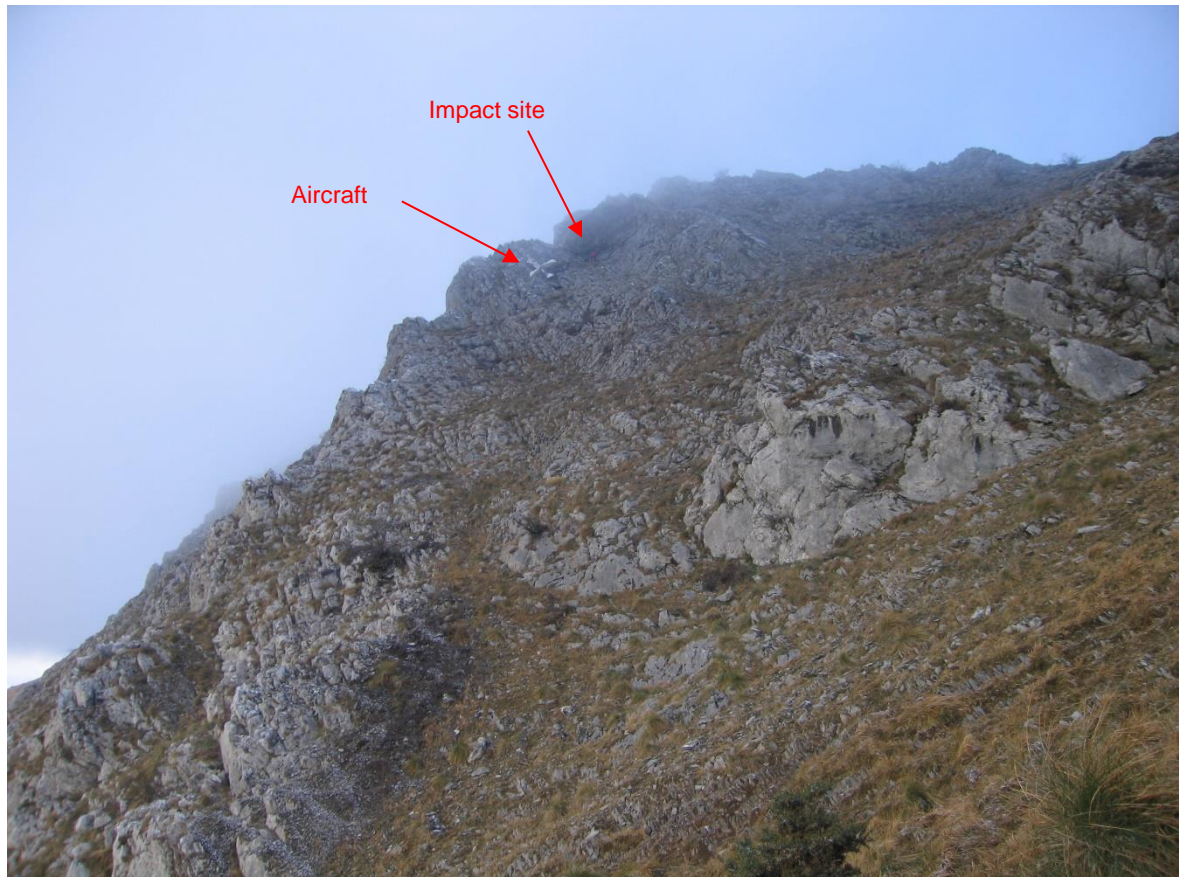
Figure 1. Photograph of Mount Ernio

Shortly afterwards, the aircraft impacted against the south face of Mount Ernio, located in the town of Errezil, in the province of Gipuzkoa.

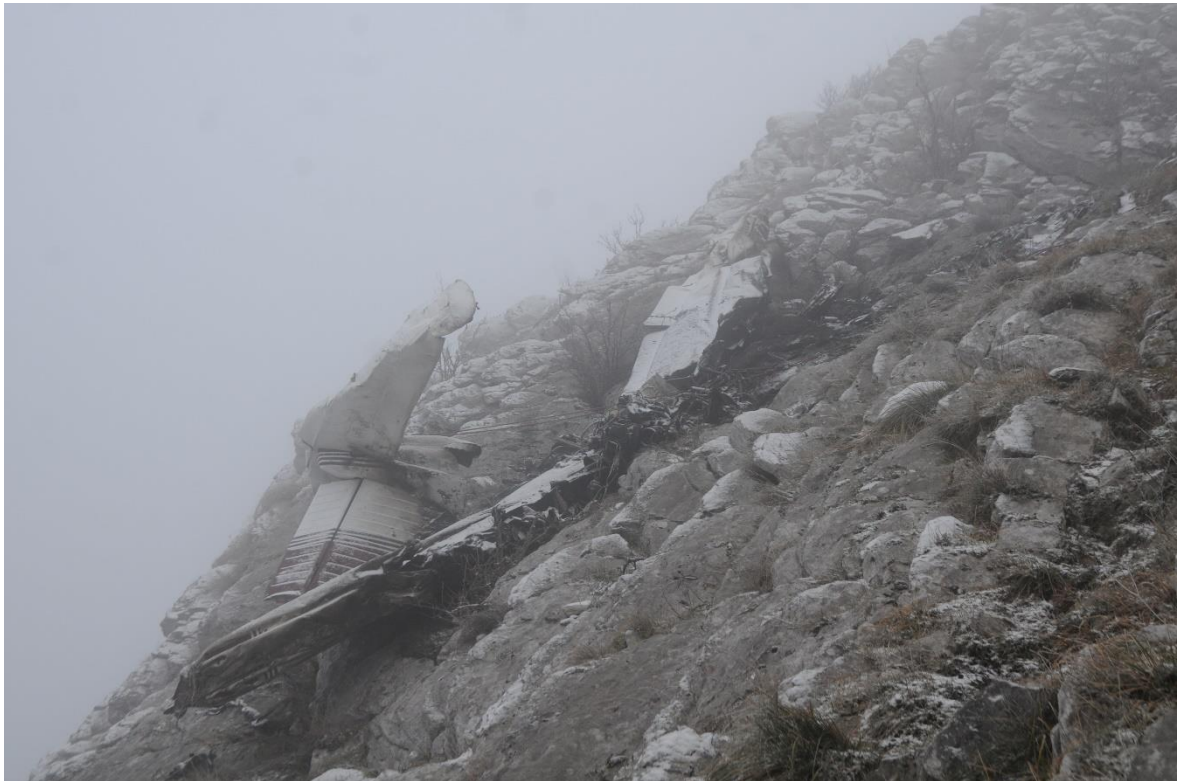
Figure 8. Photograph of the main aircraft wreckage

The photograph in Figure 8 shows the main aircraft wreckage. This photograph was taken in the afternoon on the day of the accident. It shows that the area was completely shrouded by low clouds. There was even a thin layer of snow on the ground.

The mountainside where the wreckage was found was quite steep and free from vegetation. As a result, the wreckage was highly unstable and prone to sliding easily. To keep this from happening, the regional Basque police (Ertzaintza) had secured the wreckage with ropes tied to rocks.

The only components that were found relatively complete were the two wings and the tail section. The fuselage had been almost entirely consumed in the fire that broke out after the impact.

After the impact, the aircraft slid down the slope of the mountain due to the steep incline of the mountainside. It was this sliding motion that caused the damage exhibited on the trailing edges of the elevators and rudder. The aircraft came to a stop a few meters downhill of the impact site.

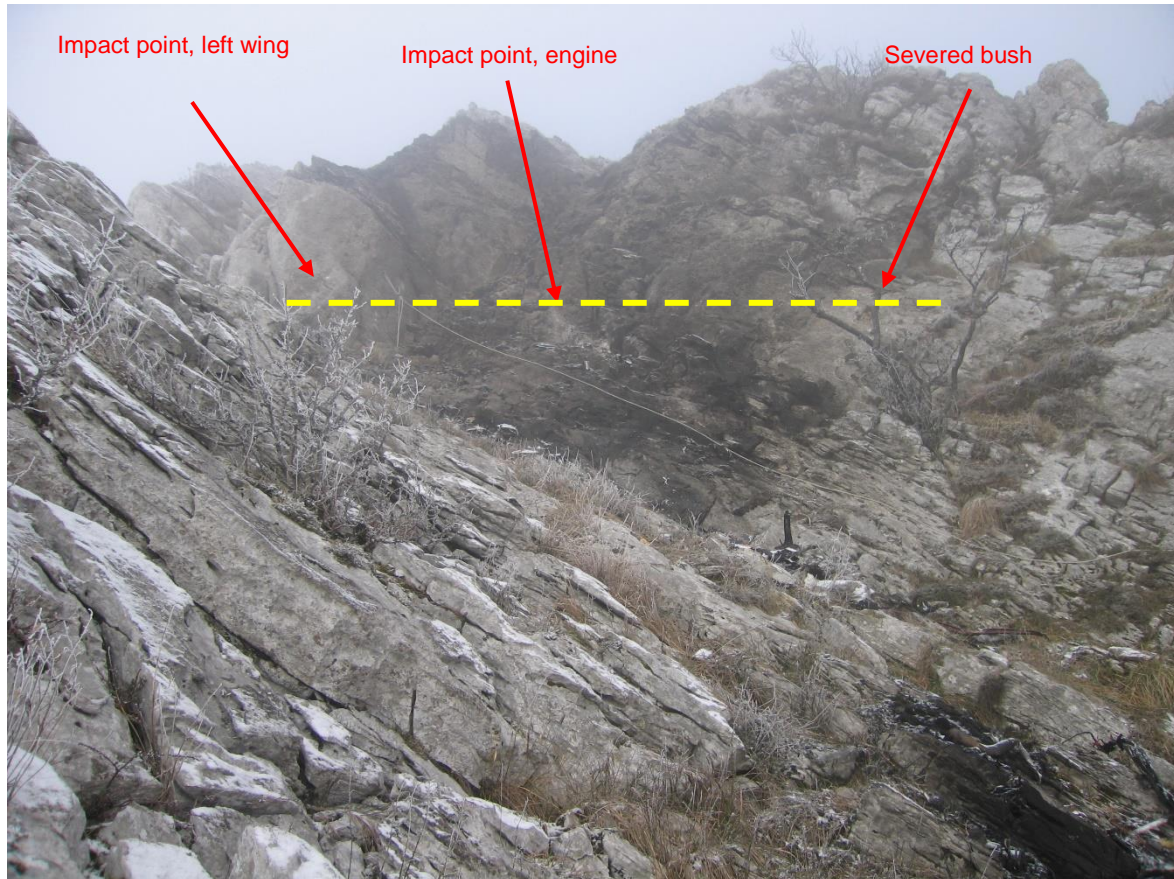
Figure 9. Photograph of the hillside where the aircraft crashed, taken from the location where the main wreckage was found

There was a ditch with smaller components and burned debris uphill, up to the beginning of a section of rock that was almost vertical (Figure 9). No cockpit instruments or controls were found save for an artificial horizon and a piece of one of the two control wheels. Some fragments from the cylinders and other engine components were found, as were the two propeller blades. Both blades were damaged, but one was more so. It had lost its outer half,

approximately, and it exhibited plastic deformations and other marks consistent with a high-energy impact.

The fire had affected the entire area from the main wreckage to the wall that the airplane had impacted.

The other blade had also lost material from its end and exhibited deformations consistent with an impact.

On this wall and about 2 m above its base, there was an area where the rock was lighter in color. Upon closer inspection, it was evident that this lighter color was due to an impact. Very close to this point, two metal tube segments were found.

Some 6 m away from the impact point and to the left, the wall formed a rocky outcrop that showed signs of a recent impact. The shape of this outcrop was similar to the triangular impact shape of one of the wings. The terrain located on the other side of the outcrop (with respect to the impact point) was examined, and remnants of paint from the aircraft as well as red glass fragments were found there.

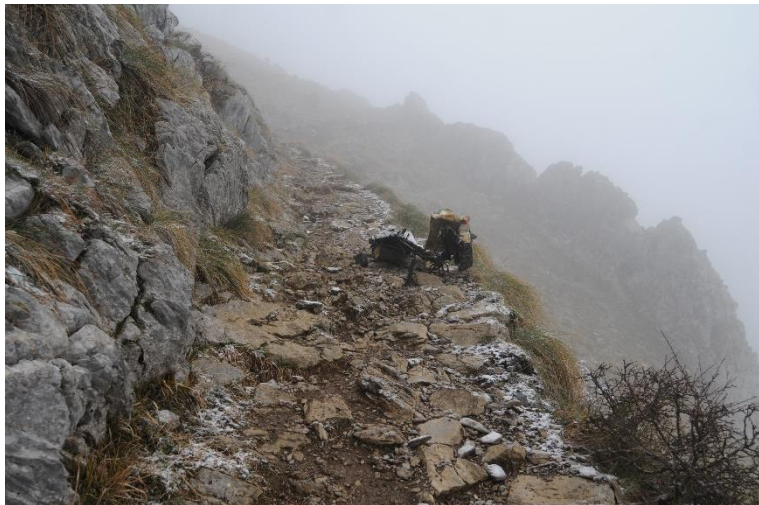
Figure 10. Photograph of the seat on the path that leads to the Summit of Mount Ernio.

After walking a little over 1 km on this trail, they found a seat.
