Report A-003/2020

Accident involving MS 892 E-150 aircraft, registration SP-IKY, on 17 January 2020 at the aerodrome of the El Berriel (Gran Canaria, Spain)

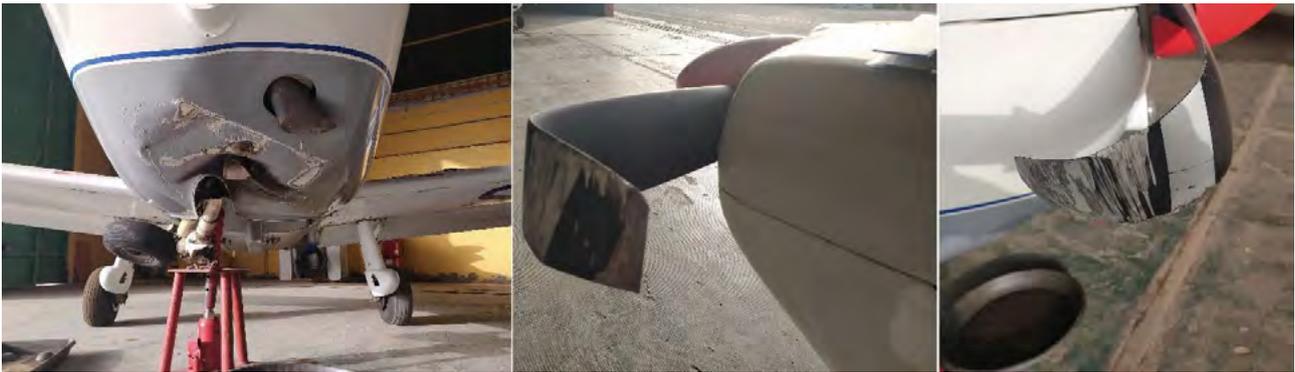
As a consequence of the accident, the nose leg collapsed and the propeller blades were damaged.

Figure 1. Damage to aircraft SP-IKY

It was observed that the nose leg had been deformed due to the impact suffered in the touchdown, as well as that there had been damage to the propeller blades due to contact with the pavement.

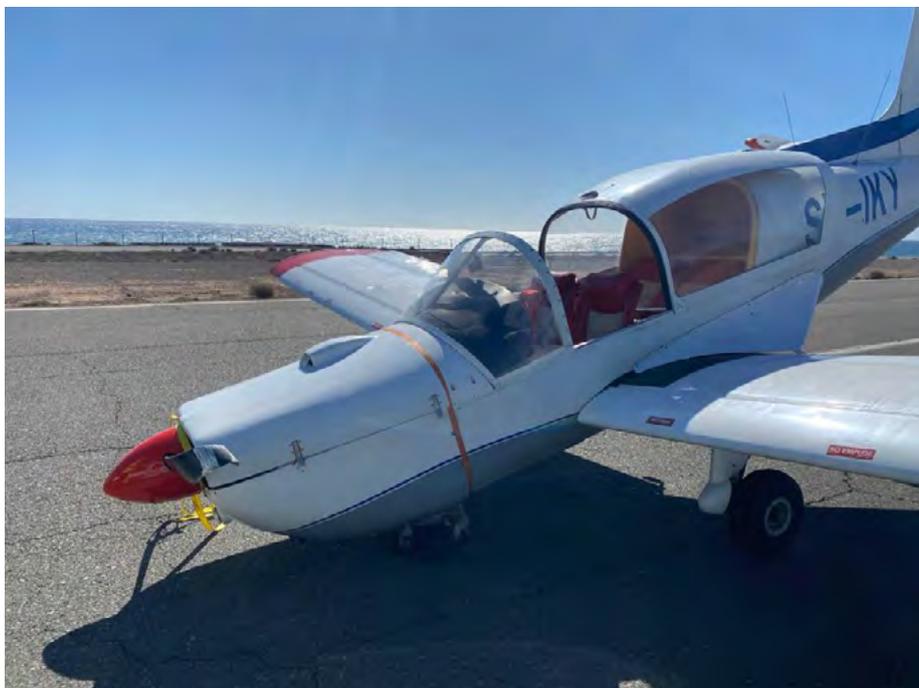
The landing was made on runway 07 of the aerodrome, leaving the aircraft stopped there after the front train collapsed, as shown in Figure 3.

Figure 3. SP-IKY aircraft after the accident

As a consequence, the front axle and propeller were damaged.
