Technical report

A-003/2021

Accident involving an AEROSPOOL WT9
DYNAMIC LSA CLUB aircraft, registration EC-
MVK, on runway 08 at Casarrubios del Monte
Aerodrome (Toledo) on 20 February 2021

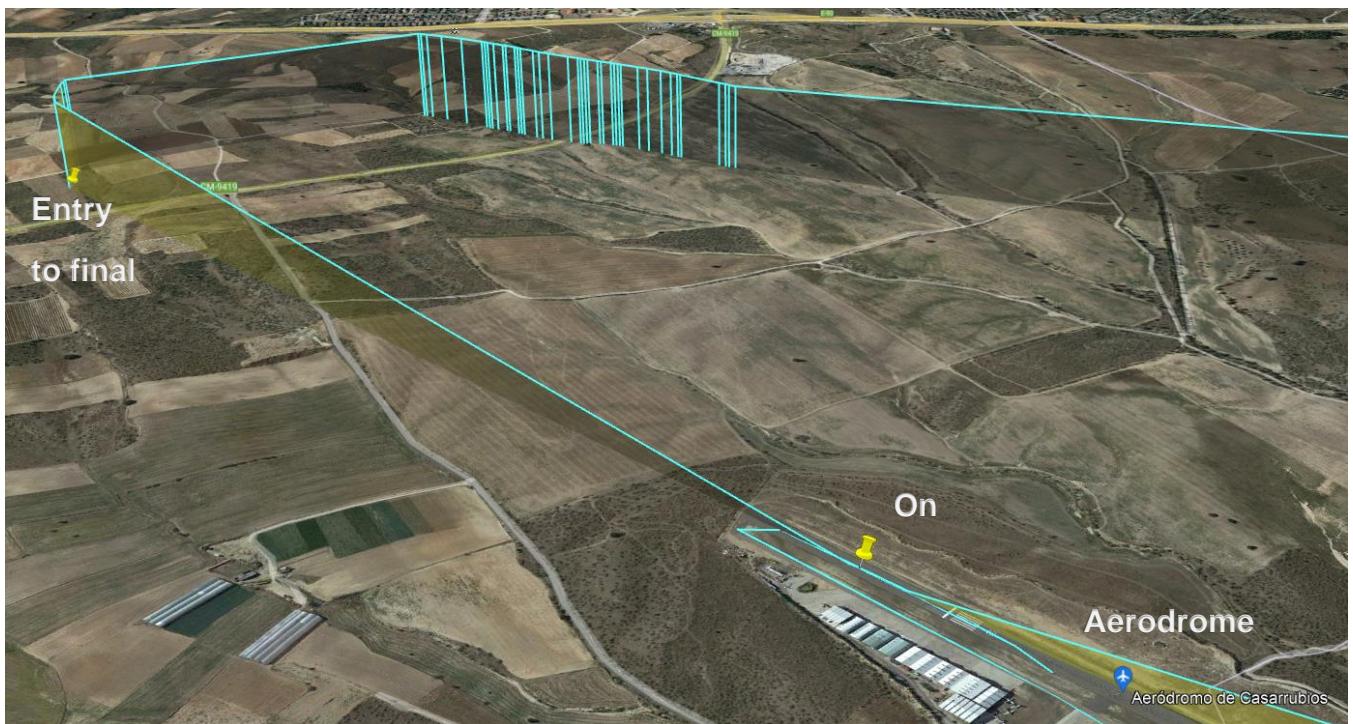
The Alert data file contains no data on the final moments of the accident flight. Specifically, no alerts were issued between 12:59:02, when the aircraft entered the final approach leg at approximately 150 feet above the ground on a heading of 100° and at 59.9 kt (point labelled Final Approach in the image below, figure 2), and 12:59:57, when the aircraft had already landed and was moving at 54.6 kt on a heading of 78.5° (point labelled On Ground in the image below, figure 2). The distance between those two points is about 1,840 m. Therefore, based on the aircraft's altitude when it entered final and the distance travelled, we have calculated that its final approach had a glide slope of 10.75%.

Previously, during the turn from base to final approach, several angle-of-attack warnings were issued.

Figure 2: Illustration of the final approach leg

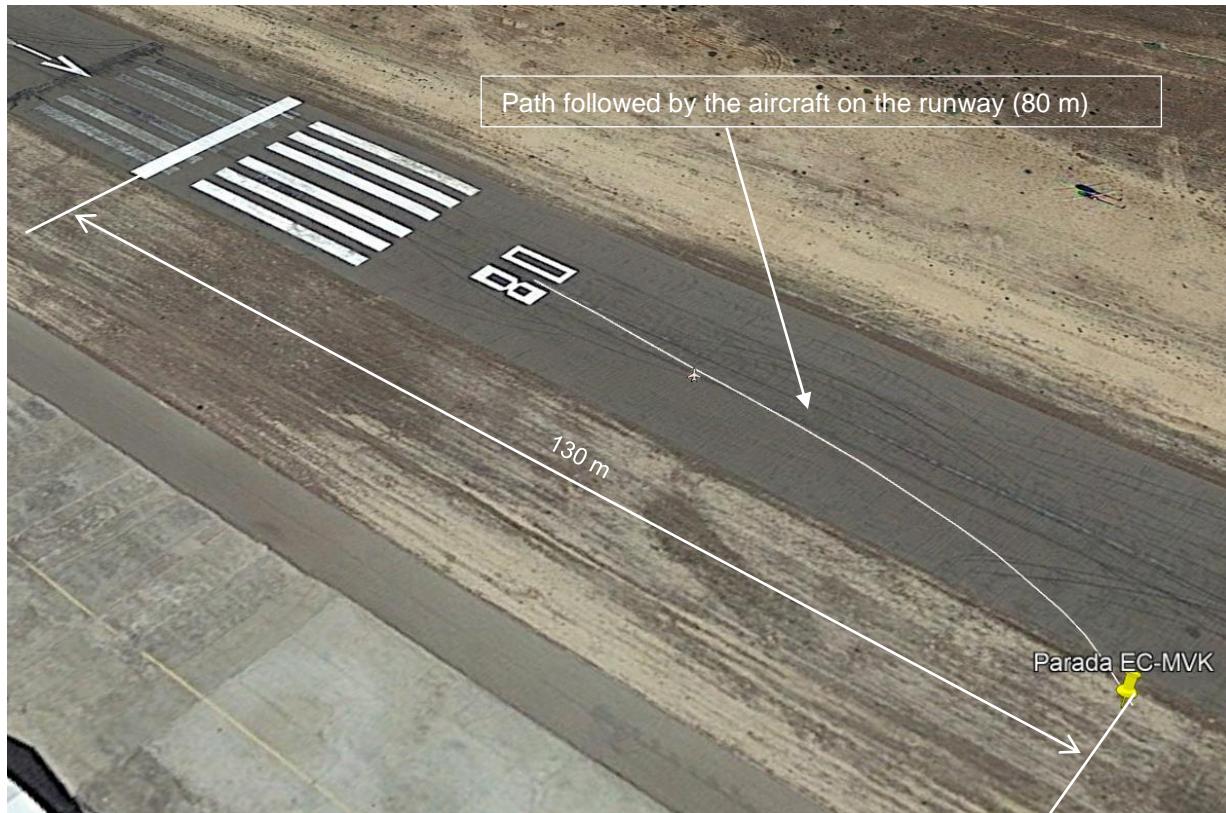
The aircraft travelled approximately 80 metres from the first point of impact before finally coming to a stop on the right-hand side of the airstrip with its propeller cone off the runway; at this point, the pilot cut all power and switched off the entire electrical system. The stopping point was about 130 metres from the runway threshold (see figure). After shutting down the engine and electrical system, both pilot and passenger exited the aircraft uninjured and without assistance.

Figure 3: Approximate path followed by the aircraft as it dragged along the runway after the second bounce.

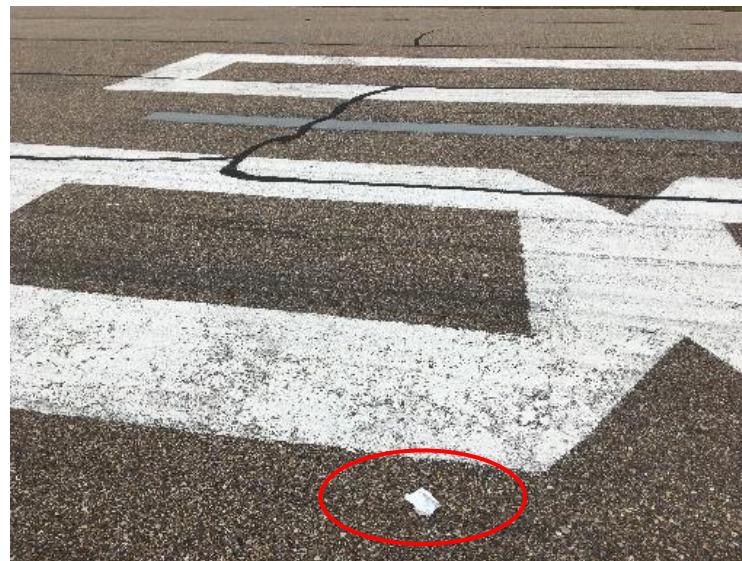
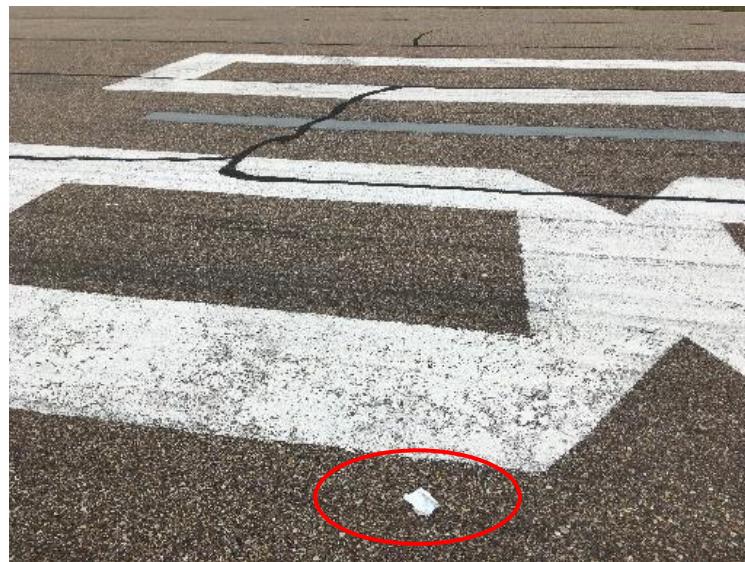
The airfield inspection found a piece of the aircraft's nose leg fairing next to the runway designator numbers

Figure 4: Piece of the nose leg fairing

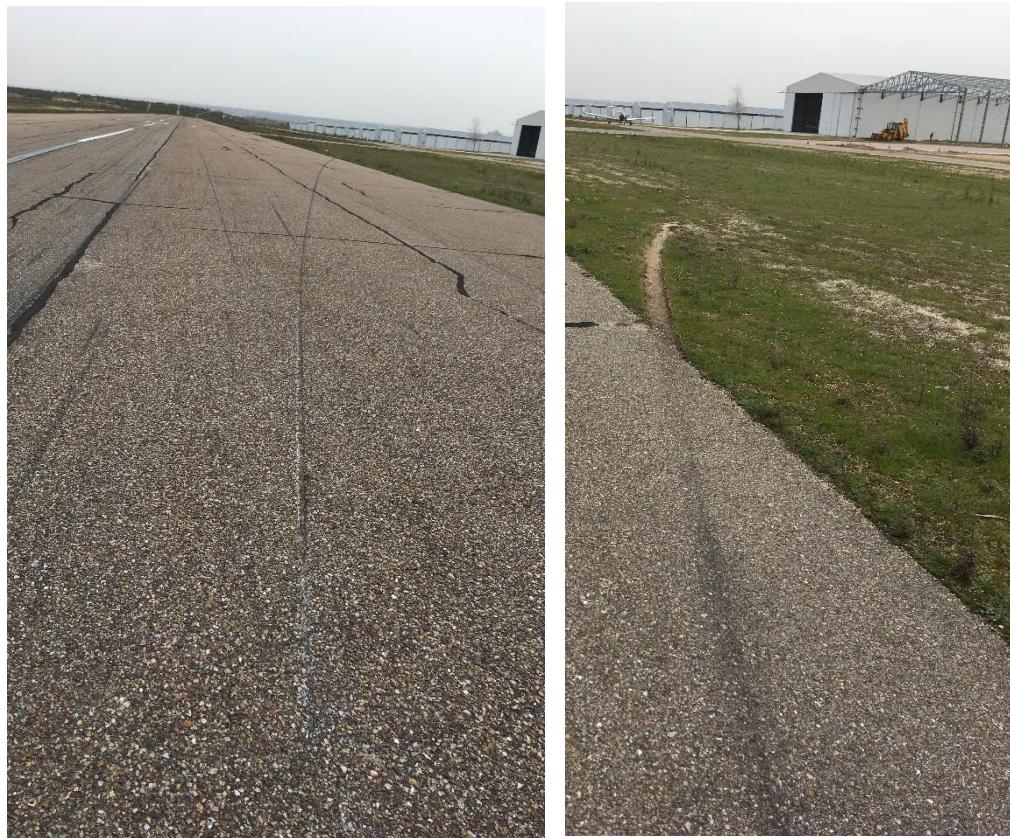
A 60-metre-long mark left by the aircraft as it slid along the runway started approximately 15 metres in front of the fairing piece. In addition, there was a 5-metre-long mark on the grass side strip, which had been made by the propeller cone:

Figures 5 (left): mark on the asphalt; and 6 (right): mark on the edge of the runway and the mud and grass side strip

The damage to the nose leg was studied during a visit to the airfield. It had partially come away from its mount and had bent backwards and slightly to the right, presumably when it hit the runway. It had also lost some of its material due to being dragged along the runway. This material made the marks on the asphalt. The wheel had burst and the fairing had broken into several pieces.

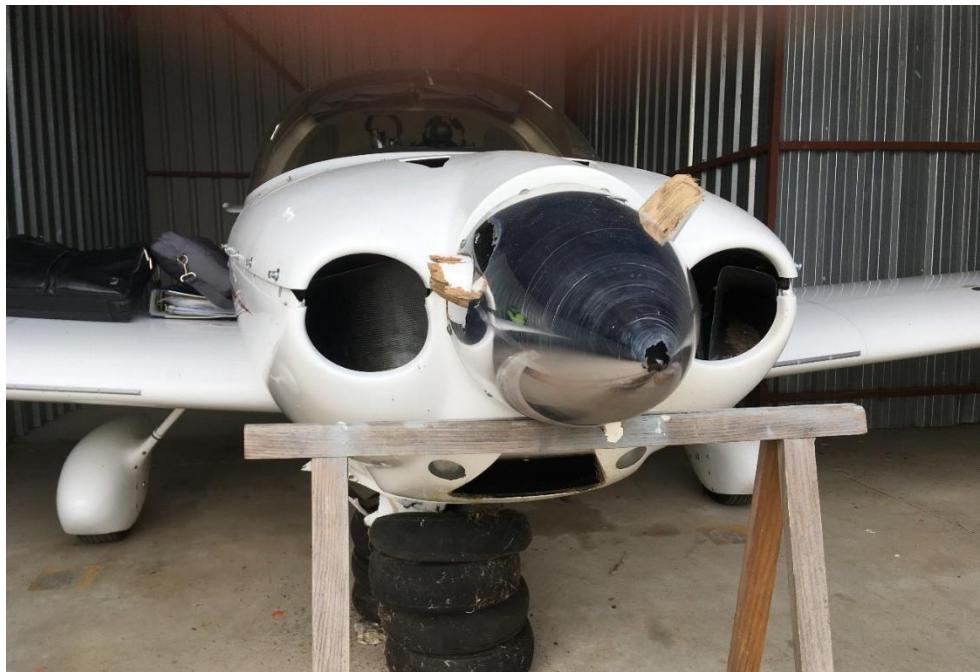
Its propeller blades were destroyed when they impacted the ground with the engine at full power.

Figure 7: damage to the propeller blades

The damage to the propeller blades, which had been severed close to the hub, suggests the engine was delivering power at the time of impact.

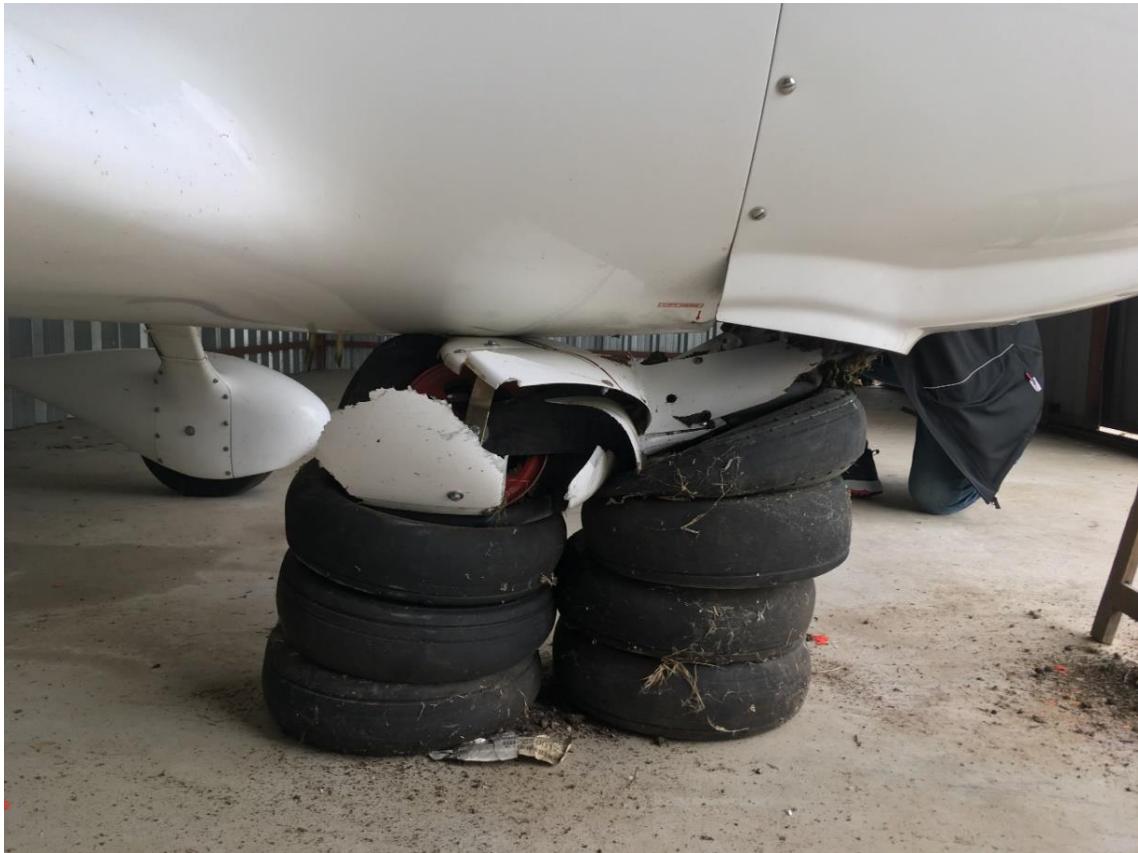
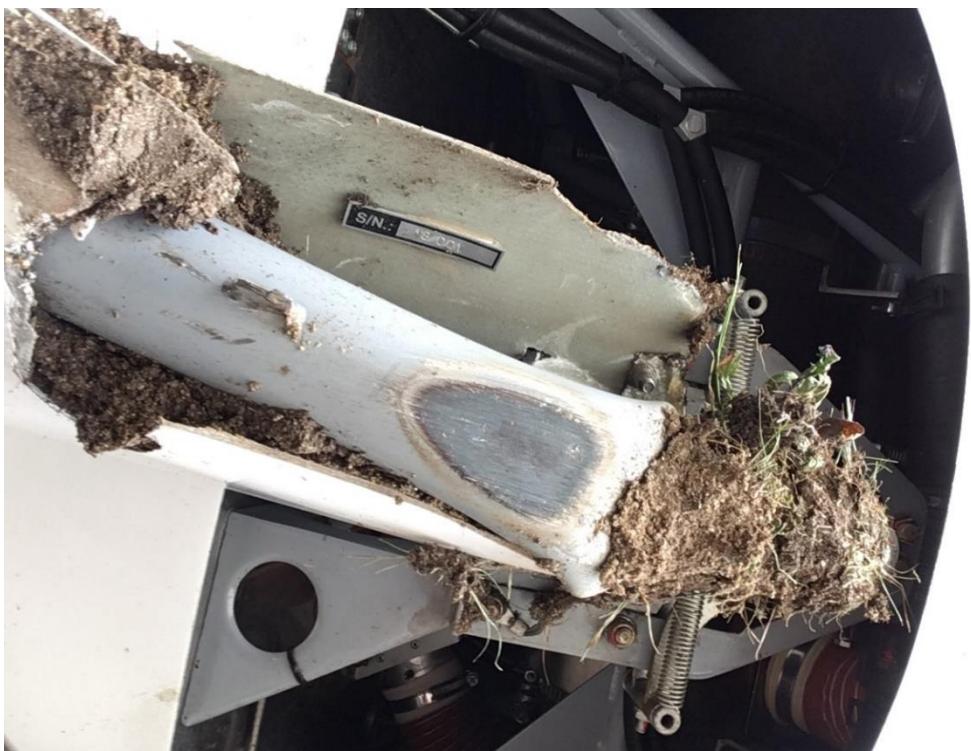
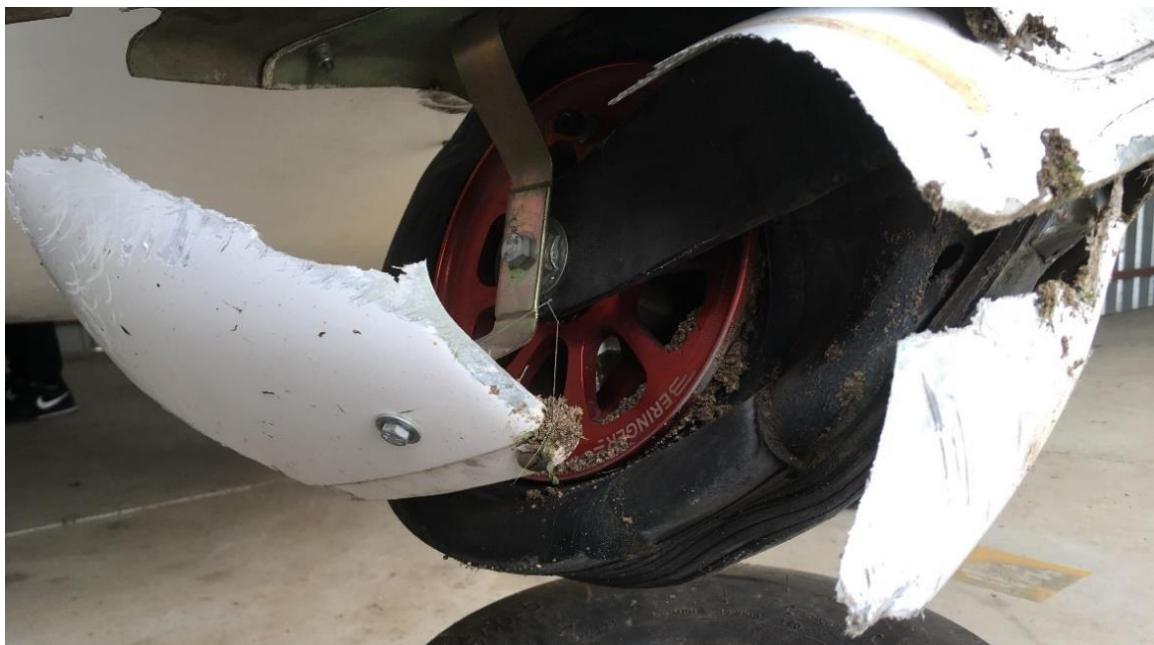
The aircraft sustained damage to the nose gear and nose wheel when it hit the runway on the second bounce.

Figures 8 (previous page, bottom), 9 (this page, top) and 10 (this page, bottom):
damage to the nose leg

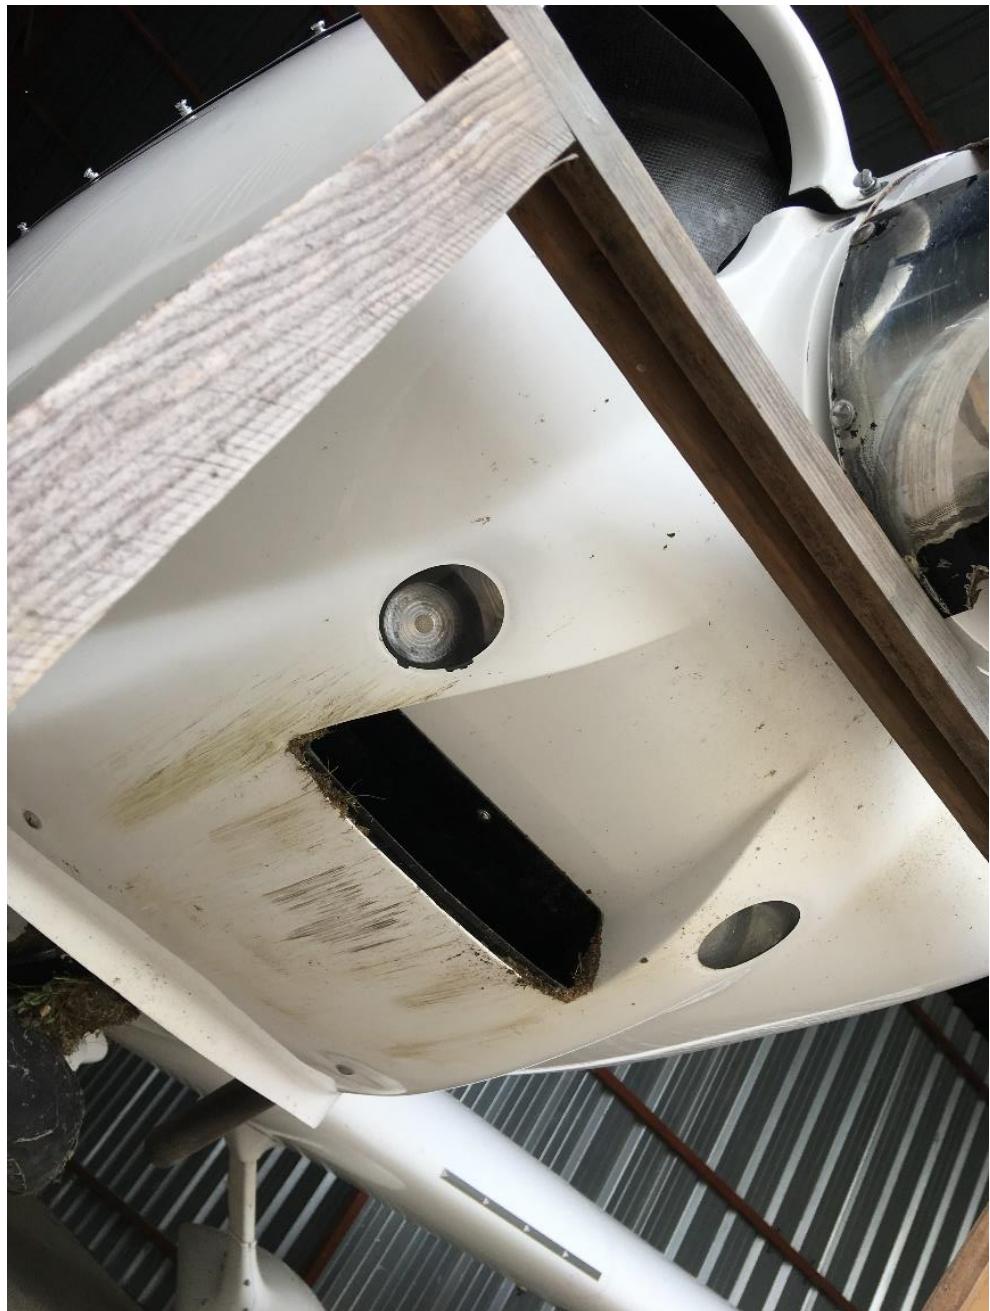
The front lower fairing also sustained minor damage.

Figure 11: damage to the underside of the engine fairing:

In addition, there were scratches on the underside of the engine fairing, again as a result of the aircraft dragging along the runway.

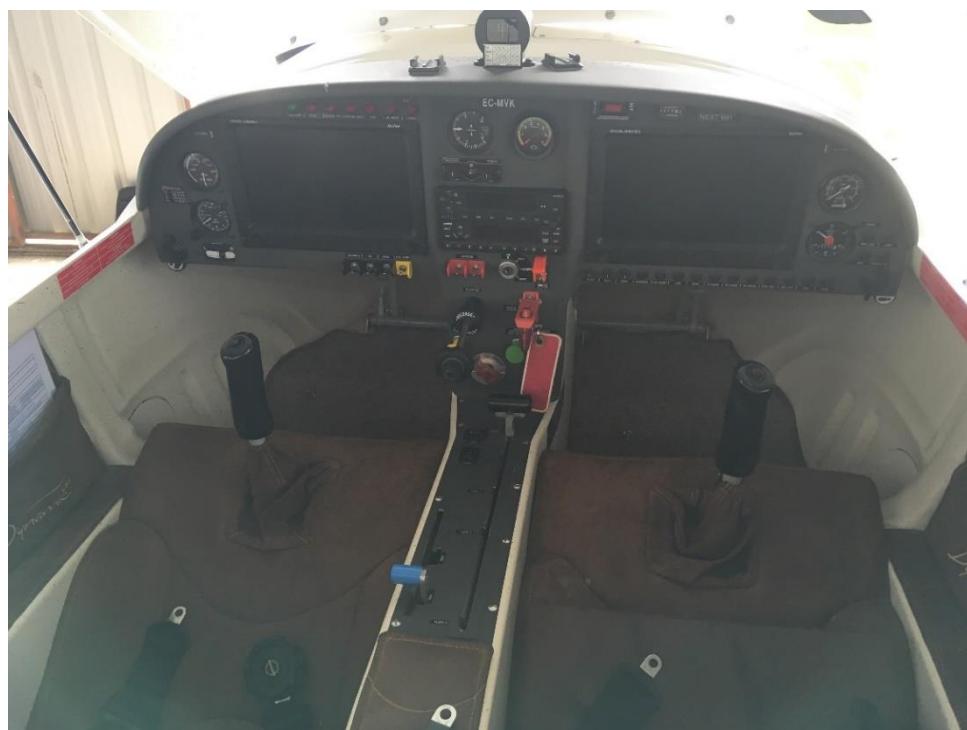
There was no damage to the interior of the cabin. At the time of the inspection, all the systems were switched off:

Figure 12: Cabin
