## Report A-004/2020

Accident involving a DIAMOND  
D-40 aircraft, registration OH-DTF  
at the Córdoba Airport on 23  
January 2020

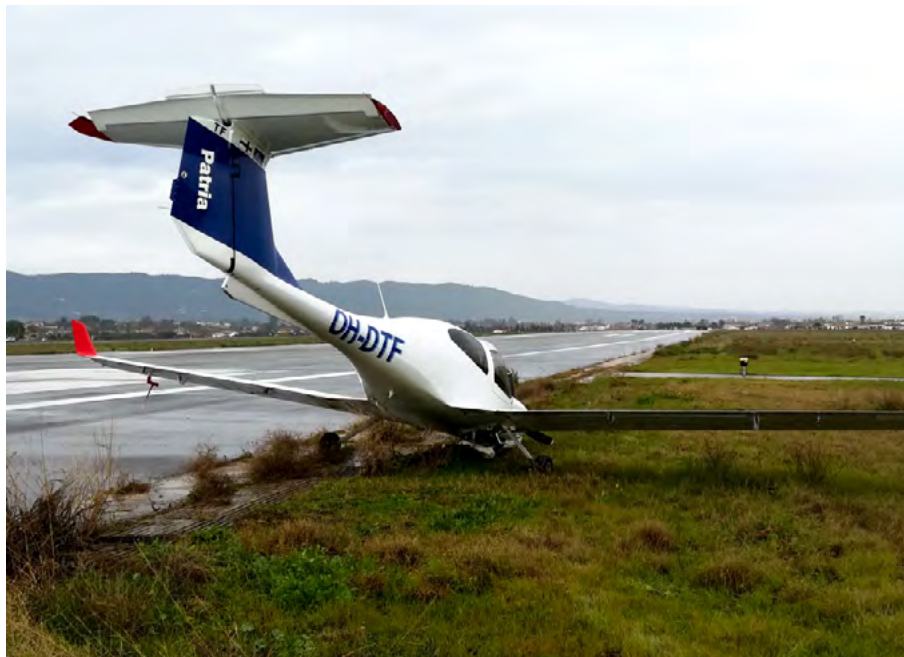
Upon contacting the runway, the airplane rose again before finally touching down, falling on its main gear wheels. It then continued traveling to the runway 21 threshold, where it veered off the right side of the runway and came to a stop next to the runway.

Figure 1. Final position of the aircraft

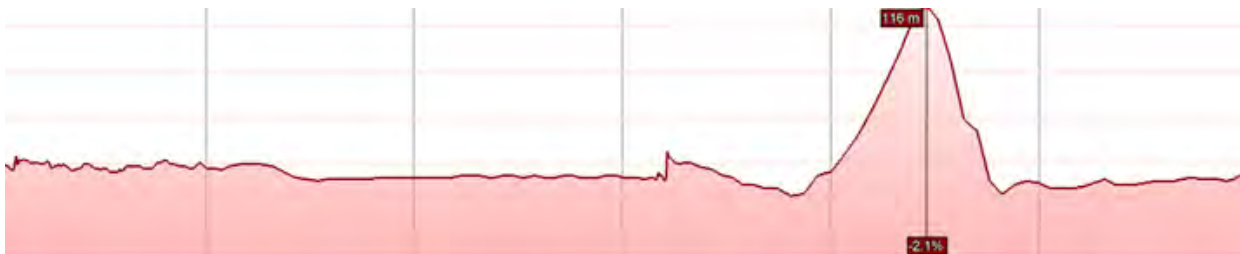
The aircraft did not have flight recorders, as they were not required by law. It was, however, equipped with a GARMIN G1000 GPS, which recorded the flight and which revealed that the takeoff began at 11:55:44 and that at 11:56:04, the aircraft reached a maximum altitude of 380 ft, with an indicated airspeed of 71 kt. At that point its altitude over the runway was 73 ft (22 m), since the airport's elevation is 307 ft. From that moment on, it began to descend and it stopped 32 s later. The figure below shows the flight profile.

Figure 3. Flight profile recorded in the GPS

The information obtained from the GARMIN G1000 GPS that recorded the flight indicates that it reached a maximum altitude of 380.57 ft with an indicated airspeed of 71.16 kt, which is above the maximum stall speed of 66 kt. This rules out the possibility that the airplane stalled.

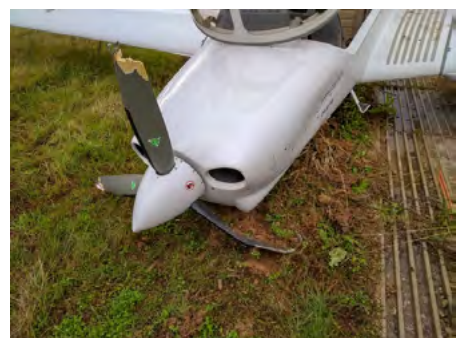
As a result of the initial impact and subsequent runway excursion, all three propeller blades broke and there were varying degrees of damage to the lower engine fairing, to the front gear wheel in the area where it attaches to the fork, to the fairing of said wheel, to the right main gear wheel, affecting the brake disk and caliper, and to the left wing, which had a mark on its lower surface.

Figure 4. Damage to the propeller blades

The nose wheel gear collapsed on the first impact, and it was also when the propeller broke.

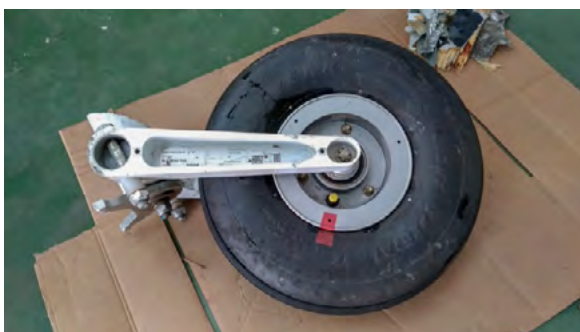
Figure 5. Damage to the nose wheel gear
