OPERATIONAL SAFETY RECOMMENDATIONS

Reference: REC 12/21, REC 13/21, REC 14/21 y REC 15/21

Date: 26 May 2021

Investigation A-011/2021, opened by the Civil Aviation Accident and Incident Investigation Commission, has found that:

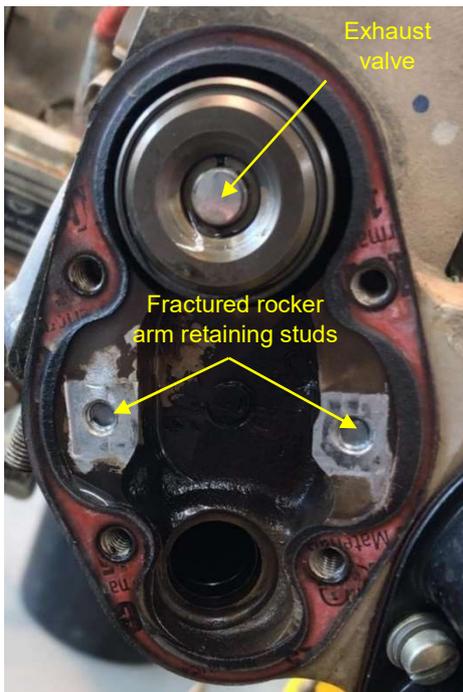
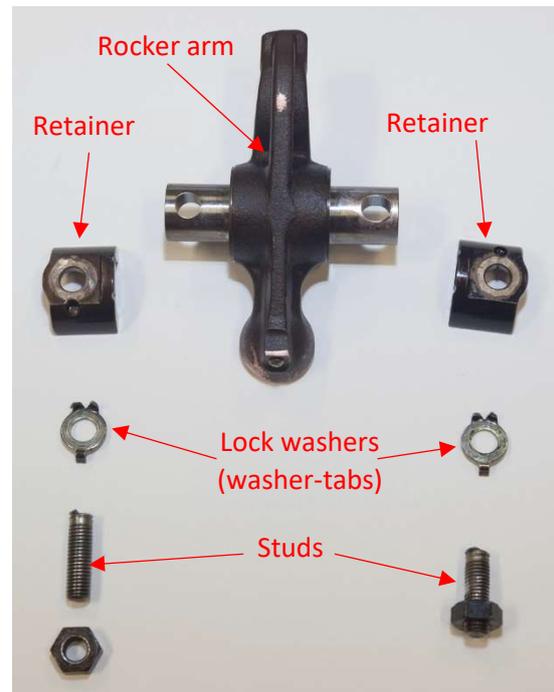
The exhaust valve rocker arm in engine cylinder no. 4 was found completely detached.

- The shaft remained assembled in the rocker arm housing. The two washers on each side of the rocker arm were also in position.
- The retainers were loose but showed no signs of significant damage.
- The two stud bolts that hold the retainers had fractured at the point where they enter the cylinder head (figure 1 – left photograph).

- One of them had its threaded nut, and the other did not.
- The threads on the stud bolt that did not have the threaded nut showed no significant damage. Its missing nut was found entirely separated from the stud with its threads in good condition.
- The two lock washers were also found detached, intact, and with no appreciable damage.

Figure 1. Photographs of the exhaust area of cylinder no. 4 (left) and of the elements that were found loose (right)

The fact that a loose, unscrewed nut was found without damage to the threads of either the stud or the nut suggests it gradually unscrewed itself.

The purpose of the lock washer is to prevent the nut from working its way loose during engine operation. The fact that the nut had done so suggests the washer did not serve its purpose. Given that there were no signs of any significant damage that might have affected its performance, the most probable hypothesis is that the washer was incorrectly installed.

REC 12/21: It is recommended that Continental Motors, Inc. should carry out the necessary actions and investigations to determine the cause and nature (isolated, organisational, etc.) of the circumstances that led to the faulty assembly of some of the rocker shaft lock washers at its facility in Mobile (Alabama).

REC 13/21: It is recommended that Continental Motors, Inc. should implement measures to ensure the correct installation of the lock washers.

REC 14/21: It is recommended that Continental Motors, Inc. should determine which engine units have potentially left its factory in Mobile (Alabama) with an incorrectly installed lock washer.

REC 15/21: It is recommended that Continental Motors, Inc. should contact all operators of aircraft equipped with engines potentially affected by this problem in order to verify the extent of the problem and, where necessary, replace the defective washers.

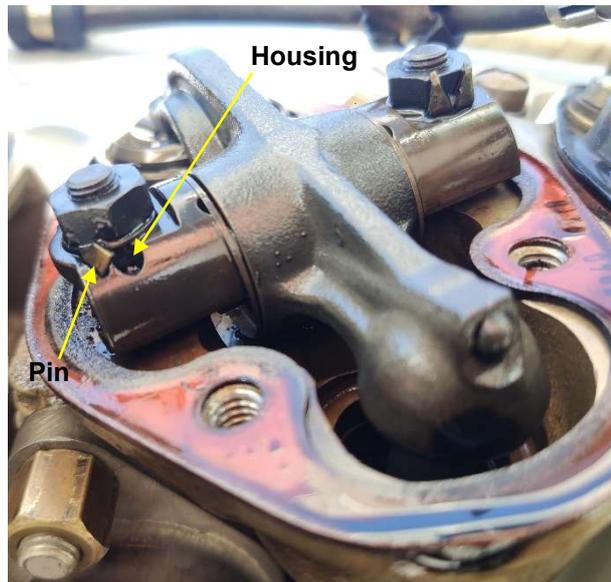
We found that one of the retainer nut lock washers in the exhaust valve of cylinder no.3 was incorrectly installed, as the pin had not been inserted into the retainer housing (see figure 2).

If the pin is not inserted into the housing, the washer doesn't brake the nut effectively and, therefore, it could come loose.

Figure 2. Photograph of exhaust valve rocker arm cylinder no. 3, engine IO-240-B32, s/n: 1035257.
