TECHNICAL REPORT

A-013/2022

Accident occurring on 3 March 2022 during disembarkation of a Boeing 737- 800 aircraft bearing the registration EI- DHH, operated by RYANAIR, at Ibiza Airport (Balearic Islands, Spain)

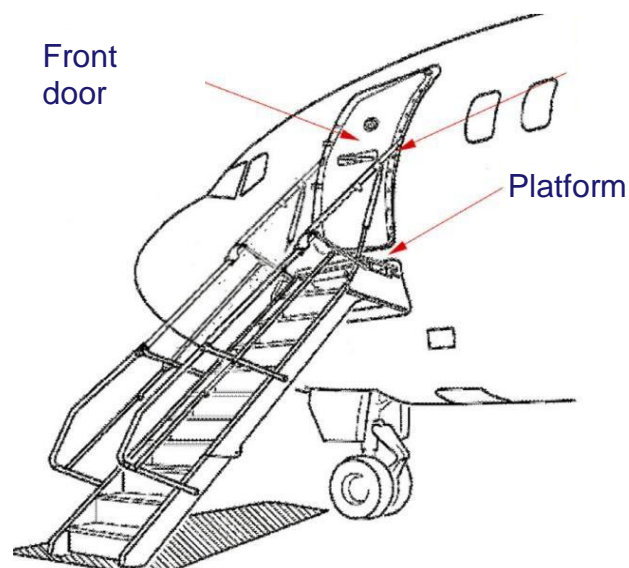
Figure 1. Extendable front stairs on the Boeing 737-8SA

These types of stairs have narrower steps and thinner and lighter handrails than the stairs that are external to the aircraft, which are normally provided by airport handling services³.

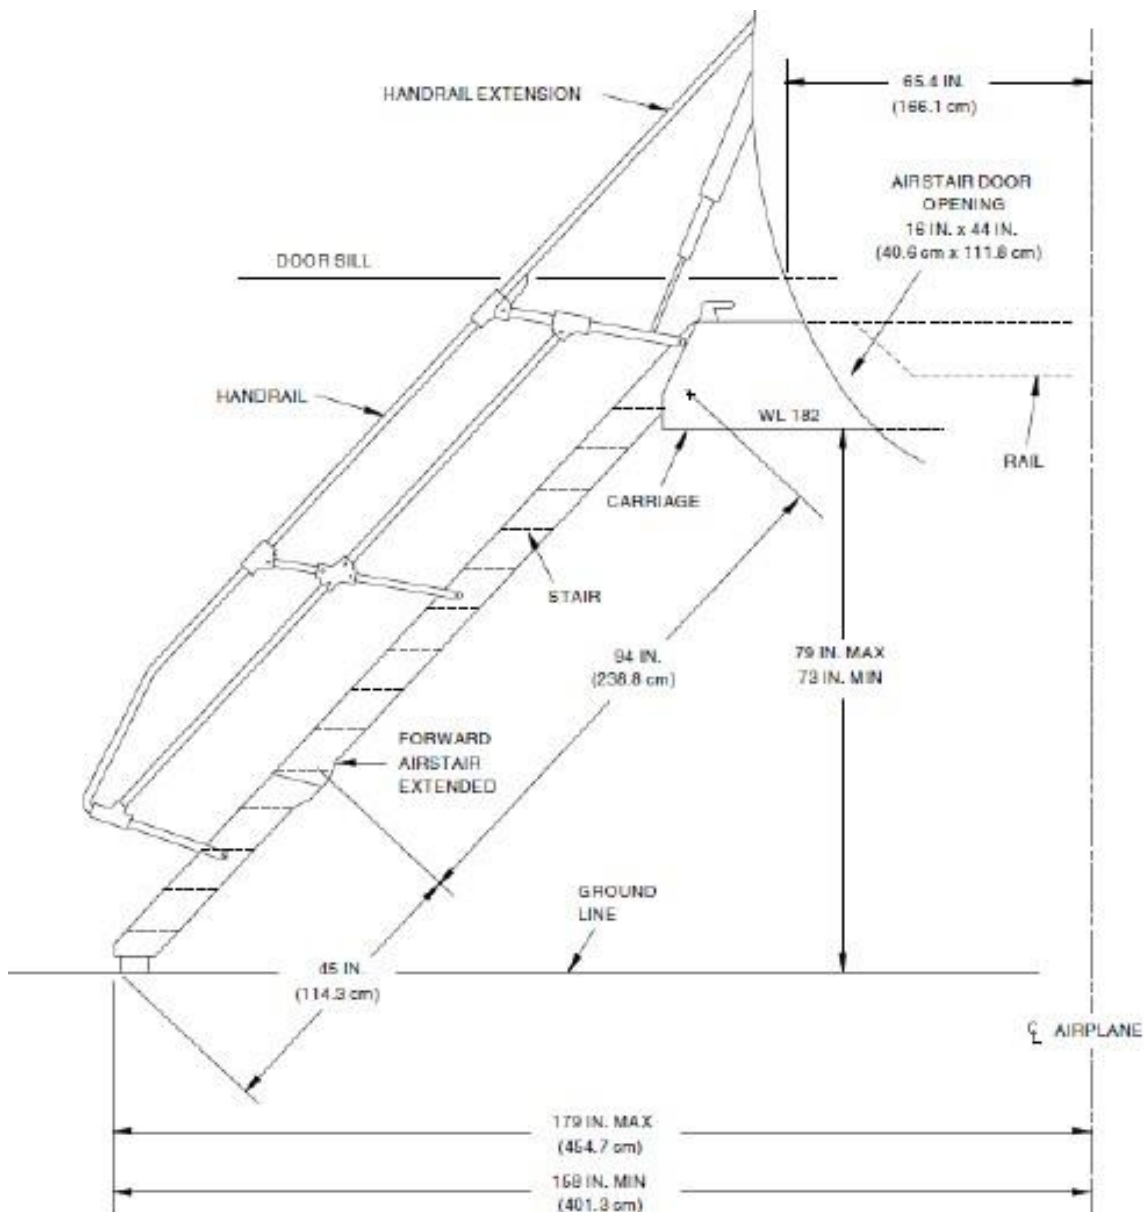
The dimensions of the stairs are defined in the Boeing document titled “Airplane Characteristics for Airport Planning”. The height of the stairs can vary, ranging from 1.85 m to 2 m, with a length of 3.53 m. Consequently, the gradient of the slope ranges from 62 % to 69 %, respectively.

The stairs are 0.62 m wide and have a total of 12 steps, covered with non-slip material in the tread area.

Figure 2. Dimensions of the extendable front stairs on the Boeing 737-8SA
