CIAIAC

Report A-015/2017

Accident involving a Bell 206B3
helicopter, registration D-HHMP,
operated by Rotorsun, in Pego
(Alicante) on 5 August 2017

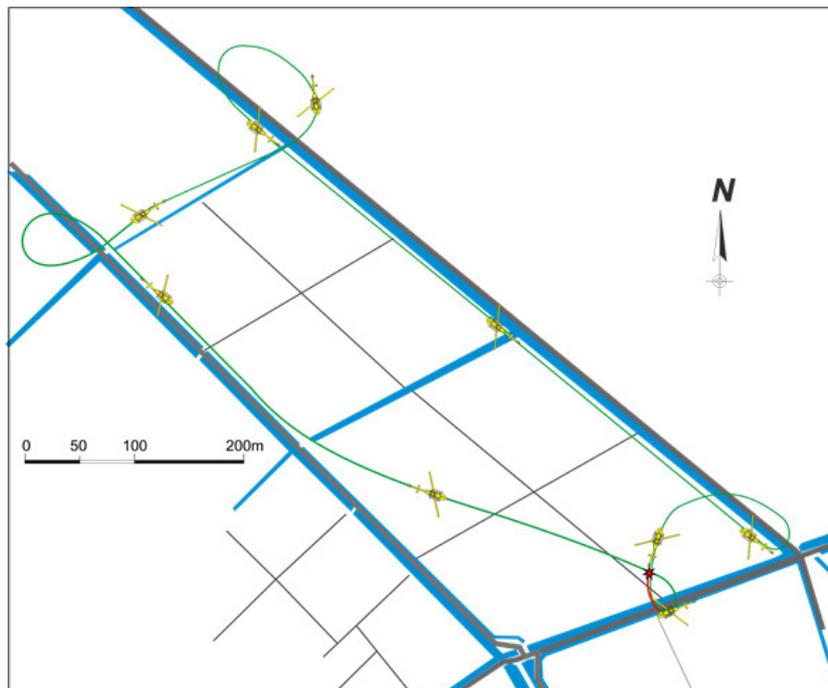
Figures 1 and 2 show, respectively, the flight path taken on the flight prior to the accident, and the final takeoffs recorded on the DGPS, including the one immediately prior to the accident.

Figure 1. Flight path taken by the helicopter in the flight before the accident flight

An analysis of the flight paths obtained from the data recorded by the differential global positioning system (DGPS), shown in Figures 1 and 2, does not reveal any anomalies in the operation performed. It does show, however, that the flight paths taken by the aircraft in the last takeoffs carried out, shown in Figure 2, involved a right turn in every case.

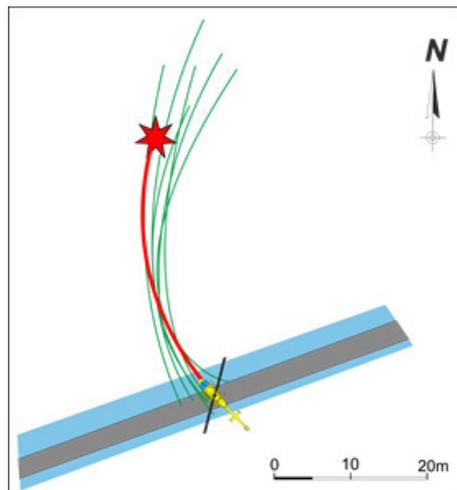
Figure 2. Flight paths taken by the aircraft in the final takeoffs recorded by the DGPS

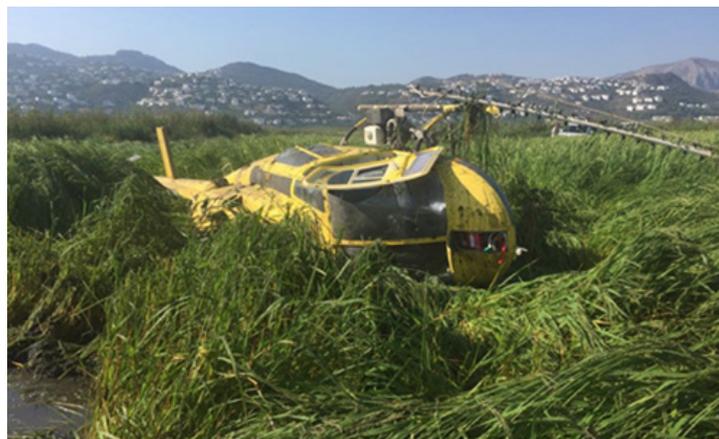
The aircraft impacted at coordinates $38^{\circ} 51' 43''$ N, $0^{\circ} 03' 11''$ W, at an elevation of 0 m. It came to rest on its right side near an irrigation canal for the rice paddies, some 50 m away from the takeoff point.

After the initial contact between the fumigation boom and the ground, the aircraft's right skid impacted the ground, pivoting in an attitude consistent with dynamic rollover. The aircraft came to rest on its right side after the impact.

Figure 3. Condition of the aircraft after impact

In these conditions, it is likely that the helicopter descended more than the pilot expected, surprising him and not giving him enough time to react before the boom on the right side made contact with the field he was spraying. This caused the dynamic rollover of the aircraft, which initially pivoted about the spray boom and then about the right skid before the main rotor eventually impacted the ground.
