TECHNICAL REPORT

A-015/2021

Accident on 08 May 2021, involving a STORM FURY RG aircraft, registration EC-XSB, off the coastline of Cala Reona (Murcia, Spain)

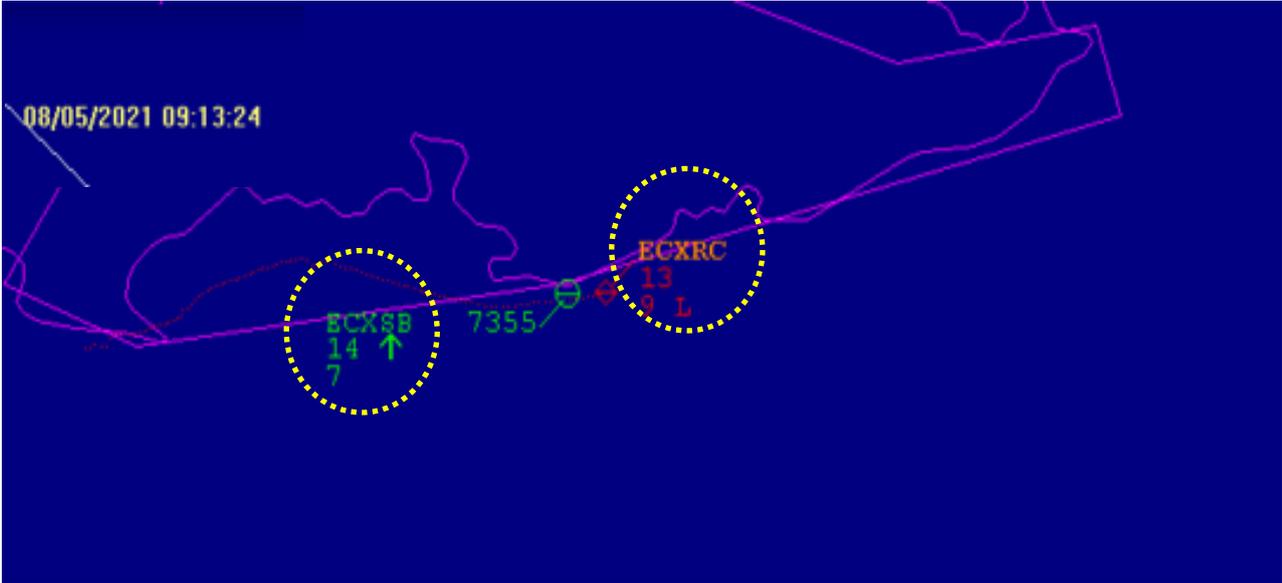
Figure 2. The two aircraft on the RADAR lay for the first time

At 11:13:24 h (figure 2), the two aircraft appeared for the first time on the RADAR display, and aircraft EC-XSB can be seen on the SACTA display travelling through 1,400 ft AGL with a ground speed (GS) of 70 kt. A duplication of the transponder also appears due to some kind of problem relating to the reception of the SSR code signal. At that time, both aircraft were above the corridor's permitted altitude.

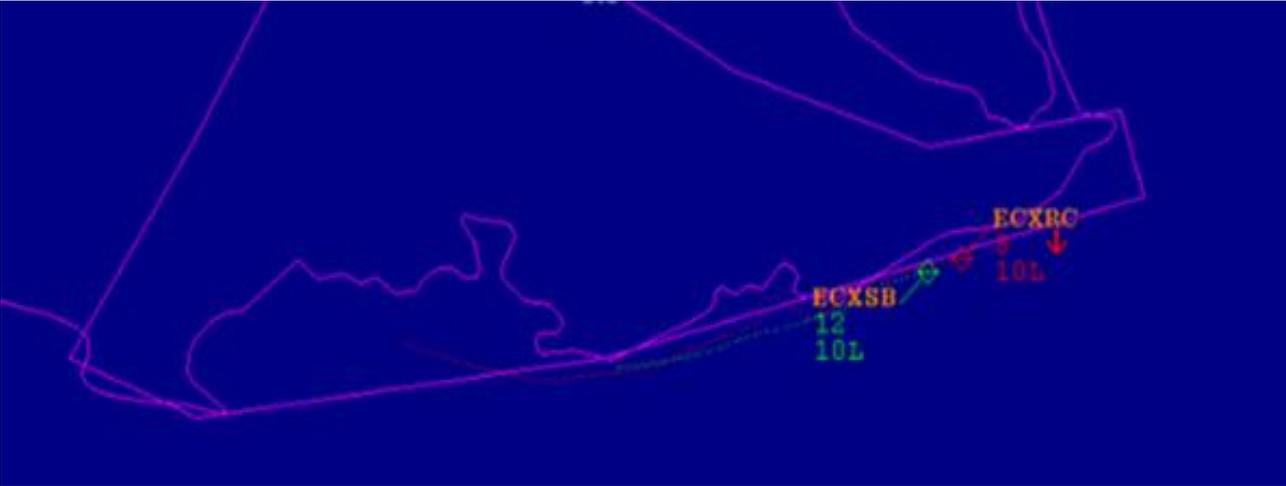
Figure 3. Position of the two aircraft on the RADAR display at 11:17:49 h

At 11:17:49 (figure 3), the trace shows the EC-XSB aircraft established at 1,200 ft AGL with a speed of 100 kt (GS). In front of it, the EC-XRC aircraft is descending through 800 ft. The first aircraft is still above the corridor's permitted altitude.

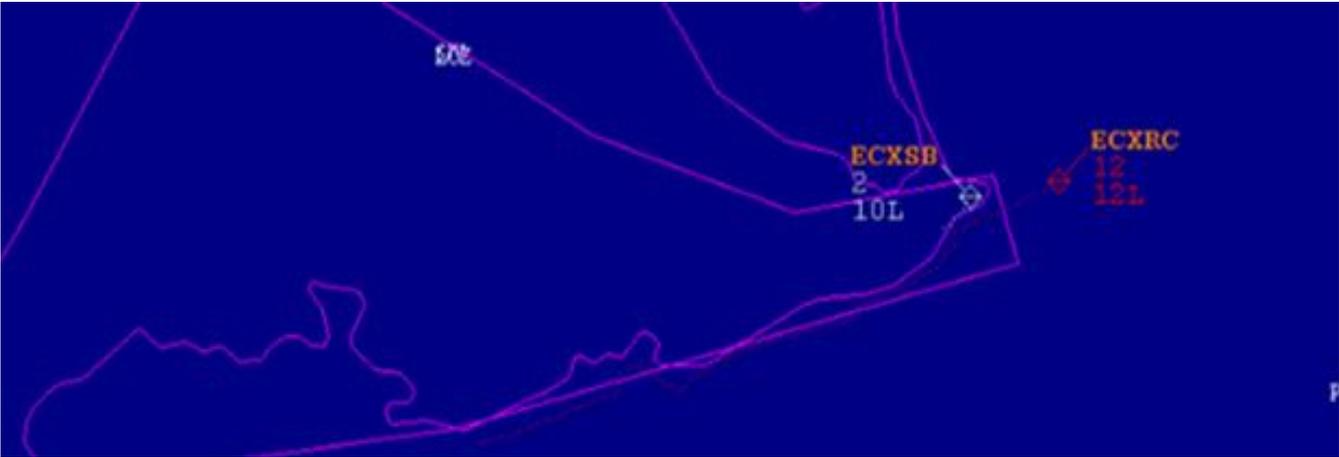
Figure 4. Position of the two aircraft on the RADAR display at 11:21:22 h

At 11:21:42 h (figure 4), the trace shows the EC-XSB aircraft maintaining 200 ft AGL flying over Cabo de Palos at a speed of 100 Kt (GS). In front of it, the EC-XRC aircraft is at 1,200 ft.

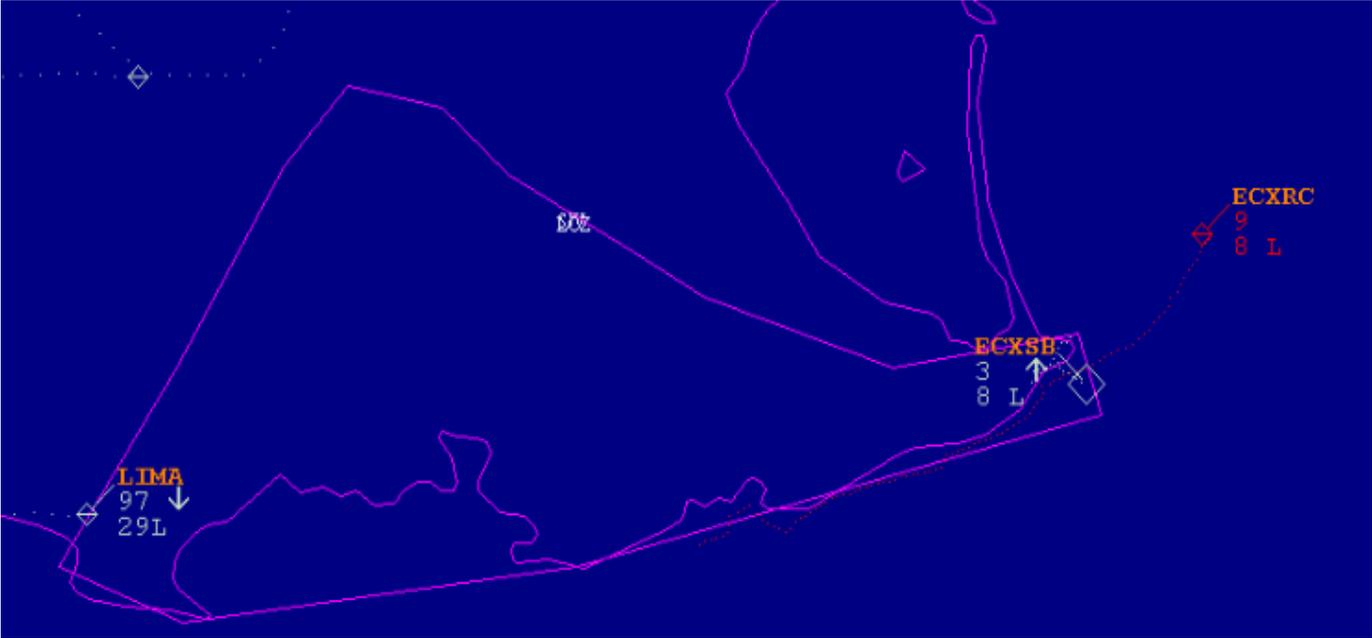
Figure 5. Position of the two aircraft on the RADAR display at 11:22:54 h

At 11:22:54 h (figure 5), the trace shows the EC-XSB aircraft at 300 ft AGL flying out to sea above Cabo de Palos with a speed of 80 Kt (GS). Ahead of it, the EC-XRC aircraft is descending through 900 ft.

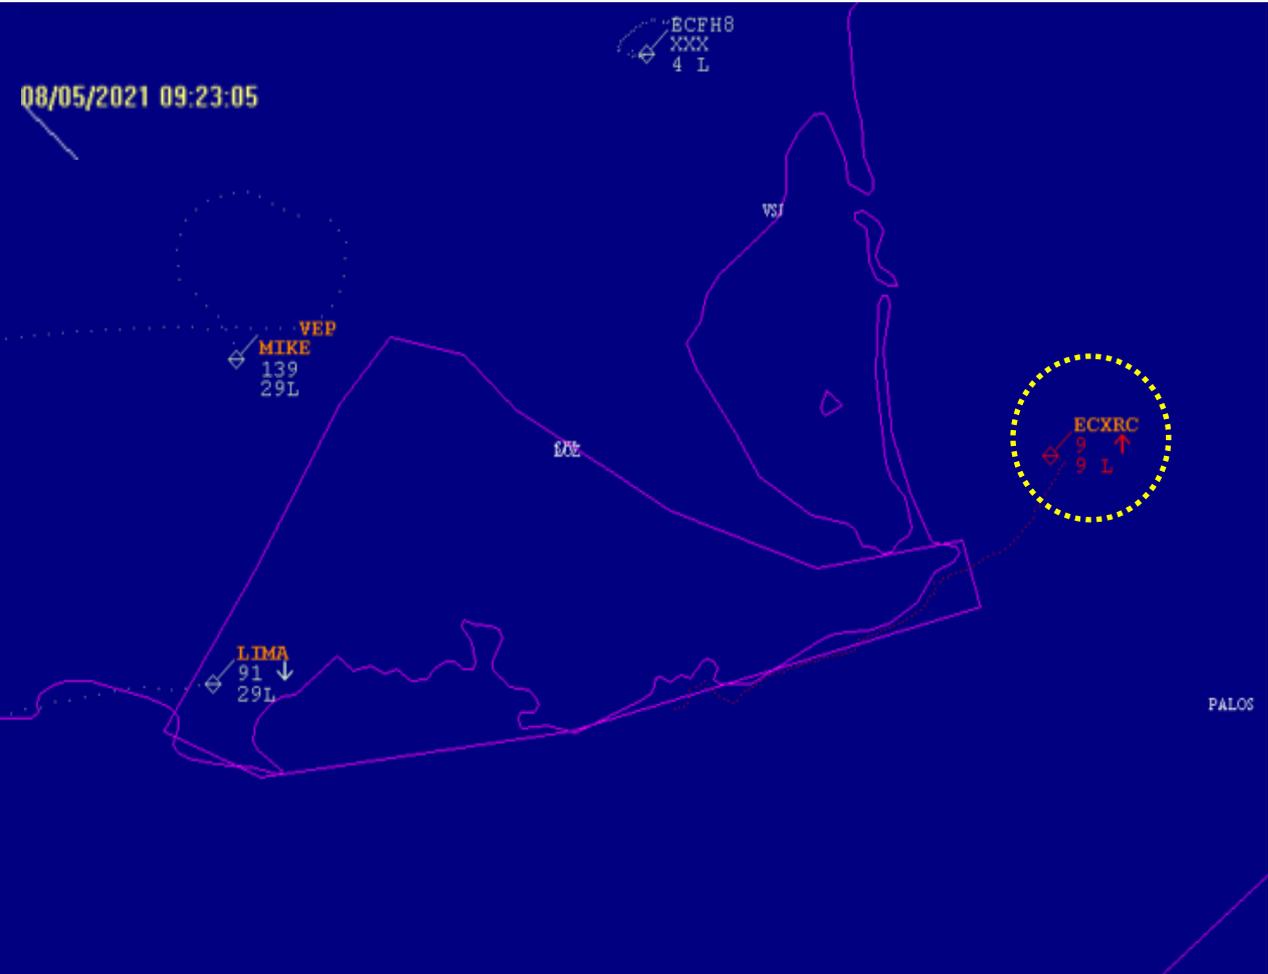
Figure 6. Aircraft EC-XSB disappears from the RADAR display

At 11:23:05 h, the EC-XSB aircraft disappears from the RADAR display

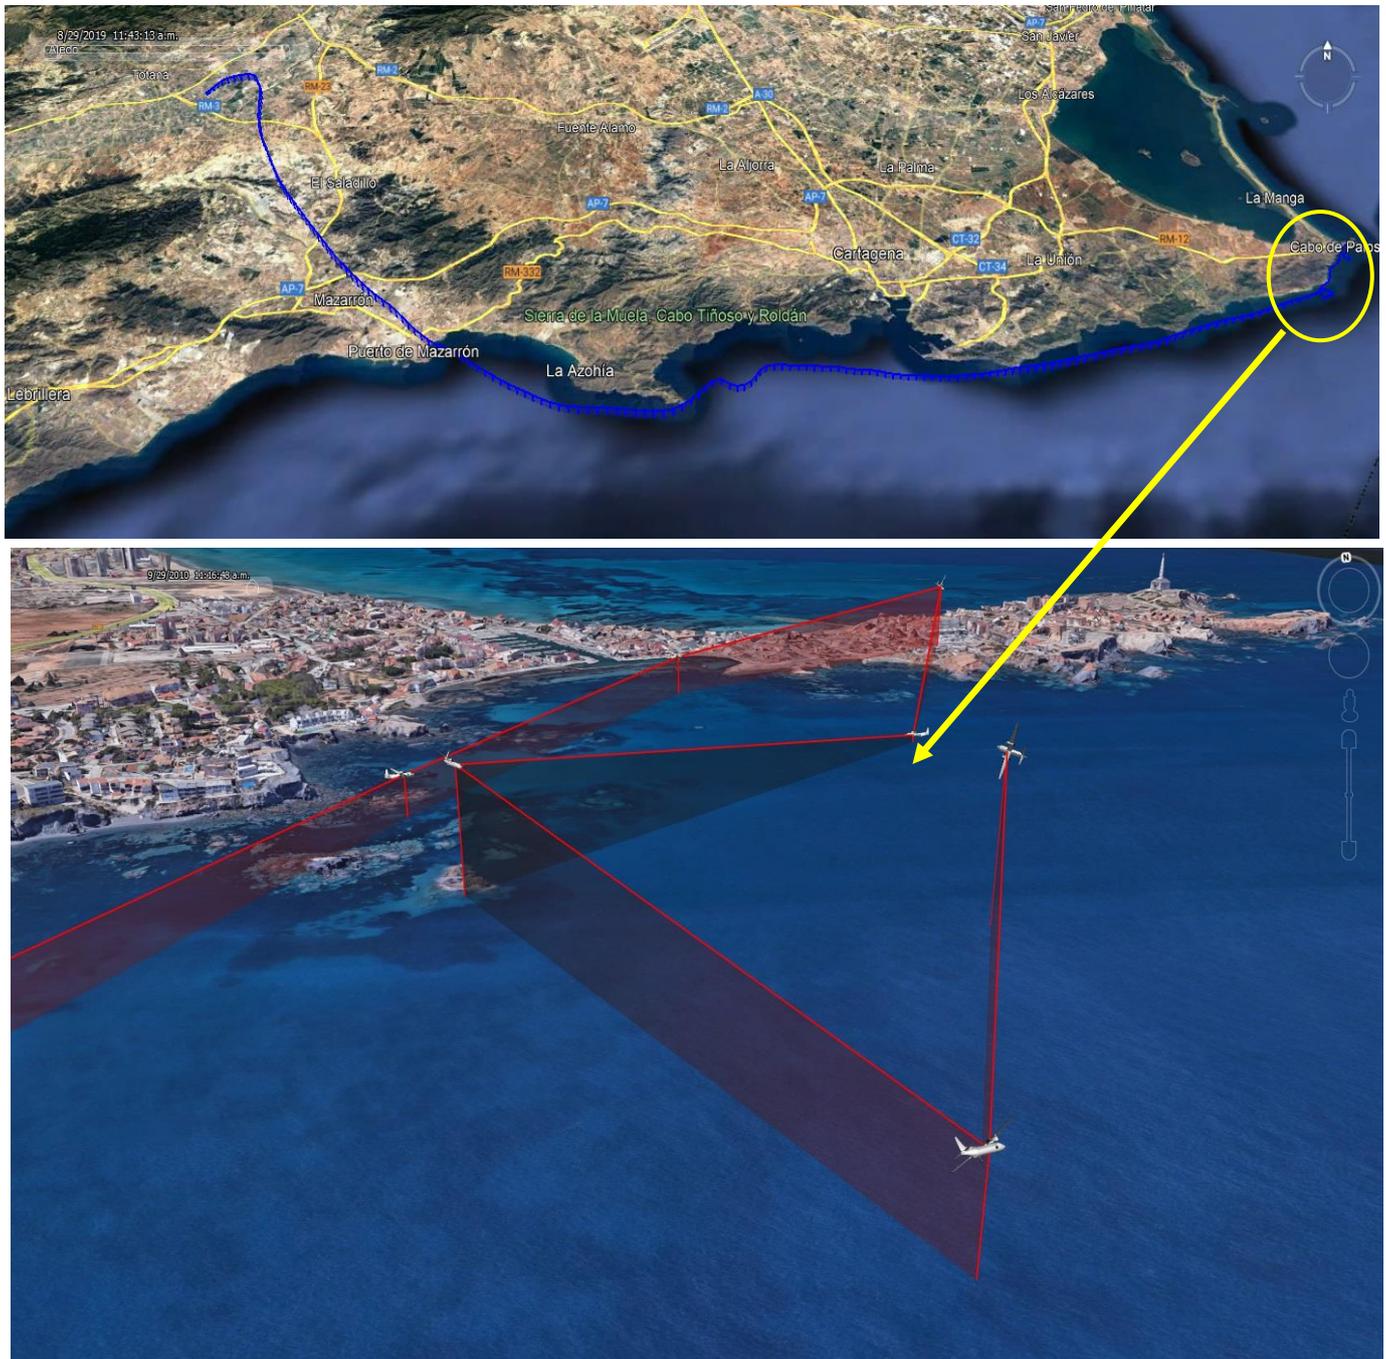
Figure 12. Flightpath of the EC-XSB aircraft

At 11:16:31 h, it began a gentle descent at 1,508 ft and, according to the data recorded by the EFIS, continued to descend at a rate of around 300 ft/min until 11:19:51 h, when the rate of descent increased to 1,098 ft/min.

Then, at an altitude of 465 ft, its speed increased to 128 km/h, and it began to descend at a rate of 734 ft/min. At this point, the aircraft was pitched 5.88° downwards, and its roll angle was 44.75° to the left. These high values, entirely outside of the standard range, would indicate that this was the moment he entered IMC conditions.

From that moment on, the aircraft continued to descend until it hit the sea, making several turns with high roll angles to both sides in the moments prior to impact. The last turn before the impact was recorded had a roll angle of 71.5° to the left, as shown in figure 12. In the last recording, made at 11:21:11 h, the aircraft's flight profile shows a steep descent before the recording ends.

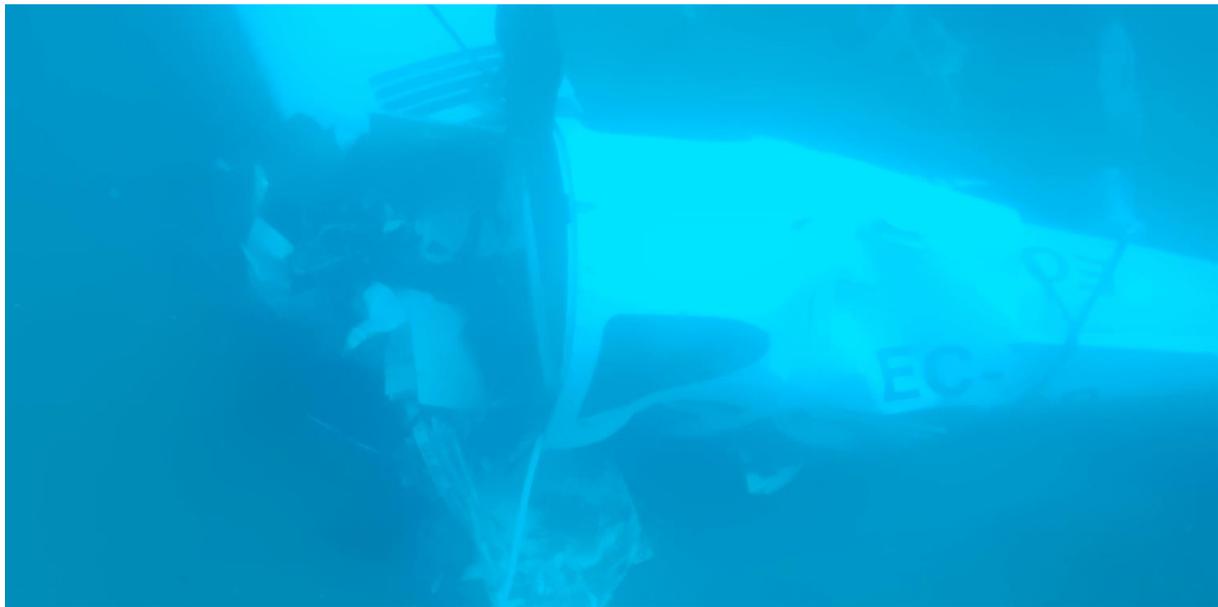
Figure 14. Aircraft on the seabed

The fuselage had a deformation that extended from the top to the left side area, on a level with where the license plate letters began.

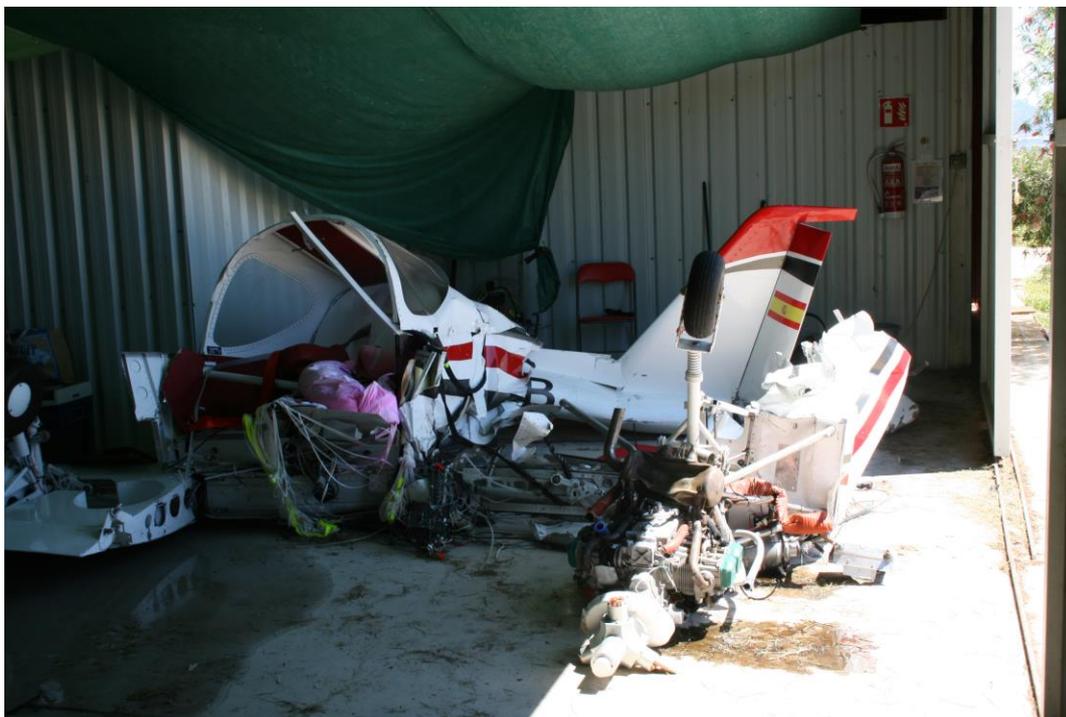
Figure 15. Photograph of the aircraft in the hanger

The right wing was also practically intact apart from a minor impact to the flap that caused a small downward deformation near the external hinge and attachment point.

The right main gear housed in that wing was deployed and locked.

The left wing showed signs of a significant impact and was missing practically all the cladding on both its upper and underside, although its entire internal structure was intact.

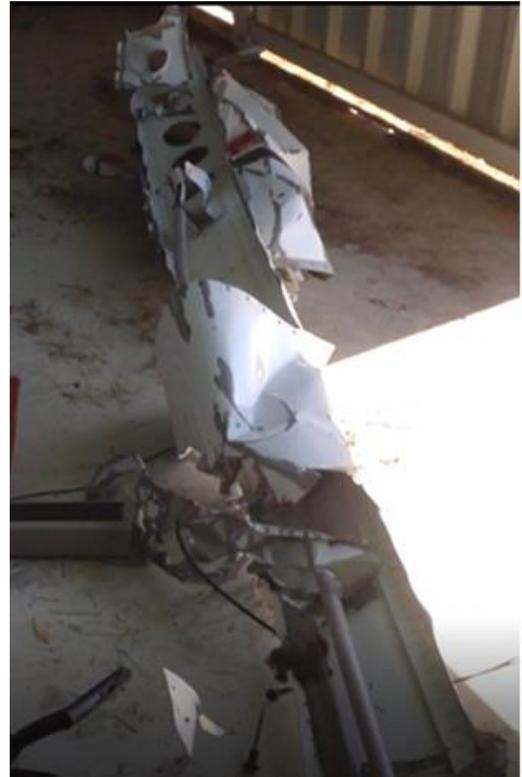
Figure 16. Left wing

The leading edge spar was almost intact but showed signs of a severe impact. .

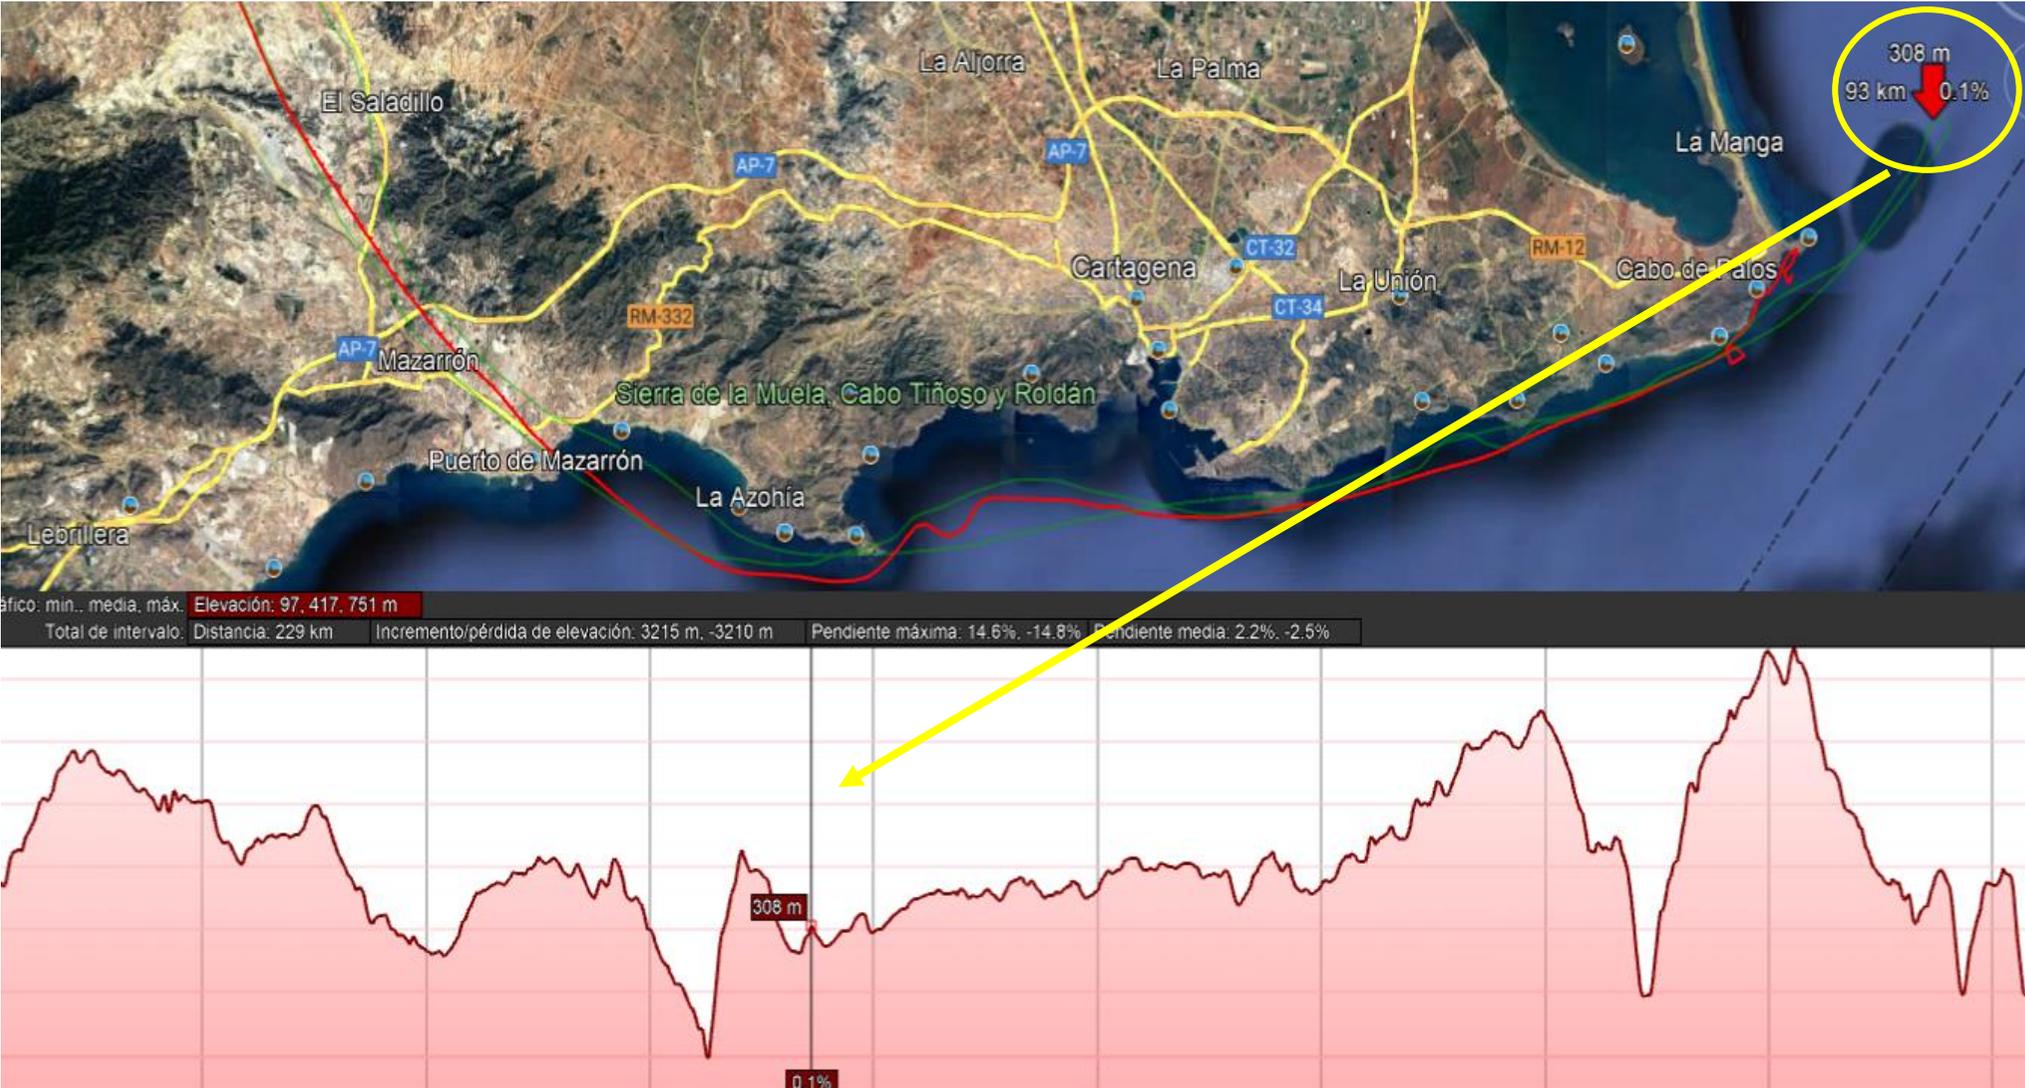
ANNEXE 3. FLIGHT PROFILE OF AIRCRAFT EC-XRC

The following figure shows the moment the EC-XRC aircraft turned around. The figure of the Anexx 2 is the flight profile, which shows that it made a very steep descent and subsequent climb. On both the outbound and inbound legs, it changes its altitude numerous times.
