## Report A-016/2019

Accident involving a Diamond Aircraft DA 40 D aircraft, registration G-RKAH, in the vicinity of the Huesca Airport (LEHC) on 10 April 2019

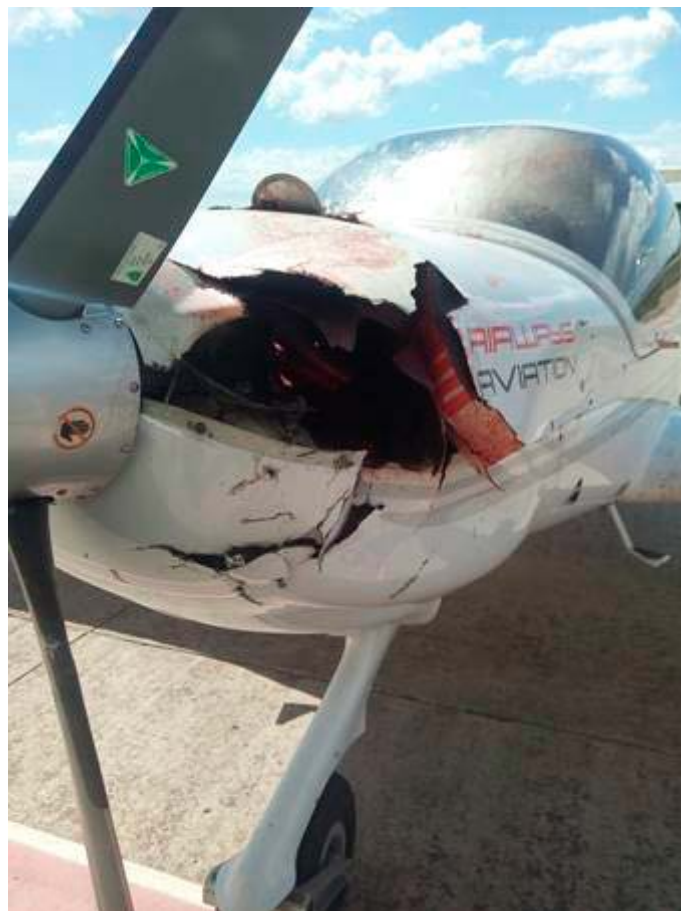
Much of the front left part of the aircraft's nose was damaged.

As a result of the bird strike, the aircraft sustained significant damage to its propeller, including the gearbox, the engine cover and the engine (engine mounts, radiators, accessories and connections).

Fig. 1 Front view of the aircraft

The accident was caused by the head-on collision between a vulture and the aircraft.
