## Report A-018/2018

Accident involving a Socata Rallye  
235 E aircraft, registration EC-CYO, in  
the vicinity of the aerodrome of  
Fuentemilanos (Segovia) on 15 May  
2018.

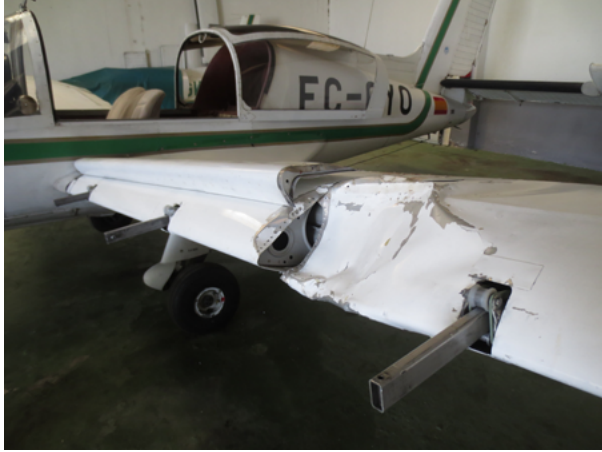
During the return flight to the aerodrome, the leading edge on the inboard third of the aircraft's left wing impacted a vulture.

Figure 2. Deformation of the leading edge<sup>2</sup>

As a result of the birdstrike, the aircraft sustained significant damage to both the structure and the leading edge slats on the left wing.

This damage indicates that the vulture impacted the top of the slats, deforming them and then, as a consequence of the strong impact, the structure was also deformed.

The nature of the damage is consistent with a slightly downward flight path by the vulture with respect to the aircraft's flight path.

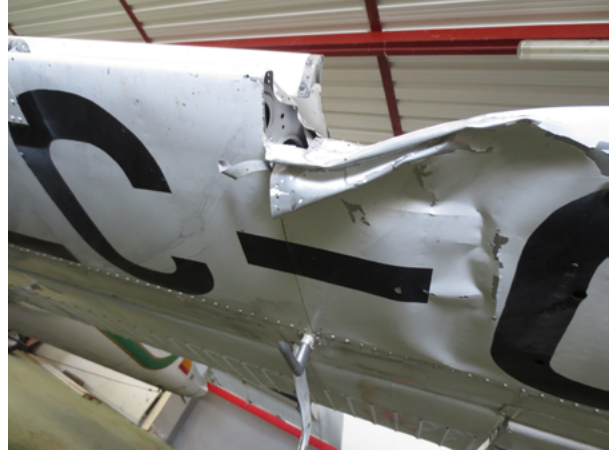
Figure 3. View from the bottom

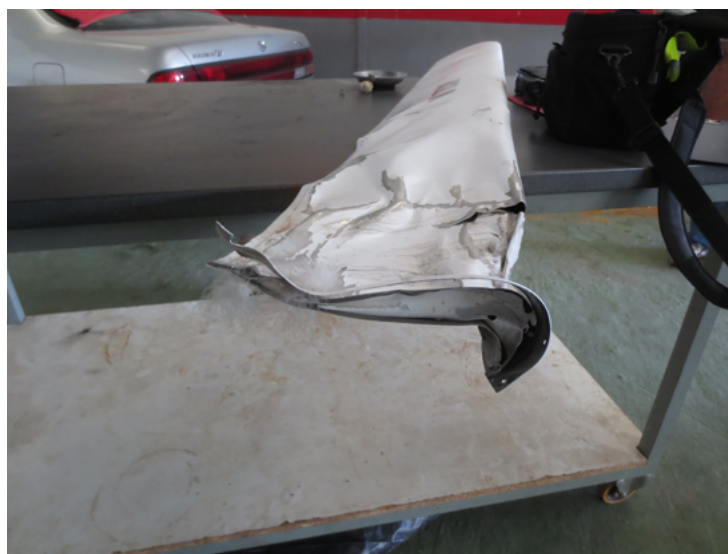
Figure 4. Deformación del slat
