Report A-018/2020

Accident on 20 June 2020,
involving a TECNAM P2002-JF
aircraft operated by FlyBai,
registration EC-MOH, at Burgos
Airport

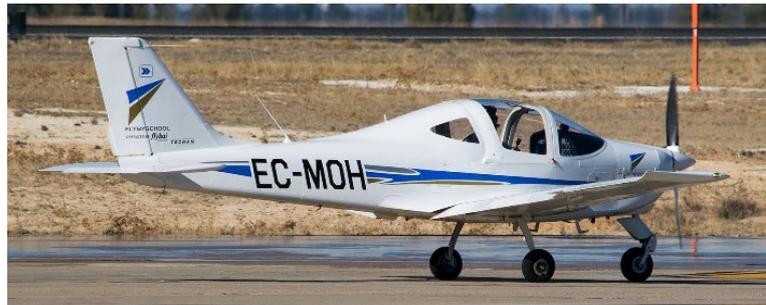
During the landing roll, when the aircraft had already slowed down, the left main landing gear leg detached.

The aircraft came to a halt on the runway, resting on its right and front landing gear legs and left-hand wing and horizontal stabiliser tips.

Figure 1. Photograph of the aircraft

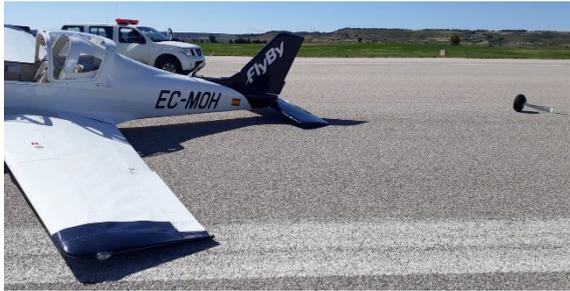
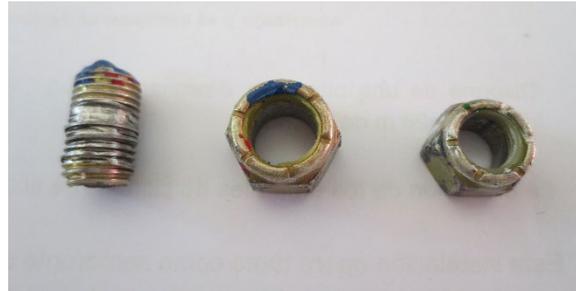
Figure 4. Photographs of the aircraft on the runway and the nut and bolt fragments found on the runway. The left main landing gear had detached, and was on the runway a few metres behind the aircraft (see figure 4).

A light, roughly 5 m-long mark made by the tip of the left wing was the only visible mark on the runway.

A leather spacer, a fragment of a bolt and two nuts were also found on the runway.

The inner mounting bolt was also in its housing inside the structure, although it had snapped at the first thread. The bolt fragment found on the runway matched the missing part of the inner bolt.

The two nuts found on the runway were for the inner bolt and the outer front bolt.

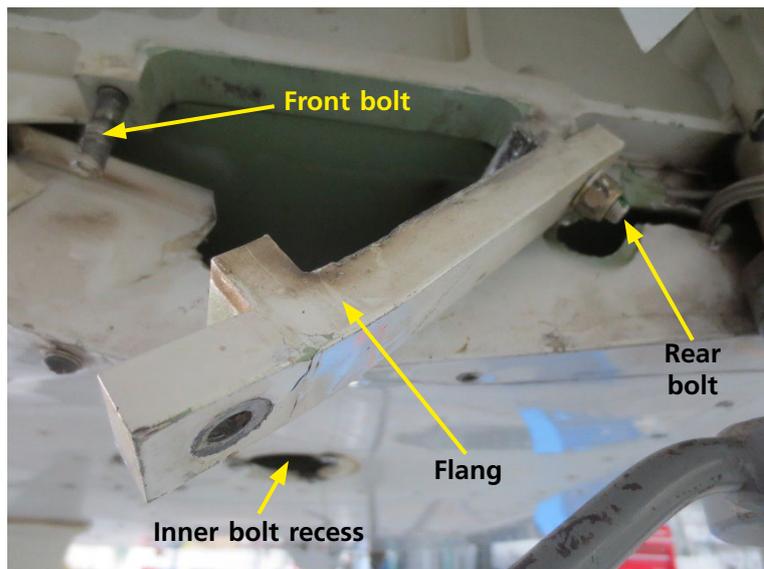
Figure 5. Photograph of the attachment points of the left main landing gear

The right main landing gear was dismantled and its geometry was compared with that of the left gear, noting that the latter was about 15° more open than the right.

The aircraft's inspection showed that the leaf spring damper on the left main landing gear was more open than that of the right main landing gear. This condition could have been caused by a hard landing, a circumstance not uncommon in school aircraft. In addition to deforming the leaf spring damper, a hard landing could potentially also have damaged the mounting bolts of the left main landing gear, which would further compound the damage caused by the excessive tightening torque.

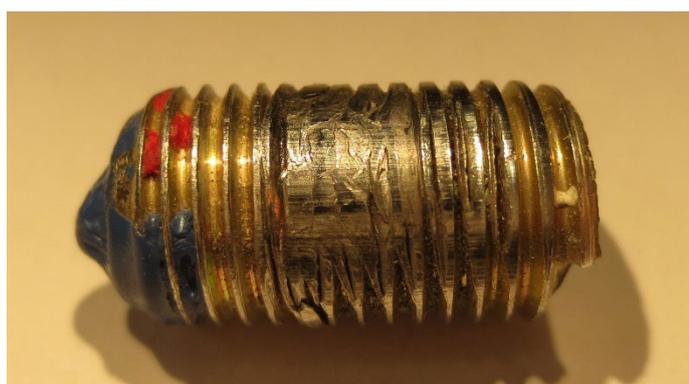
The bolt had fractured at the first thread, i.e. at the point where the shank ends and the threaded area begins.

Between threads n° 10 and 12, there was a fragment of nut thread, corresponding to about two screw turns, which was loose.

At the end of the bolt, there were traces of two different types of safety putty (red and blue), which is used to quickly detect if a nut has come loose. The red putty was probably applied by Tecnam when manufacturing the aircraft because that is the only colour they use. The blue putty must have been applied subsequently, possibly on various occasions after the nut was re-tightened.

Figure 7. Photograph of the sheared fragment of the inner bolt (MS20006-27)

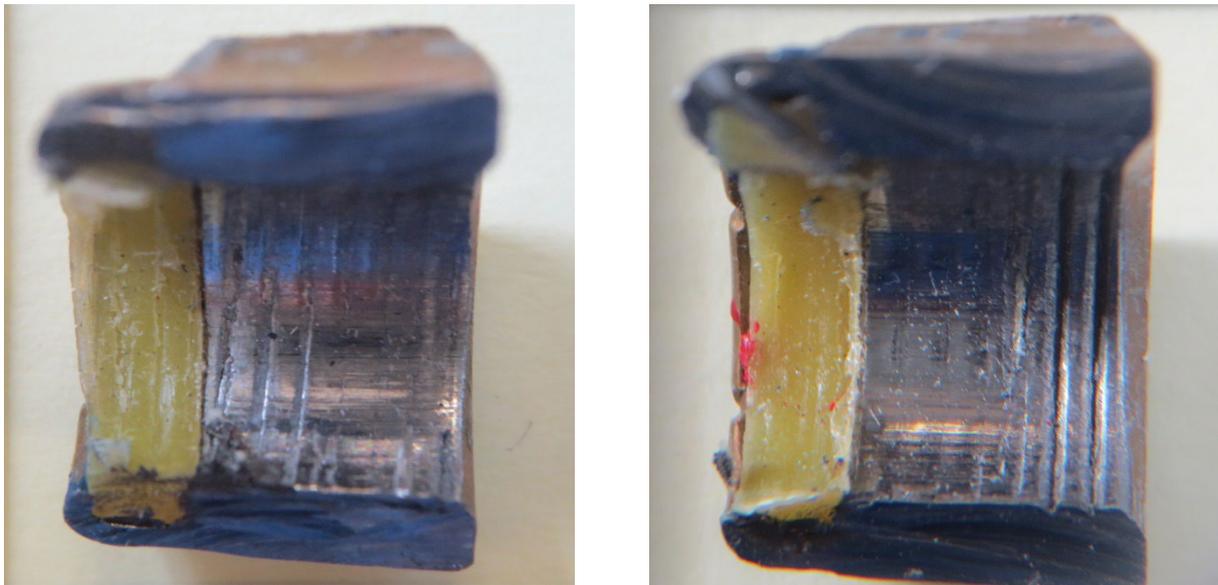
An inspection of the inner surface of half "A" with a binocular magnifier revealed that the four threads closest to the supporting face of the nut had been wholly sheared, while the three furthest from the seating face retained a little of their height. There were multiple longitudinal marks parallel to the axis of the bolt. There were no anomalies at the bottom of the threads.

Figure 8. Photographs of the inner bolt nut AN-365-624A, half "A" (left) and half "B" (right)

The four threads closest to the nut's outer face in half "B" were also sheared. However, the three remaining threads, which are the closest to the seating face, retained approximately half their height. There were multiple longitudinal marks parallel to the axis of the bolt.

Conversely, the examination of the inner bolt nut (AN365-624A) revealed that the threads were sheared by an axial load mechanism, and there was no evidence of previous damage due to over-tightening. However, the three threads closest to the supporting face of the nut displayed appreciable differences in each of the nut halves. This may have been due to an uneven distribution of the axial load, favouring the supporting face and causing the nut to wedge.

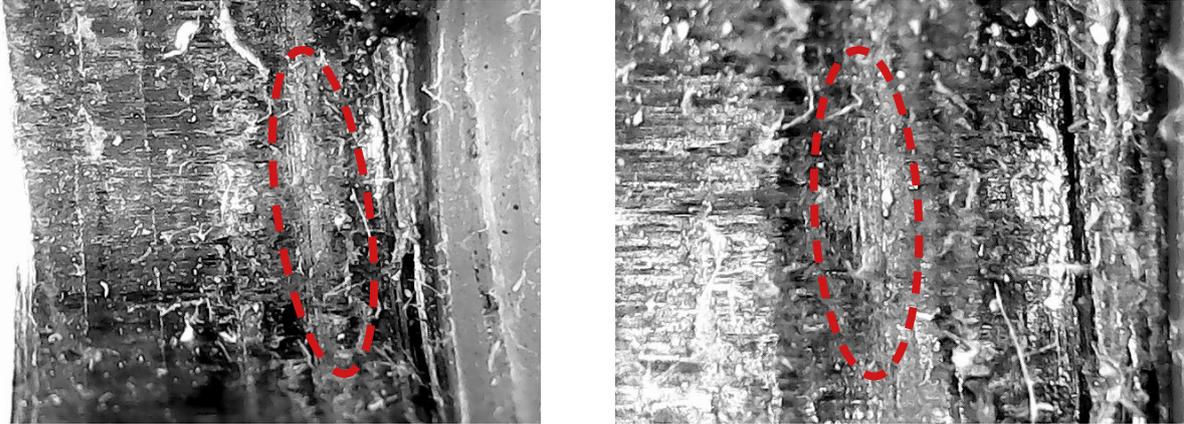
An inspection with the binocular magnifier revealed circumferential scratch marks (marked with a red dashed line in Figure 9) in various places around the sheared threads.

These marks are characteristic of the shear processes that occur when excessive torque is applied due to the relative rotation between the nut and the bolt, which generates the circumferential marks. Had shear only occurred from axial overload, there would only be marks in the axial direction.

Figure 9. Detail photographs of the sheared threads on the nut (AN365-524A) of the front outer mounting bolt of the left main landing gear

The examination of the front outer bolt nut showed that two different mechanisms contributed to the shearing of its threads. The radial marks it exhibited are indicative of excess torque being applied during the bolt tightening process, which initiated the breakage due to the partial shearing of the threads. In other words, the threads were only sheared in one part of the thread section, not all of it. As a result of this damage, the strength of the nut decreased. Even so, the nut remained threaded to the bolt until it was subjected to an axial load, possibly of less than its nominal strength, which caused the complete shearing of the threads.

REC 22/21: It is recommended that the aircraft maintenance organisation, Fly Bai Mantenimiento, S.L., should review and improve its procedures to minimise the risk of incorrect tightening torques being applied when checking the tightening torque of the main landing gear mounting bolts.

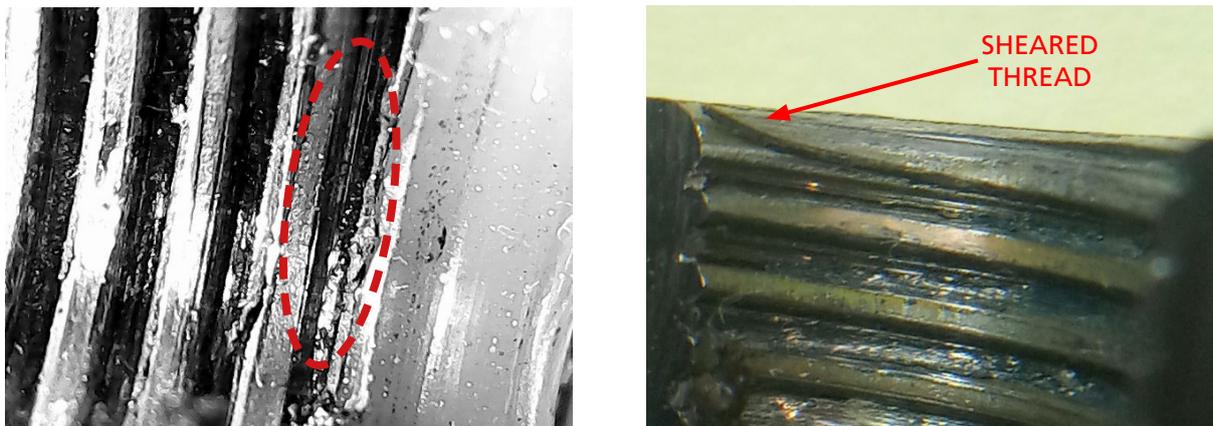
An inspection with the binocular magnifier revealed circumferential scratch marks (marked by a red dashed line in Figure 10).

Figure 10. Detail photograph of the circumferential marks on the threads (left) and the sheared section of the first thread

It also revealed that the first thread (the one closest to the nut's seating face) already had a sheared section.

The inspection of the rear outer bolt nut, which did not rupture, revealed radial marks indicative of over-tightening and possibly caused the complete shearing of a section of the thread closer to the supporting face.
