Report A-019/2020

Accident occurred to the aircraft
PIPER PA-28-161, registration
G-CETE, on June 26, 2020 at
the La Axarquia-Leoni Benabu
aerodrome (Málaga)

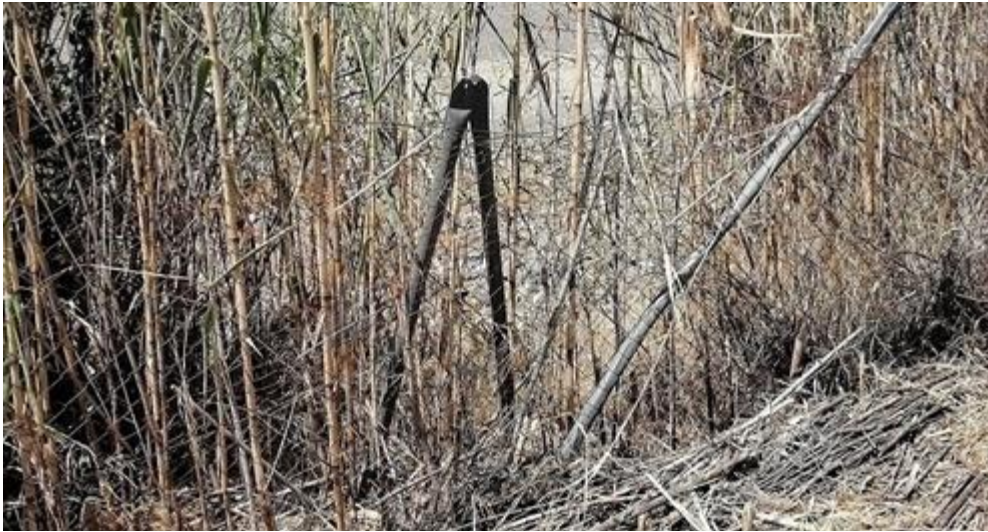
The aircraft collided with a metal fence located to the left of runway 30, which can be seen in Figure 1.

Figure 1. Damage to metal fence

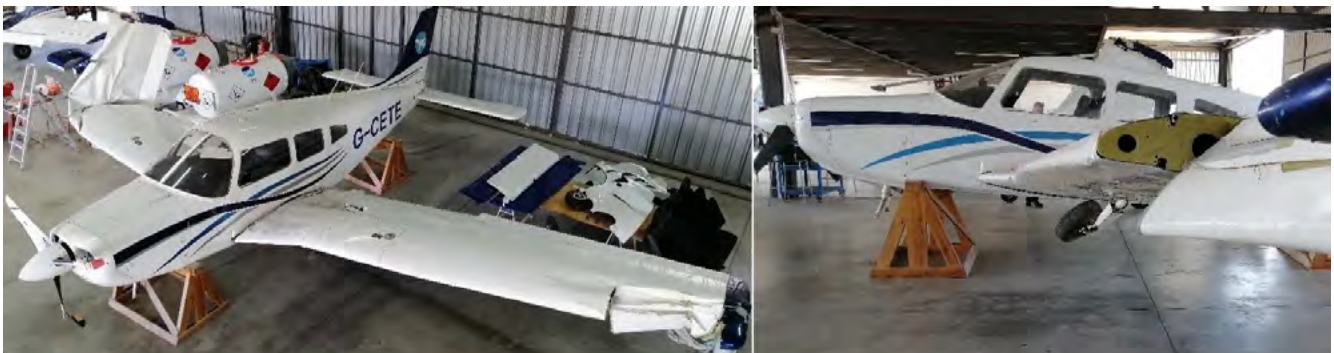
As a result of the accident, the aircraft suffered damage to both wings, landing gear and propeller. The nose and right main gear wheels were detached and the left main gear had collapsed.

Figure 3 shows the damage suffered by the aircraft.

Figure 3. Damage to aircraft G-CETE

It was observed that both wings were significantly damaged due to the impact with the fence. The damage was located mainly at the ends of the wings. It was also found that two of the landing gear wheels had come off, and that there was damage to the propeller blades.

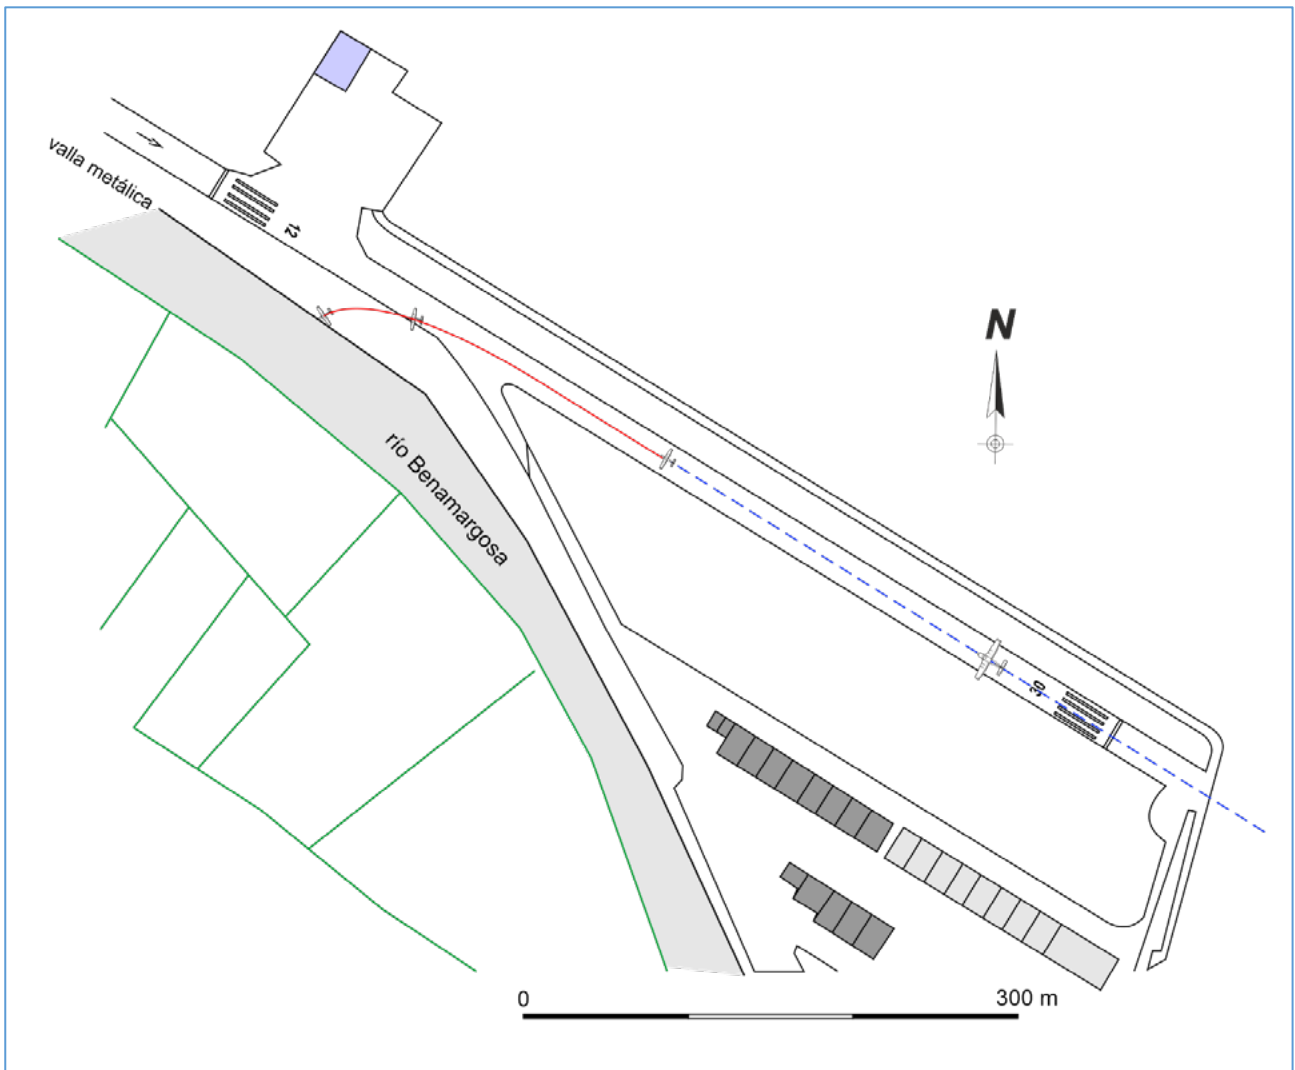
The landing was made on runway 30 of the aerodrome. The aircraft departed the left side of runway and came to rest as it collided with a fence 30 m from the runway center line.

The sketch included in Figure 4 roughly indicates the path followed and the final position of the aircraft.

Figure 4. G-CETE aircraft position after the accident
