Technical report

A-020/2021

Accident involving a Boeing 737-8AS aircraft,
registration EI-EGA, on 12 May 2021 at
Alicante Airport (Alicante, Spain)

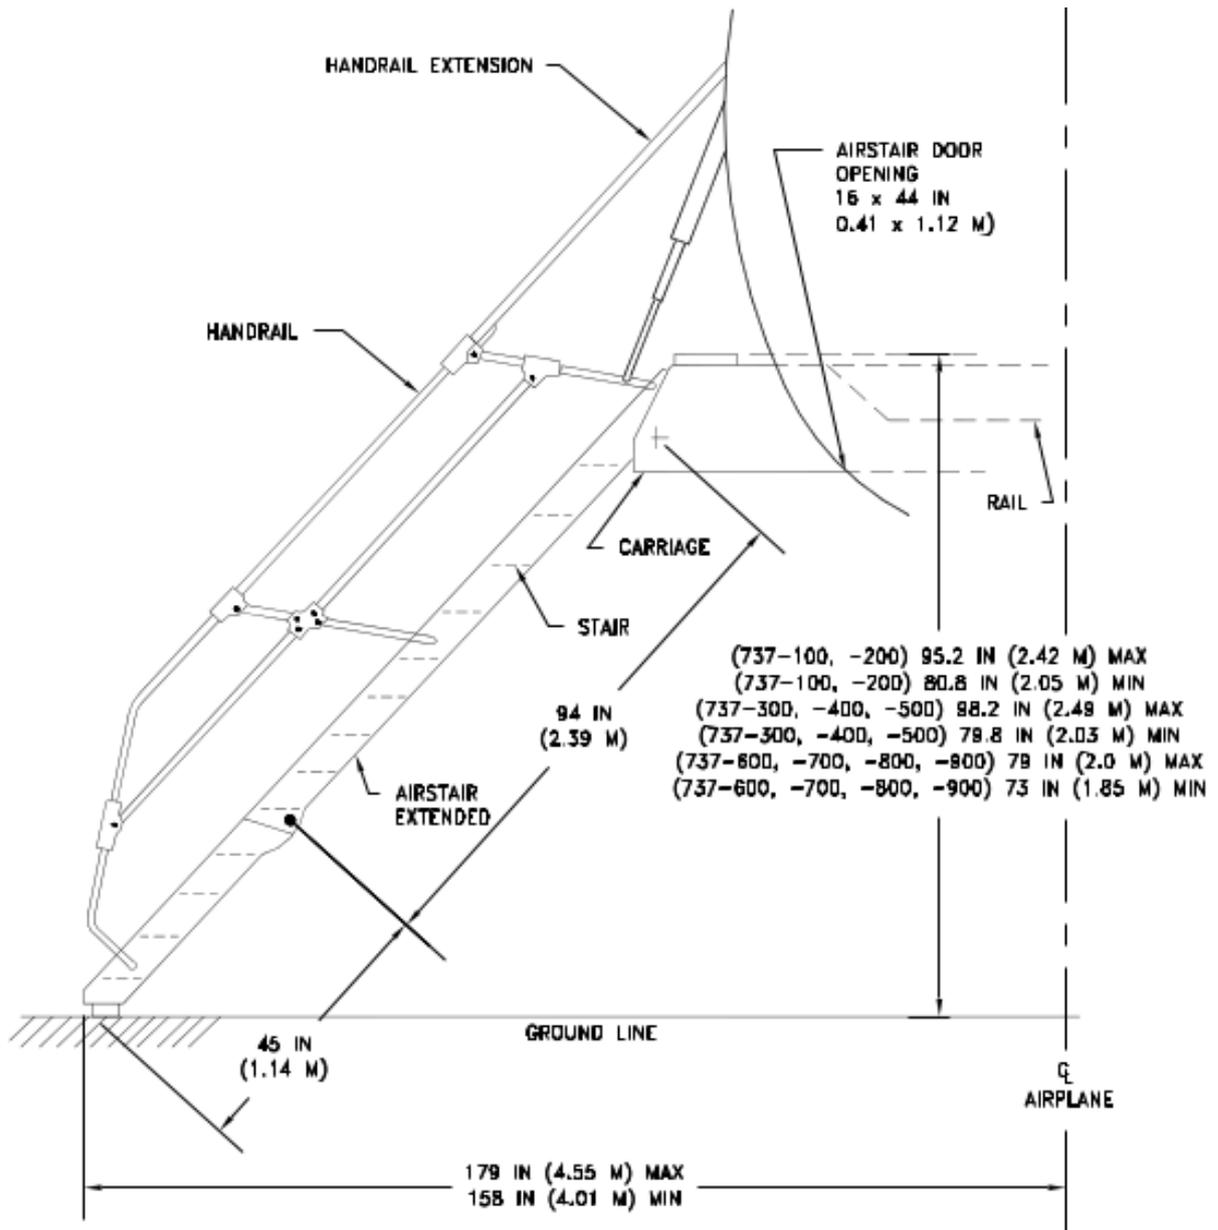
The following figure, extracted from Boeing's document on "Airplane Characteristics for Airport Planning", shows the dimensions of the stairs. The height of the stairs on the 800 model ranges from a minimum of 1.85 m to a maximum of 2 m, and the length is 3.53 m. Thus, the slope varies between 69% and 62%, respectively. The width of the stairs is approximately 0.62 m.

Illustration 1: Dimensions of the stairs on the Boeing 737 aircraft

Since the forward stairs are approximately 0.62 m-wide and about 60 cm is required to descend comfortably, this space was insufficient. According to the passenger himself, one of the suitcases got stuck on the stairs.

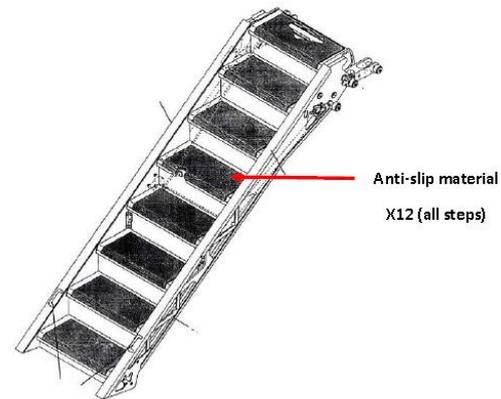
1.- The stair treads are covered with a non-slip material called 3M Safety Walk 710 - Coarse⁵

Although Ryanair's manuals also allow the use of the 3M Safety Walk 610 - General Purpose non-slip material⁶, the stairs of the aircraft in question are equipped with the former.

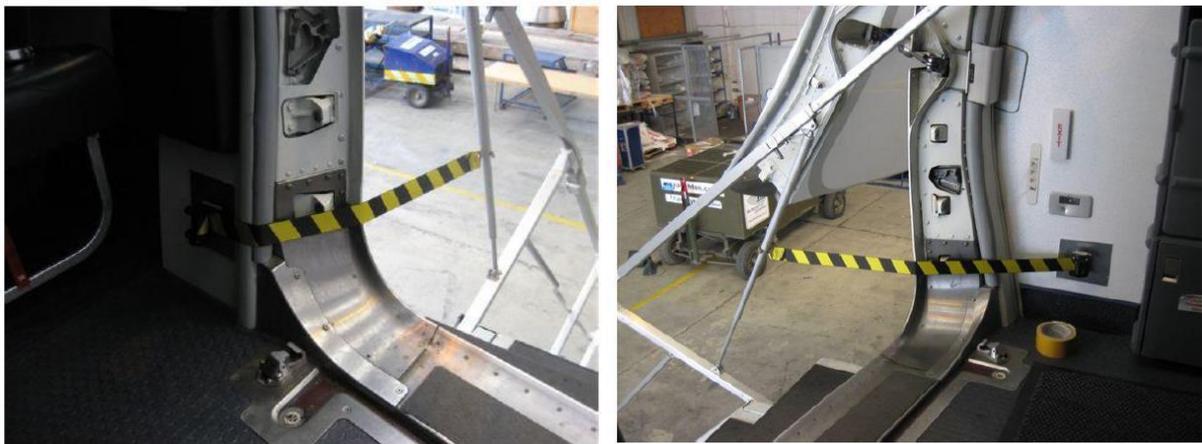
2.- In June 2010, retractable, high-visibility safety barriers were installed at the bottom of the forward Lav A bulkhead and the bottom of the cabin side wall next to and beneath 1ABC, as shown in the images:

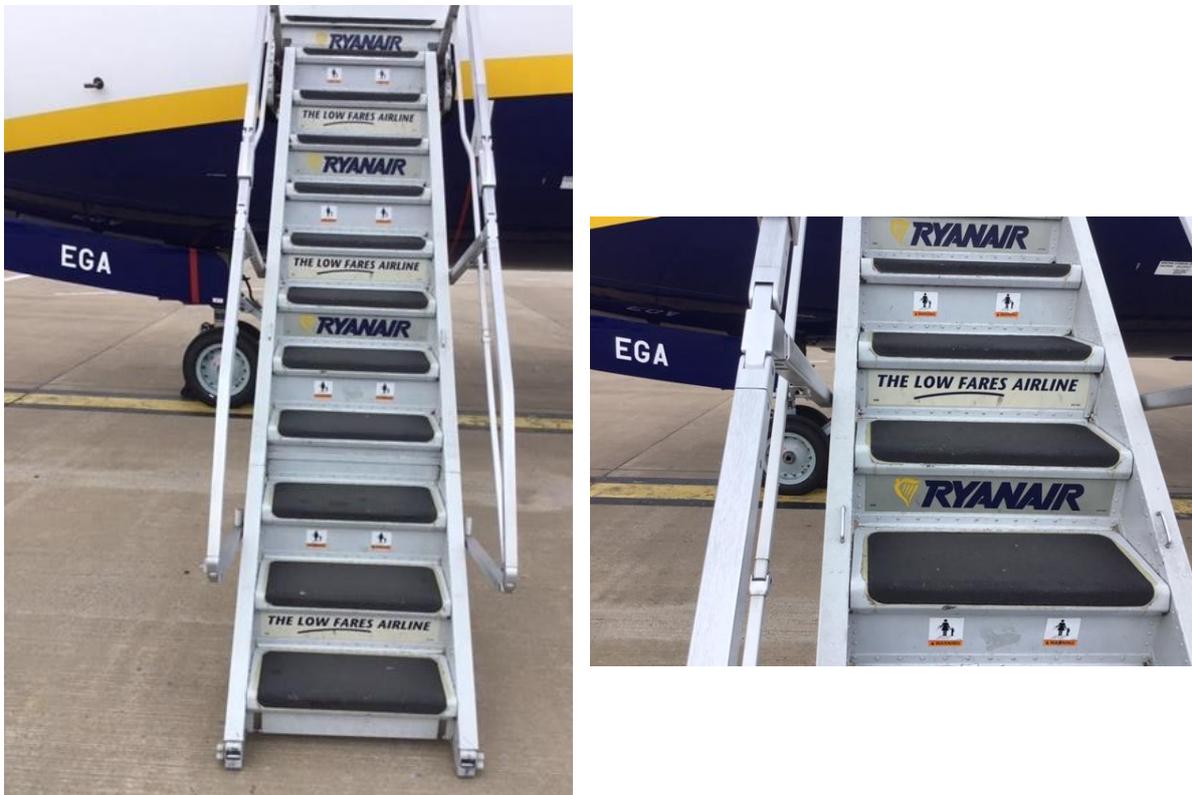
as per Special Airworthiness Information Bulletin (SAIB) NM-07-47⁷, issued by the FAA in September 2007. The stairs of the aircraft involved in this event are shown in the two photos below. The warning signs are visible on the step risers:

Illustration 2: Detail of the stairs on the Boeing 737-8AS aircraft, with registration EI-EGA

These warning signs also advised holding onto the handrail with the other hand.

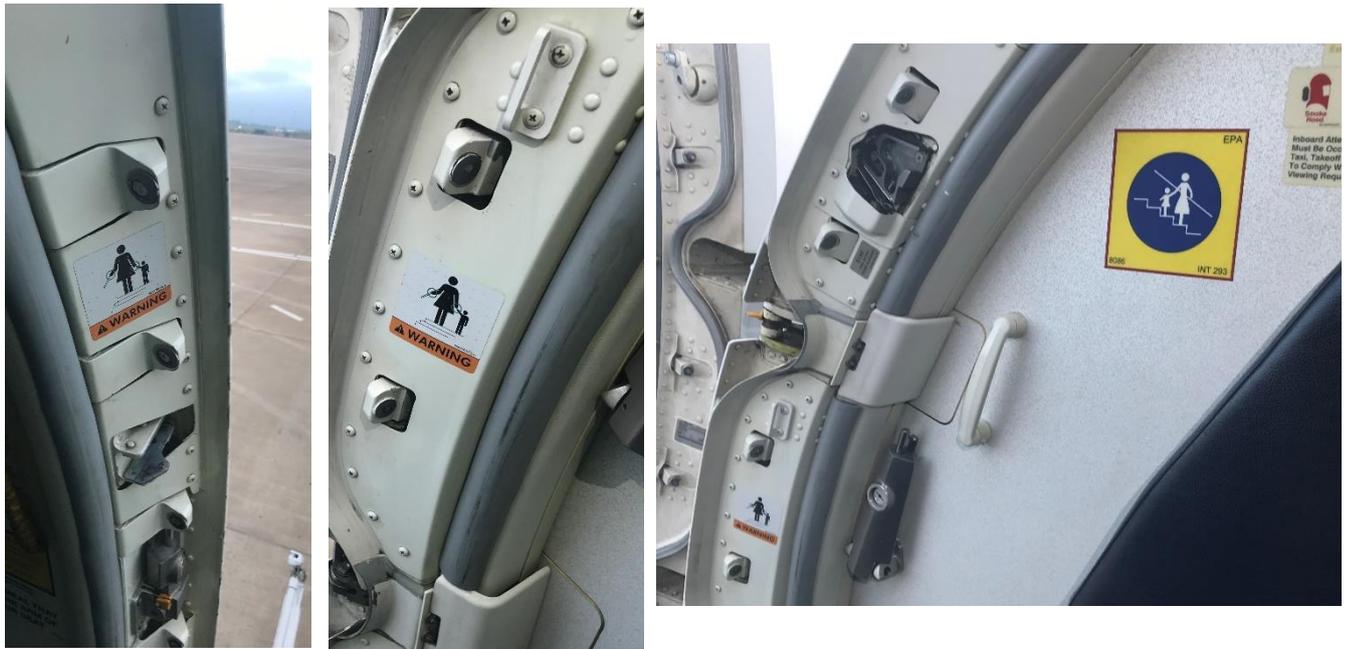
The aircraft also had warning signs on the door frames, as can be seen in the following photographs:

Illustration 3: Detail of the signs on the door frames of the Boeing 737-8AS aircraft, with registration EI-EGA

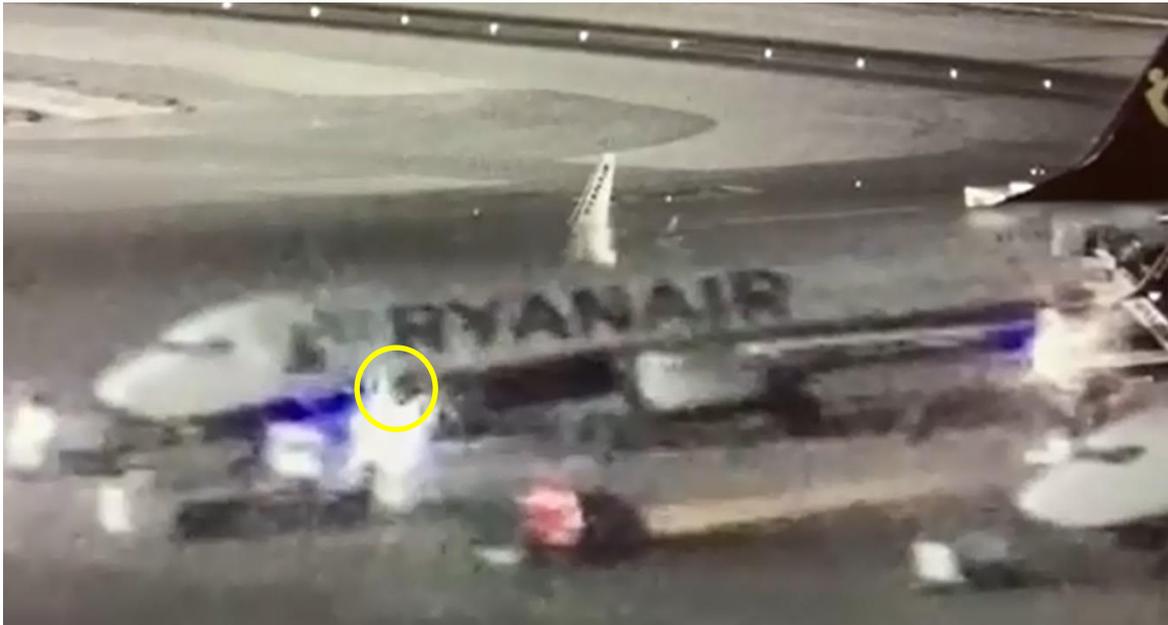
The incident was captured by the airport's cameras. However, how the passenger fell is not clear:

Illustration 4: Passenger descending the stairs moments before the fall

Even though the aircraft has warning signs recommending that passengers hold onto the handrail when walking down the stairs and that before proceeding to disembark the passengers, Ryanair advised them to do the same in a passenger announcement made in English, the injured Swedish passenger descended the stairs while holding two carry-on bags and, therefore, without holding onto the handrail.

The stuck suitcase caused the passenger to lose his balance. As both hands were holding suitcases, when he lost his balance, he was unable to grasp the handrail to prevent the fall.

REC 01/22: It is recommended that Ryanair modify its disembarkation procedure to provide the warning concerning the use of the handrail when descending the stairs in the official languages of the departure and destination countries, as well as in English.

REC 02/22: It is recommended that Ryanair reinforce its disembarkation procedure to stipulate that if a member of the cabin crew observes a passenger intending to descend the forward stairs without a free hand, they should remind them that they must use the handrail when descending the stairs.
