Report A-021/2020

Accident involving a EUROCOPTER
AS350 B2 aircraft, registration
EC-MVV, in the municipality of
La Vansa i Fónols (Lleida) on 6
July 2020

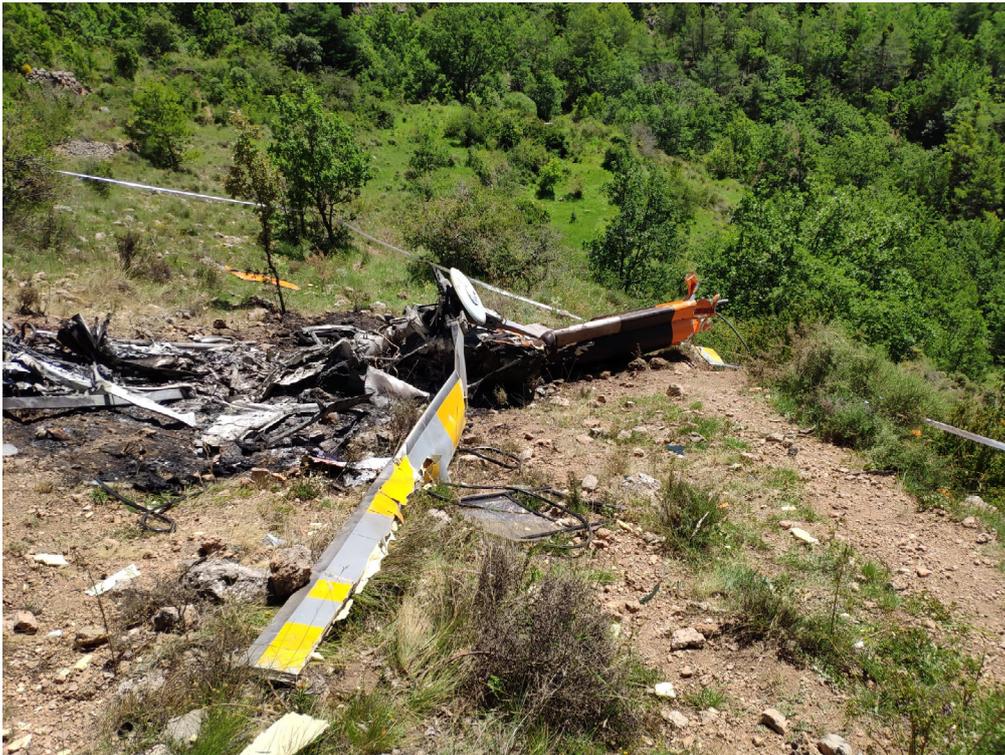
Figure 1. Final position of the aircraft

The pilot decided to take him back to the helicopter's departure airport for medical assistance. He descended towards a nearby road and, without landing on the asphalt, picked him up and flew directly towards the aerodrome on a heading of 290°. During the flight, the helicopter crashed into a steep hillside and subsequently caught fire. There were indications that the engine may have been affected by a loss of power.

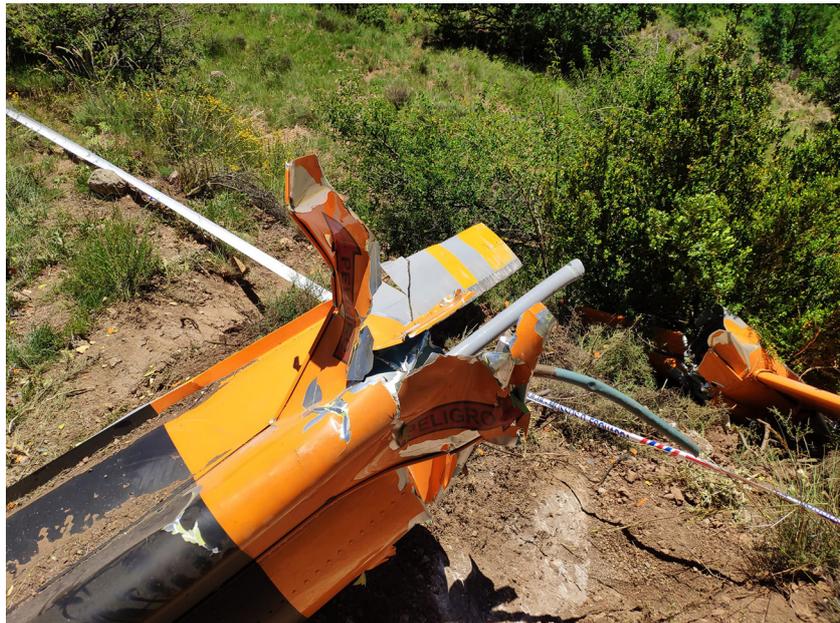
Figure 16. Tail cone and horizontal stabiliser

The entire tail cone assembly broke off on impact and ended up at the edge of a cliff. The horizontal stabiliser was found on a slope 3 m below the main wreckage, with the vertical stabiliser 1 m further below.

Both parts had dents on the right side.

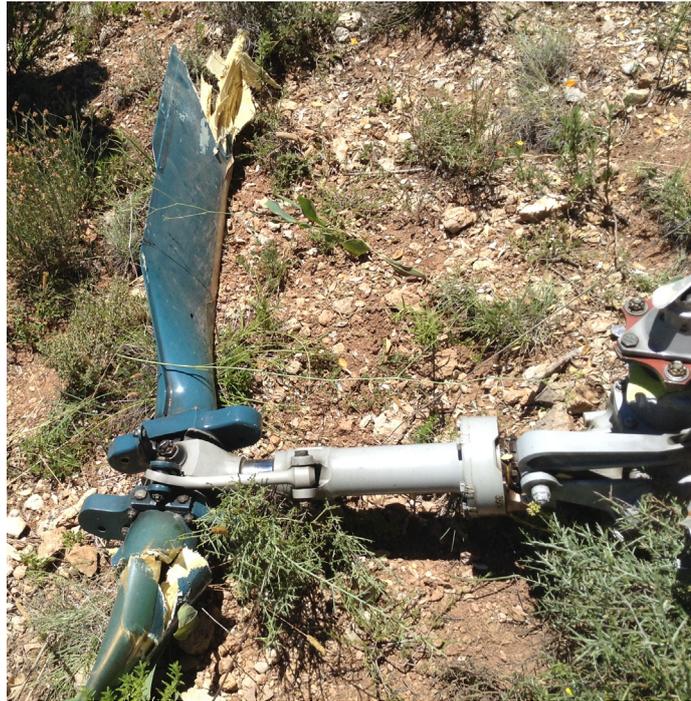
Figure 17. Tail rotor

The tail rotor was found on another ledge in the valley, approximately 20 m below the rest of the tail cone.

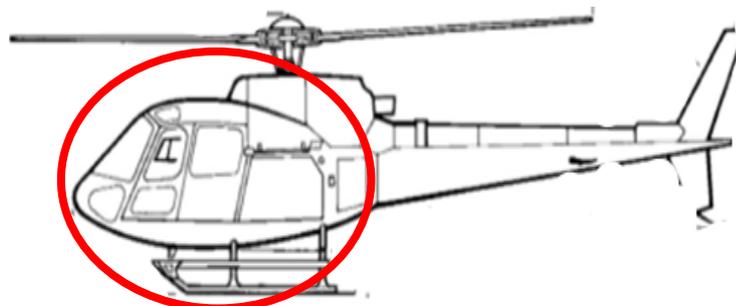
Figure 18. Fire-affected area

After the impact, a fire erupted, engulfing the engine and completely burning the cabin plus the area below and behind it.

The tail cone, stabilisers and rear rotor were the only parts not affected by the fire.

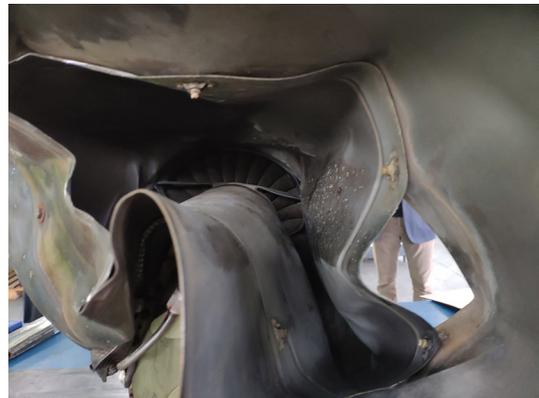
Figure 19. Exhaust deflecting nozzle

- The outlet deflecting nozzle was crushed by the impact.
- The engine had burn damage to its exterior but had not been subjected to an intense fire. The area around the deflecting nozzle had a bluish colour.
- The accessory area was partially burned.
- The inlet compressor screw was slightly proud. The underside was deformed.

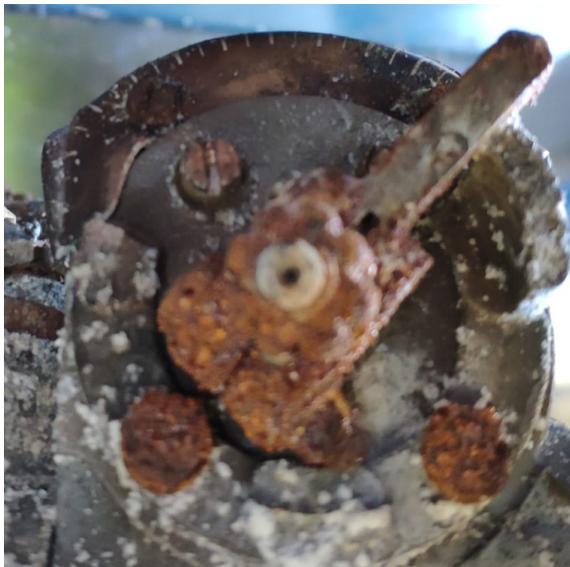
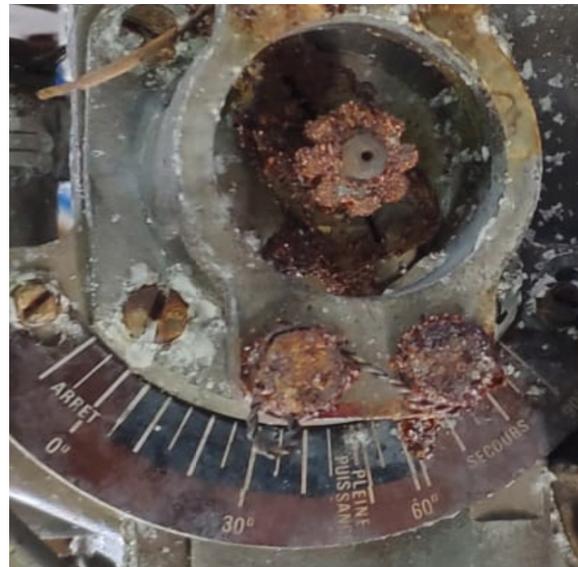
Figure 20. Position of the anticipator

- In the fuel control unit (FCU), the throttle lever was at the 60° position within the green arc (between full power and safety speed). The anticipator was at the zero position. It's used to control and adjust the position of the collective pitch lever in advance. If this fails, it's automatically compensated with the N2 revolutions, so we can disregard this as a factor in the accident.

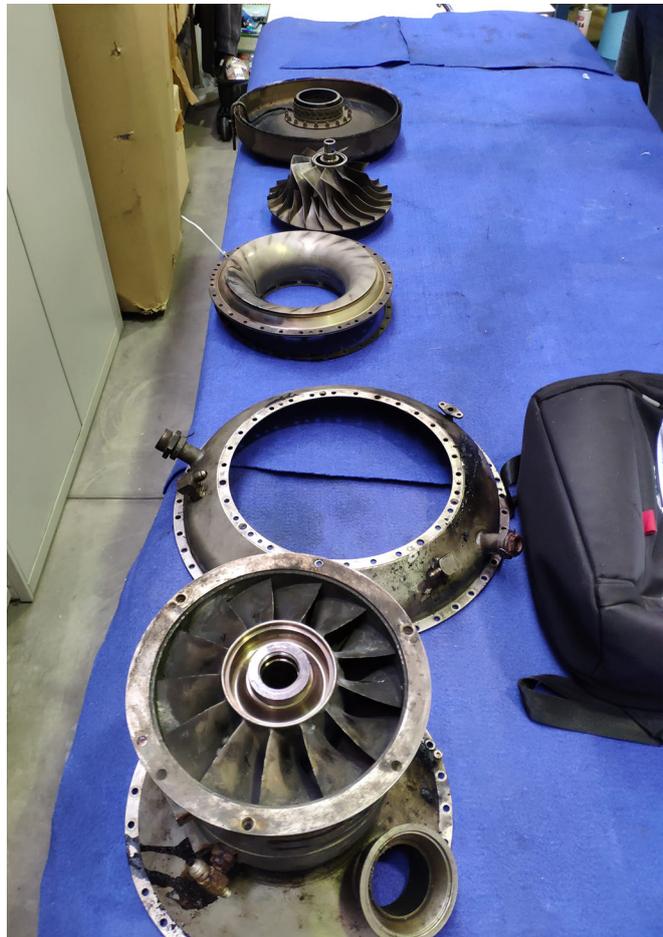
Figure 21. Disassembled parts during the inspection

- The engine oil filter was removed and found to be burned.
- The bleed valve was removed and appeared to be in good condition.
- The rear fixing screw of module 2 had snapped.

- The nozzle area was separated from the assembly.
- On removing module 2, the tightening torque applied to the screws was confirmed to be correct. The module was blocked (it didn't rotate) and burned. Probably as a result of the fire that broke out on impact.

- Shavings were also found inside. It looked as if the M3 module had blocked first and, as a result, module 2 suddenly blocked as well. This module rotates at 53,000 rpm so a sudden stop generates a lot of energy.

- All the compressor blades were worn away on their outer edge, producing shavings and chips had been generated in the centrifugal compressor as a result of residual turns of the compressor assembly.

- After disassembling the M2 and M3 modules, both were found to be in good condition. There were no breakages in any of the blades, and the shadows observed during the boroscopic inspection had been produced by the position of the viewer.

- The areas affected by the Service Bulletin's 292 72 0347 maintenance tasks were in perfect condition.
- The inspectors subsequently opened the M1 module (accessory case) and verified that all its elements were also in good condition and rotated without impediment.
