Report A-023/2020

Accident involving a TECNAM
P2002-JF aircraft operated by
BAA Training, registration LY-FTC,
at Lleida-ALguaire Airport
(Lleida, SPAIN) on 9 July 2020

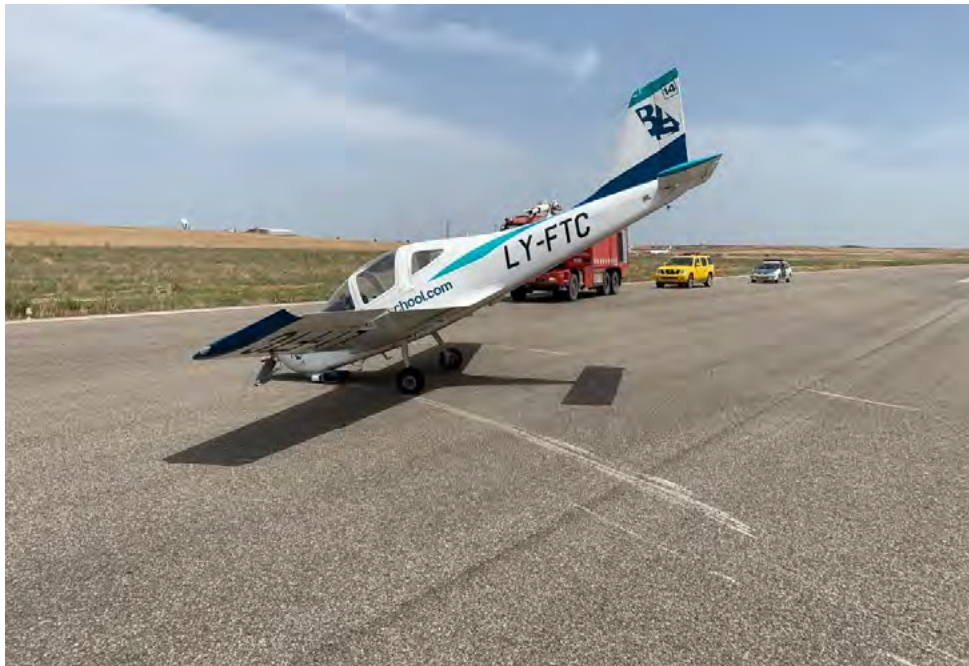
The student pilot was unharmed and was able to exit the aircraft without assistance. The aircraft sustained significant damage.

Fig. 1: Lateral view of the aircraft after the accident

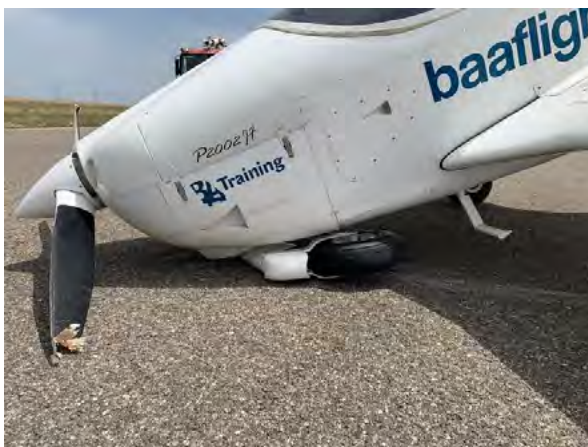
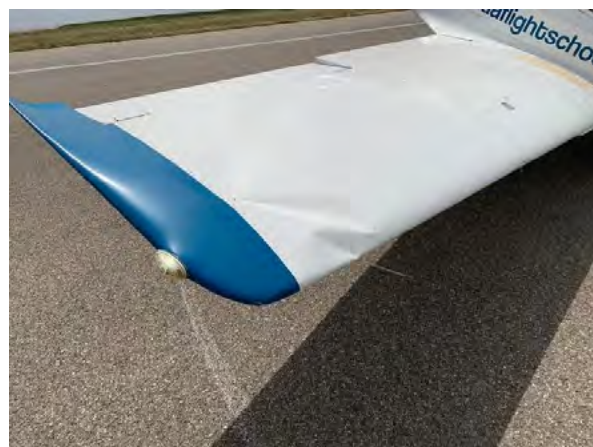
- Propeller
- Damage to engine
- Lower engine cowling
- Nose gear leg broken
- Engine mount
- Right wingtip

Figs. 2 & 3: Damage to the front of the aircraft and the tip of the right wing

As a result of sliding along the runway, the aircraft sustained damage to its propeller, engine, lower engine cowling, nose gear leg, engine mount and right wingtip.

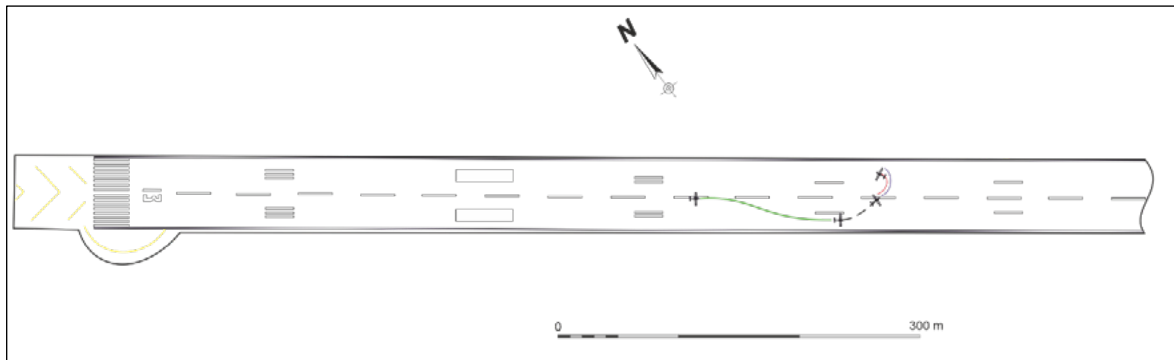
The aircraft landed on runway 13 at Lleida-Alguaire Airport. After its nose wheel collapsed, it slid along the asphalt before coming to a halt while still on the runway. In its final position, it was orientated at approximately 355°, with 13.4 m between the propeller cone and the edge of the runway.

Fig. 4: General sketch

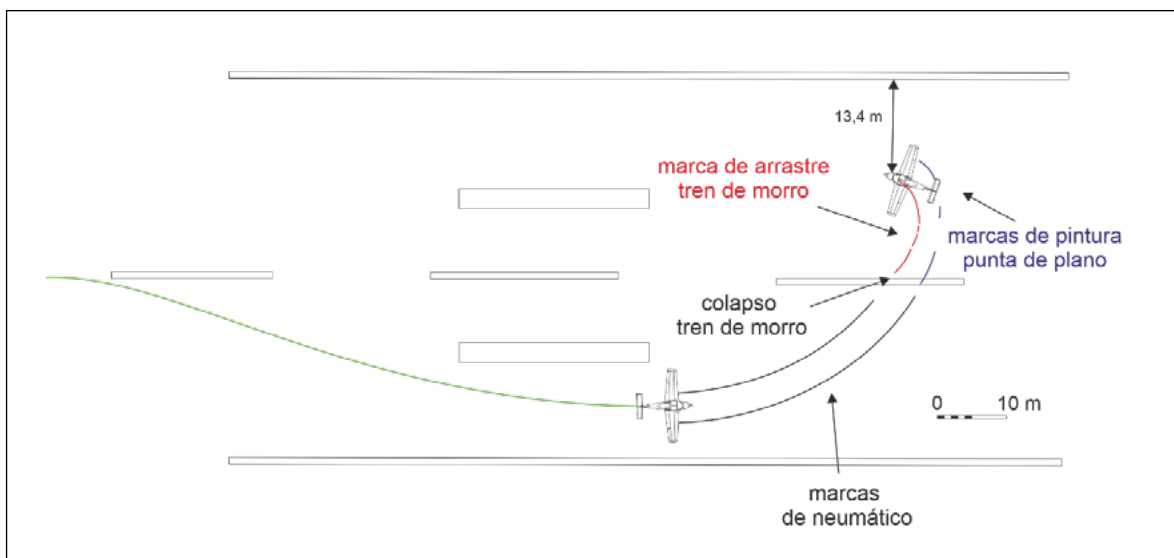
Fig. 5: Detailed sketch

Taking into account the pilot's statement and the marks the aircraft left on the runway, it appears it initially veered to the right after the brakes were applied but then made a sharp left turn that caused the tip of the right wing to hit the runway several times and the nose gear leg to collapse.

The aircraft slid along the runway before coming to a complete stop. The sketch in figure 5 shows the marks left on the runway by the tyres, the right wingtip, and the nose gear as it slid along the ground.
