Technical report

A-023/2020

Accident involving a TECNAM P2002-JF aircraft operated by BAA Training, registration LY-FTC, at Lleida-Alguaire Airport (Lleida, SPAIN) on 9 July 2020

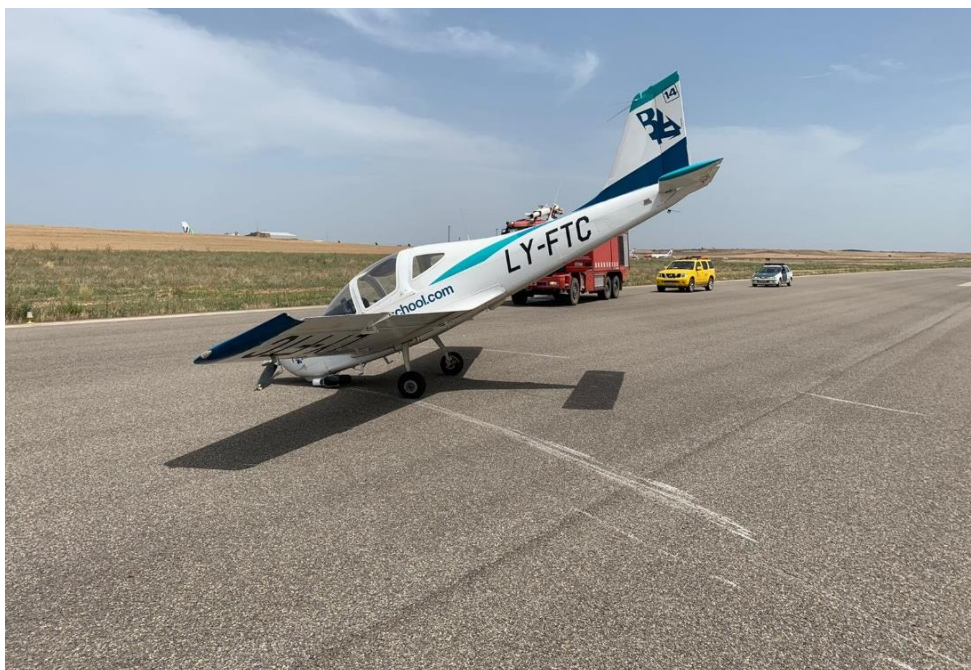
Fig. 1: Lateral view of the aircraft after the accident

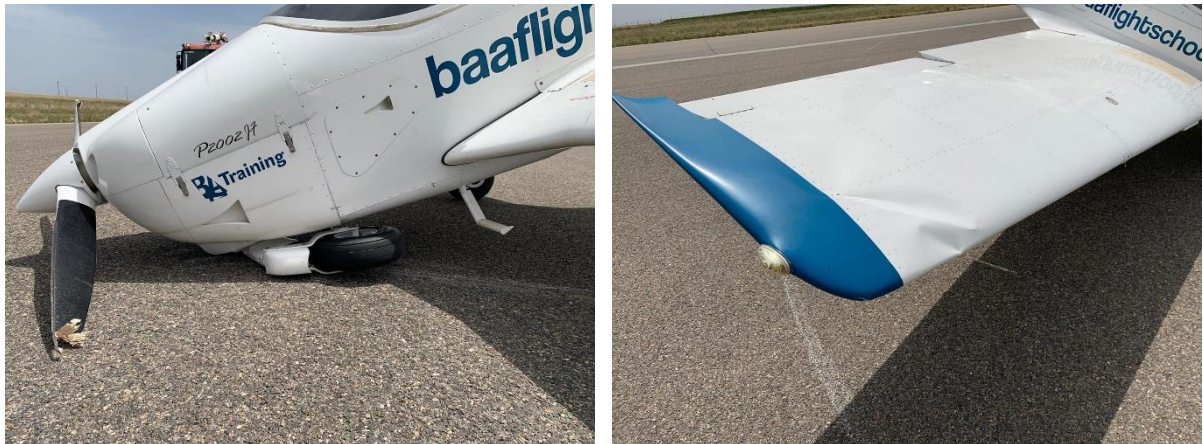
- Propeller
- Damage to engine
- Lower engine cowling
- Nose gear leg broken
- Engine mount
- Right wingtip

Figs. 2 & 3: Damage to the front of the aircraft and the tip of the right wing

As a result of sliding along the runway, the aircraft sustained damage to its propeller, engine, lower engine cowling, nose gear leg, engine mount and right wingtip.

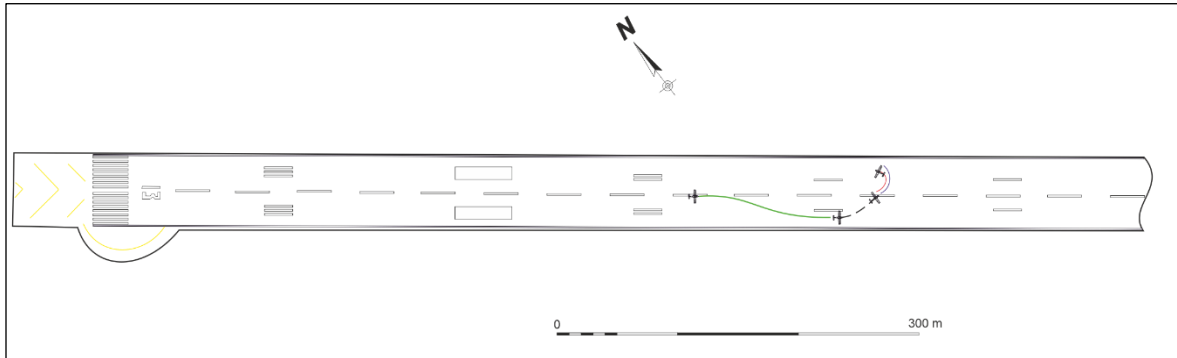
The aircraft landed on runway 13 at Lleida-Alguaire Airport. After its nose wheel collapsed, it slid along the asphalt before coming to a halt while still on the runway. In its final position, it was orientated at approximately 355° , with 13.4 m between the propeller cone and the edge of the runway.

Fig. 4: General sketch

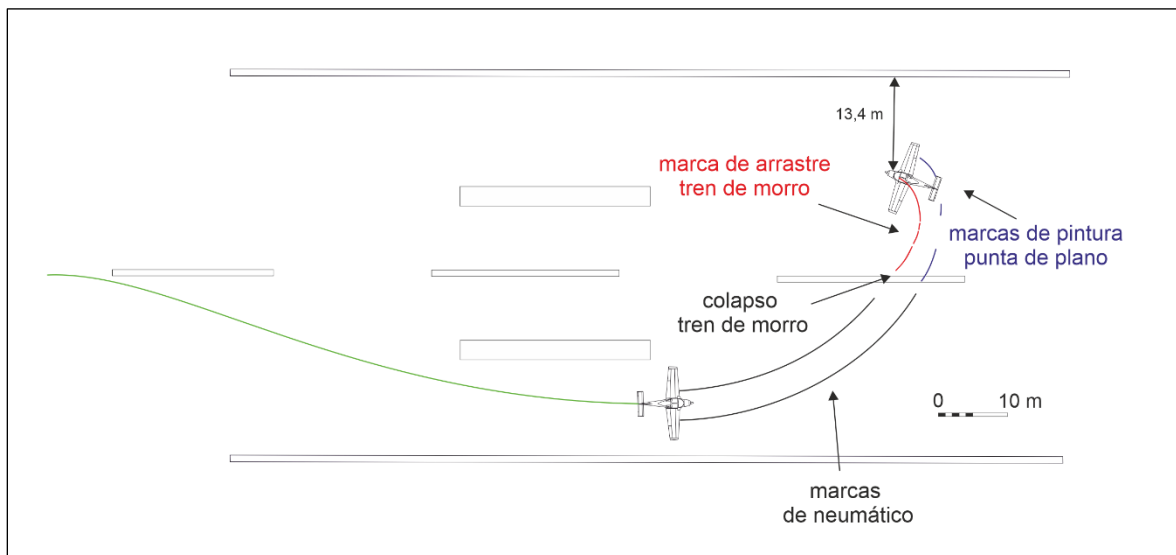
Fig. 5: Detailed sketch

Taking into account the pilot's statement and the marks the aircraft left on the runway, it appears it initially veered to the right after the brakes were applied but then made a sharp left turn that caused the tip of the right wing to hit the runway several times and the nose gear leg to collapse.

The aircraft slid along the runway before coming to a complete stop. The sketch in figure 5 shows the marks left on the runway by the tyres, the right wingtip, and the nose gear as it slid along the ground.
