**COMISIÓN DE  
INVESTIGACIÓN  
DE ACCIDENTES  
E INCIDENTES DE  
AVIACIÓN CIVIL**

**Report  
A-025/2021**

Accident involving a Boeing 737-8AS aircraft, registration EI-EVE, operated by Ryanair, at Málaga Airport (Málaga, Spain) on 13 June 2021

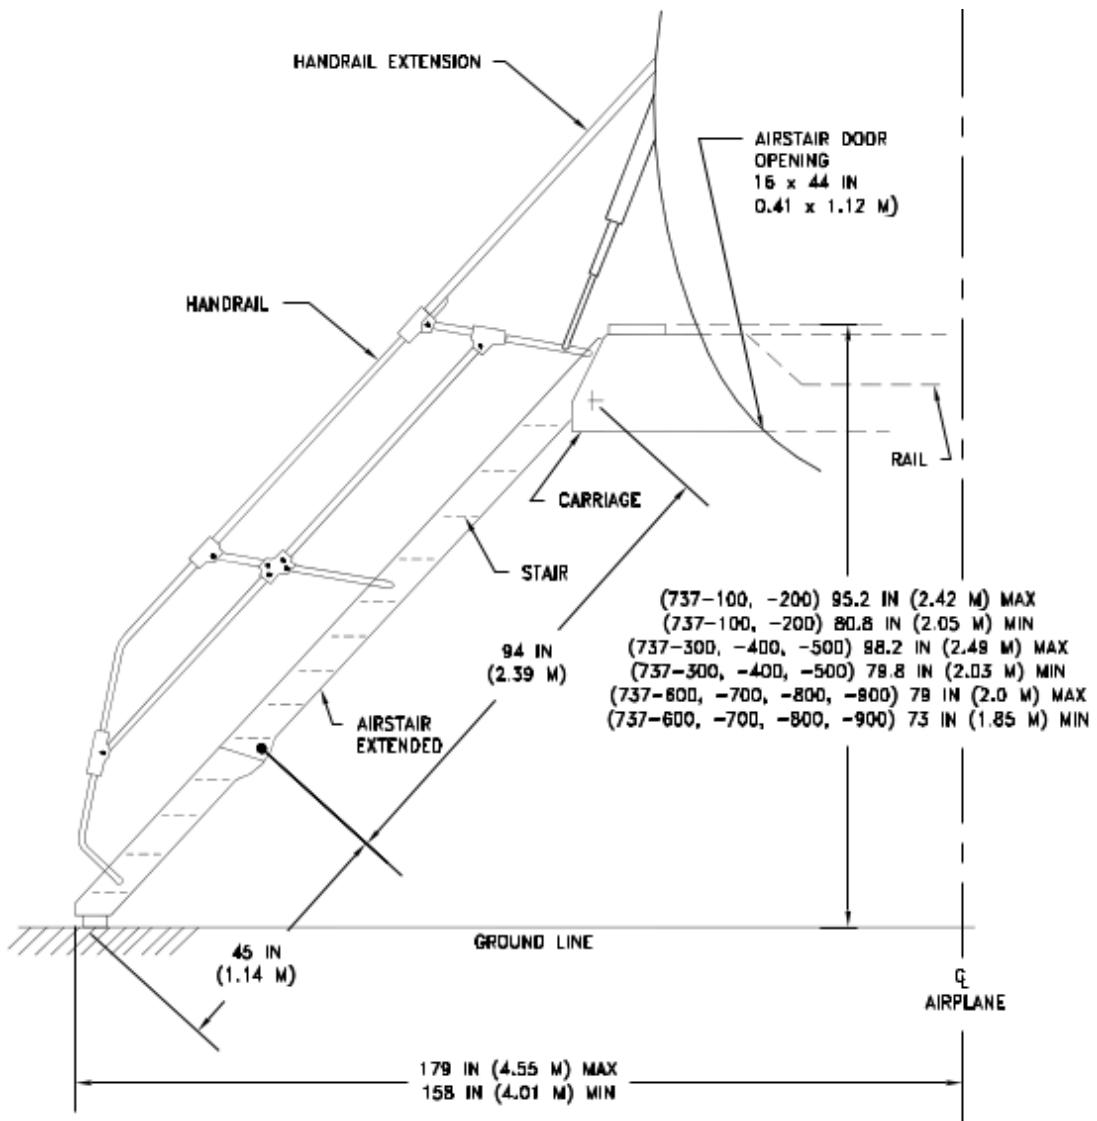
Illustration 1: Dimensions of the stairs on Boeing 737 aircraft

The following figure, extracted from Boeing's document on "Airplane Characteristics for Airport Planning", shows the dimensions of the stairs. The height of the stairs on the 800 model ranges from a minimum of 1.85 m to a maximum of 2 m, and the length is 3.53 m. Thus, the slope varies between 69% and 62%, respectively. The width of the stairs is approximately 0.62 m.

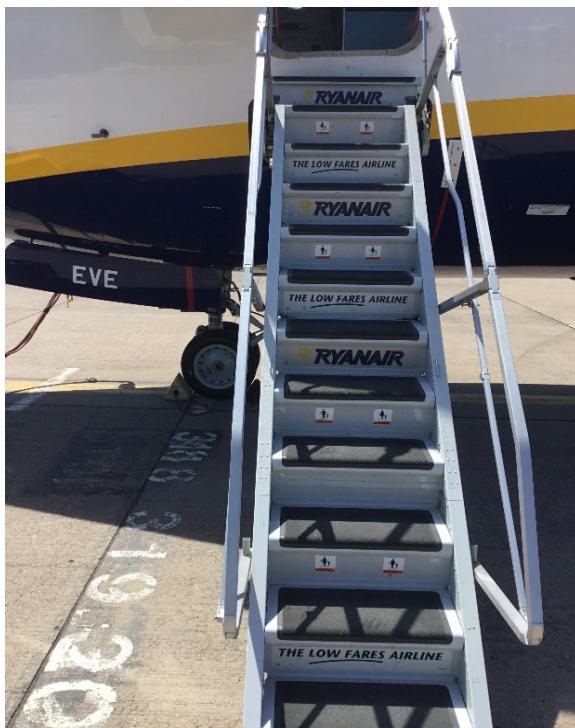
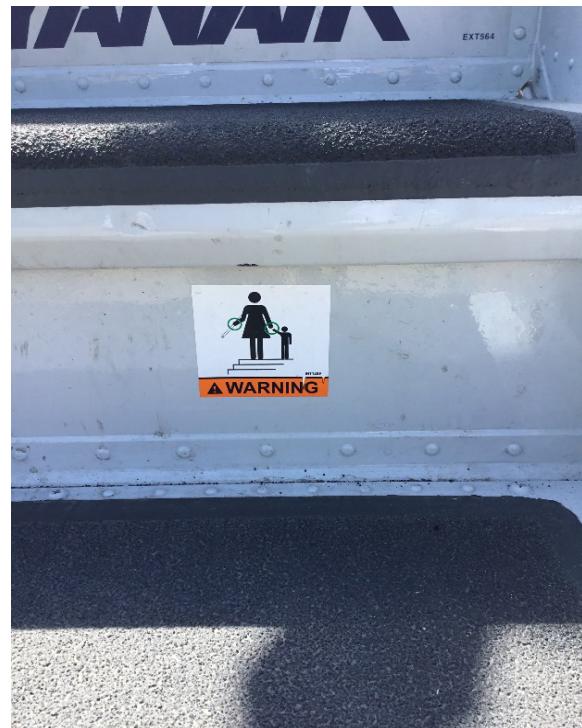
Illustration 2: Stairs of the Boeing 737-8AS aircraft with registration EI-EVE

3.- The aircraft involved in this event had warning signs advising that passengers travelling with young children should hold their hands when walking up or down the stairs, as per Special Airworthiness Information Bulletin (SAIB) NM-07-47<sup>6</sup>, issued by the FAA in September 2007. The stairs of the aircraft involved in this event are shown in the photos below. The warning signs are visible on the step risers.

These warning signs also advised holding onto the handrail with the other hand.

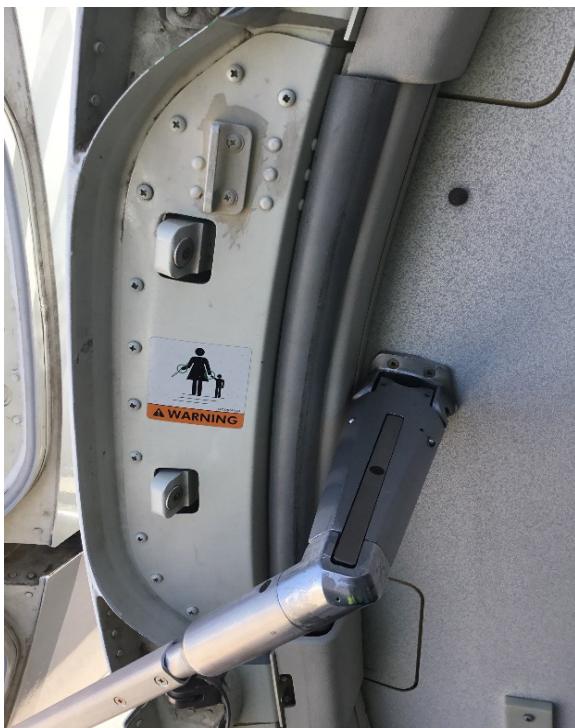
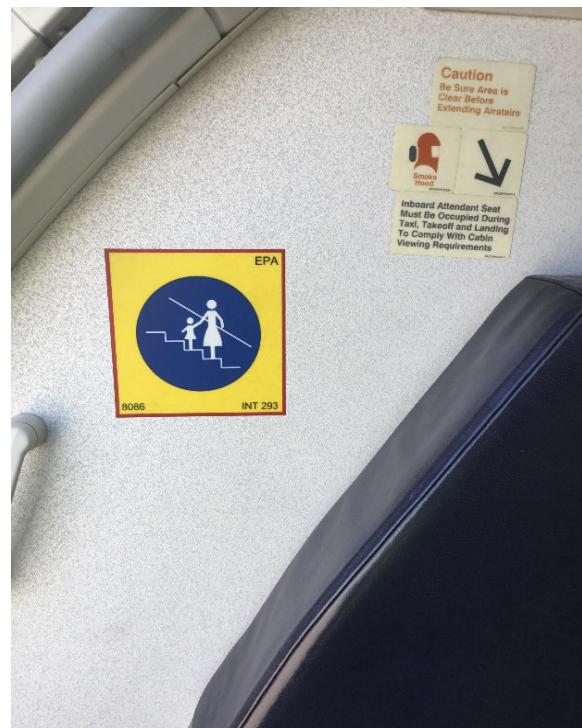
Illustration 3: Door frame of the Boeing 737-8AS aircraft with registration EI-EVE

The aircraft also had warning signs on the door frames.

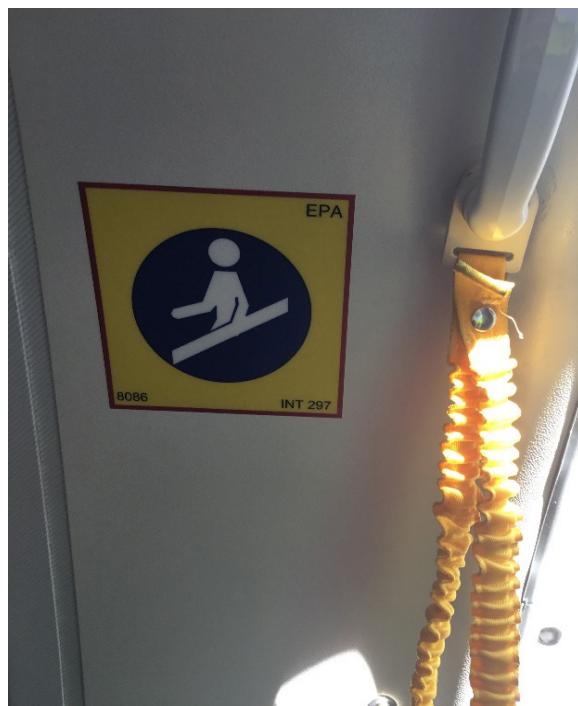
Illustration 4: Door frame of the Boeing 737-8AS aircraft with registration EI-EVE

In addition, there was another warning sign on the door frame advising passengers to hold onto the handrail with one hand.
