Technical report

A-025/2021

Accident involving a Boeing 737-8AS aircraft,
registration EI-EVE, operated by Ryanair, at
Málaga Airport (Málaga, Spain) on 13 June
2021

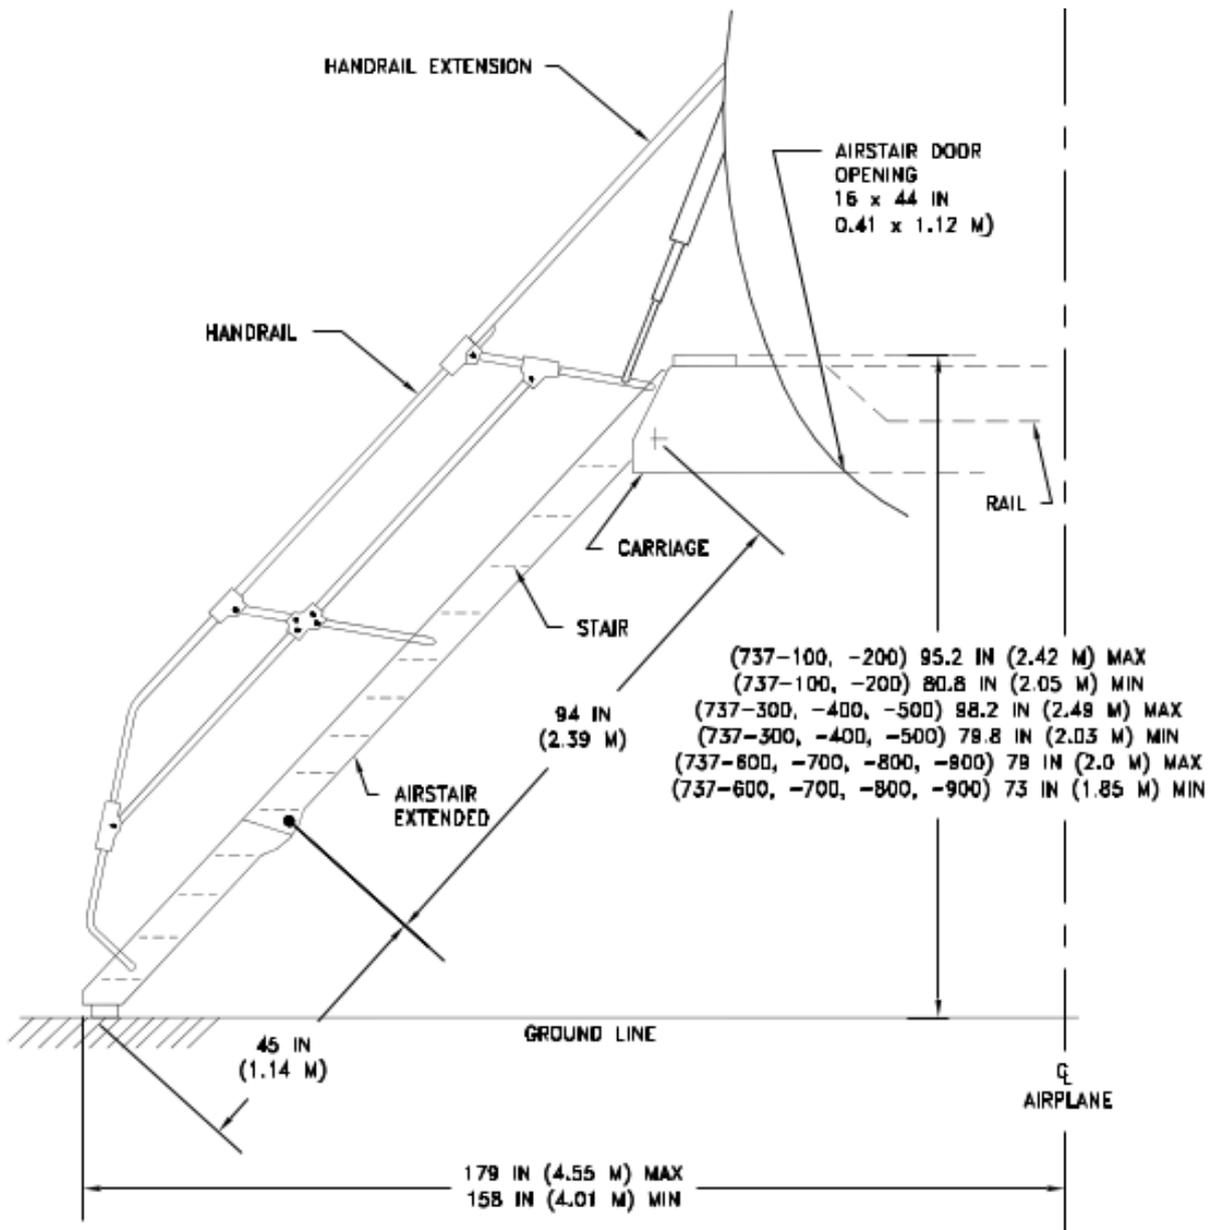
Illustration 1: Dimensions of the stairs on Boeing 737 aircraft

The following figure, extracted from Boeing's document on "Airplane Characteristics for Airport Planning", shows the dimensions of the stairs. The height of the stairs on the 800 model ranges from a minimum of 1.85 m to a maximum of 2 m, and the length is 3.53 m. Thus, the slope varies between 69% and 62%, respectively. The width of the stairs is approximately 0.62 m.

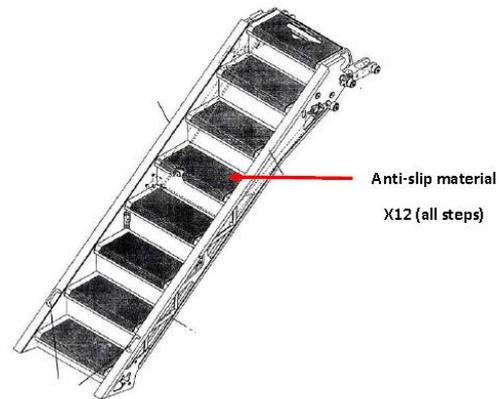
1.- The stair treads are covered with a non-skid material called 3M Safety Walk 710 - Coarse⁴

Although Ryanair's manuals also allow the use of the 3M Safety Walk 610 - General Purpose⁵ non-skid material, the stairs of the aircraft in question are equipped with the former.

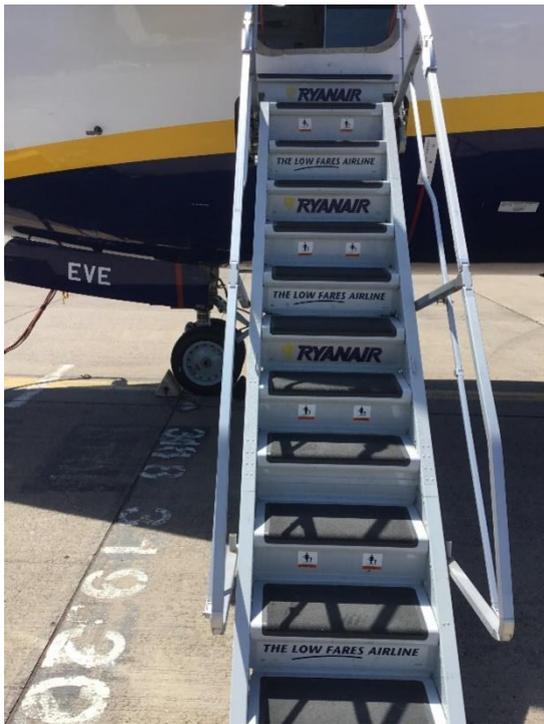
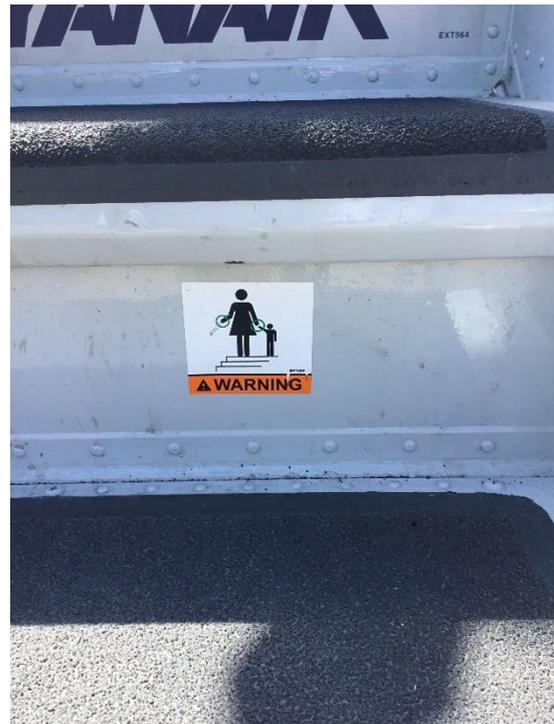
Illustration 2: Stairs of the Boeing 737- 8AS aircraft with registration EI-EVE

3.- The aircraft involved in this event had warning signs advising that passengers travelling with young children should hold their hands when walking up or down the stairs, as per Special Airworthiness Information Bulletin (SAIB) NM-07-47⁶, issued by the FAA in September 2007. The stairs of the aircraft involved in this event are shown in the photos below. The warning signs are visible on the step risers:

These warning signs also advised holding onto the handrail with the other hand.

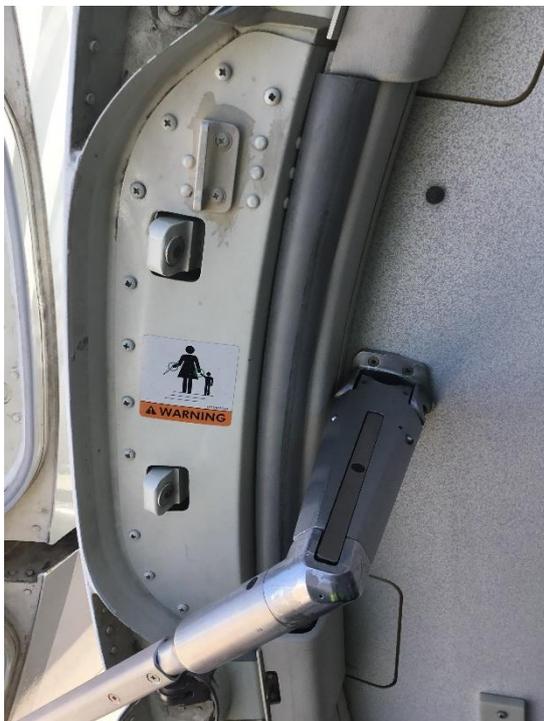
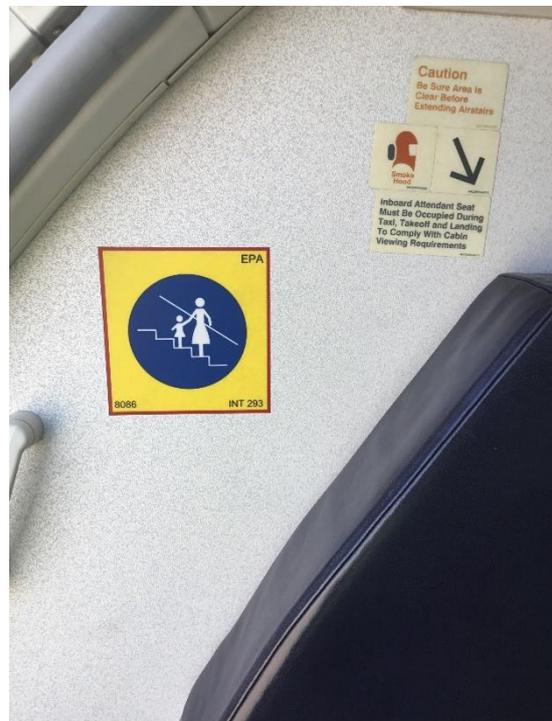
Illustration 3: Door frame of the Boeing 737-8AS aircraft with registration EI-EVE

The aircraft also had warning signs on the door frames:

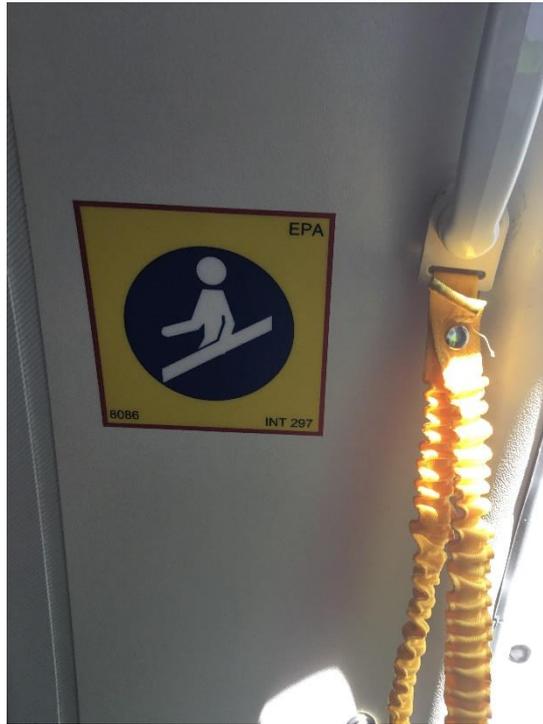
Illustration 4: Door frame of the Boeing 737-8AS aircraft with registration EI-EVE

In addition, there was another warning sign on the door frame advising passengers to hold

onto the handrail with one hand:
