## Report A-028/2017

Accident involving a PILATUS  
PC6-B2-H2 aircraft, registration  
EC-EMZ, at the aerodrome of  
Empuriabrava (Girona, Spain) on 23  
November 2017

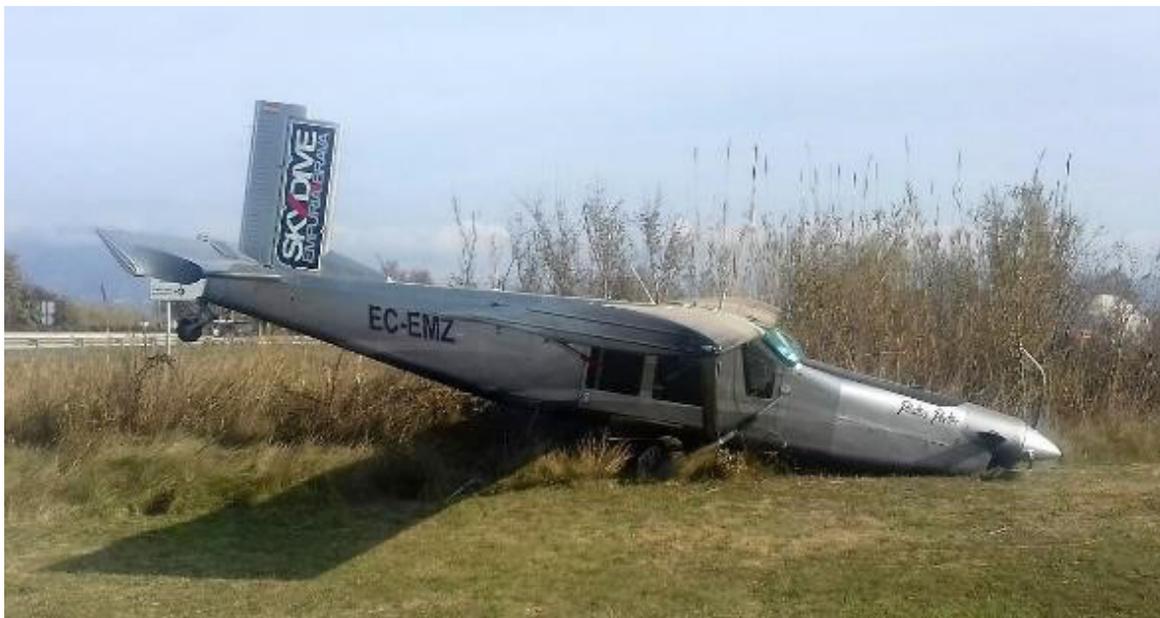
Photography 1. Aircraft at accident site

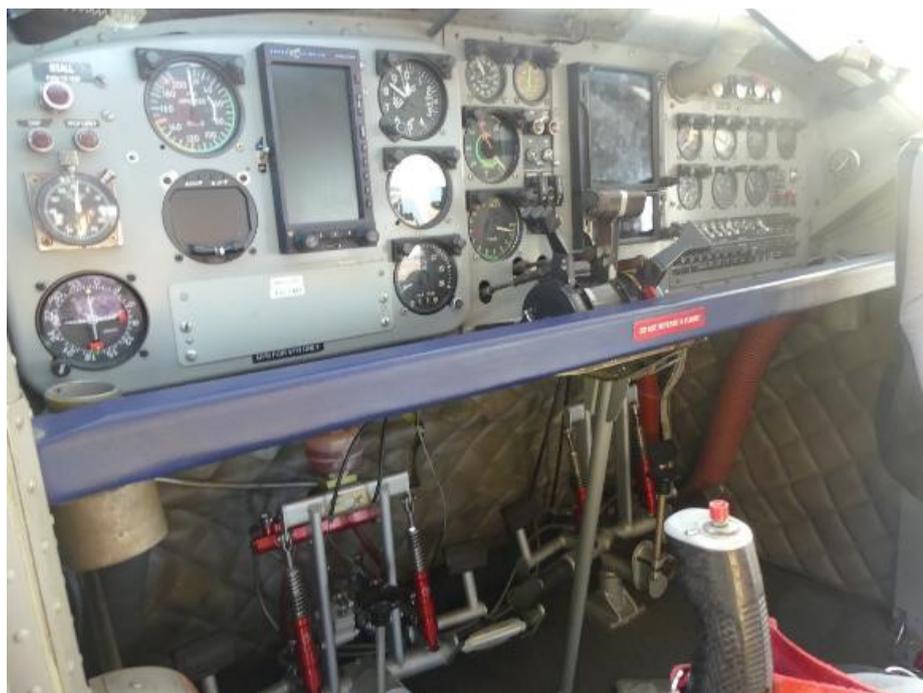
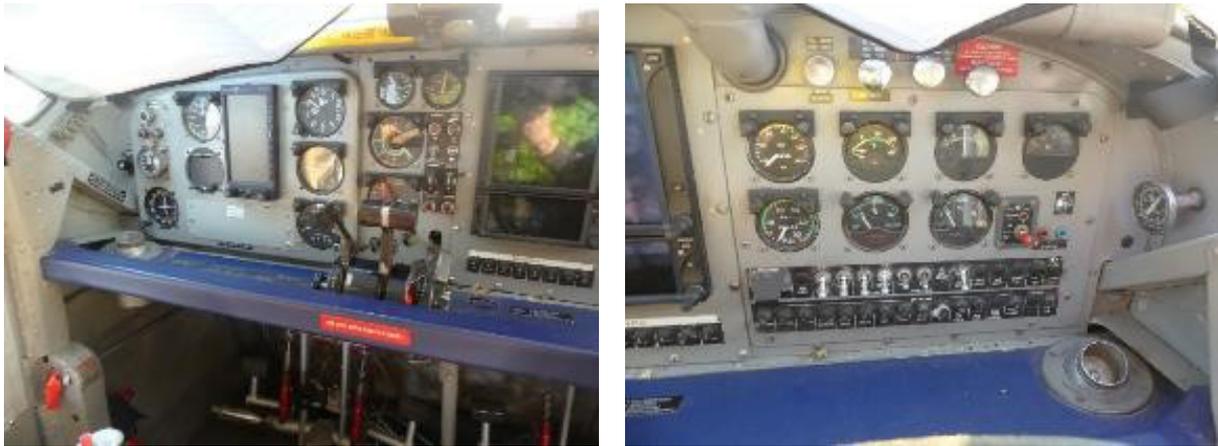
Photographs of the instrument panel in the cockpit at the accident site after the event.

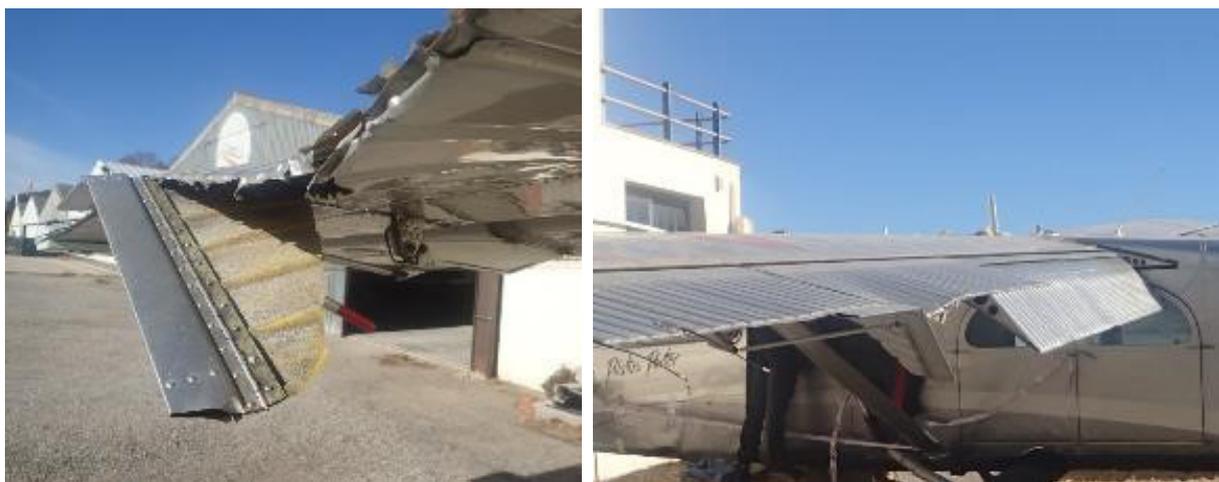
Photograph 3. Damage to flap and aileron on left wing

- Left wing:
  - o Warping of the leading edge of the wing.
  - o The flaps on both wings were extended and the left flap exhibited external damage.
  - o There was warping and tearing on the left aileron, next to the trim tab actuating rod.
  - o In the top part of the wing, windshield frame was displaced upward some 20 cm.
- Main landing gear:
  - o Left gear:
    - The wheel was bent backward and toward the fuselage, warping the sheet metal on the lower part of the pilot access door, preventing it from opening.
    - Broken shock absorber.
    - Leg attachment struts bent backwards.
  - o Right gear:
    - The wheel was bent backward and toward the fuselage.
    - The warped wheel had damaged the access step to the passenger cabin.
    - Broken shock absorber.
    - Leg attachment struts bent backwards and broken.

The damage to the wings was also consistent with impacting the vegetation on the ground, namely the shrubs and small trees located left of the airplane in the direction of motion.

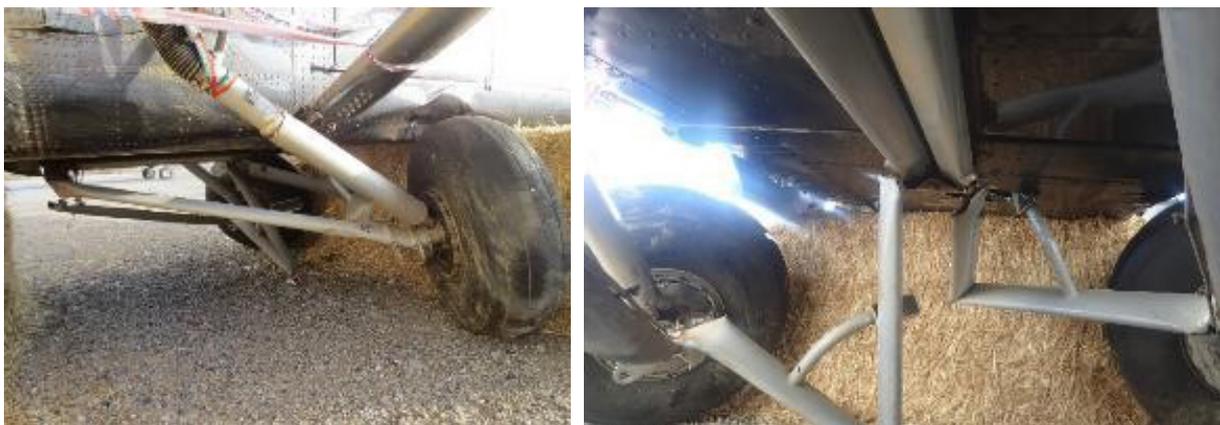
Photograph 4. Damage to landing gear

There was no scattering of debris, since the aircraft fell to the ground after the landing gear impacted the canal, which bent the gear backwards and caused the airplane, which had no speed left, to fall to the ground.

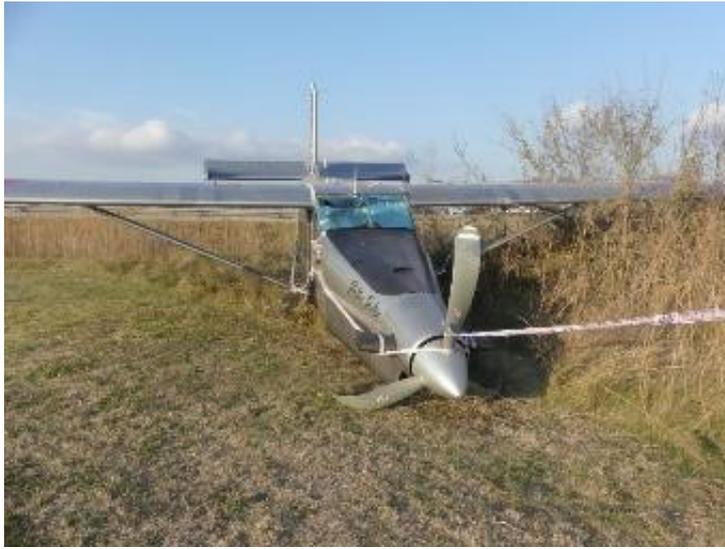
- Windshield:
  - o Broken in the center.
  - o Frame loose in the top corner of the right wing.
- Engine cover:
  - o Bottom rear portion, behind oil radiator, abraded.

**Fotografía 5.** Aeronave en el lugar del suceso

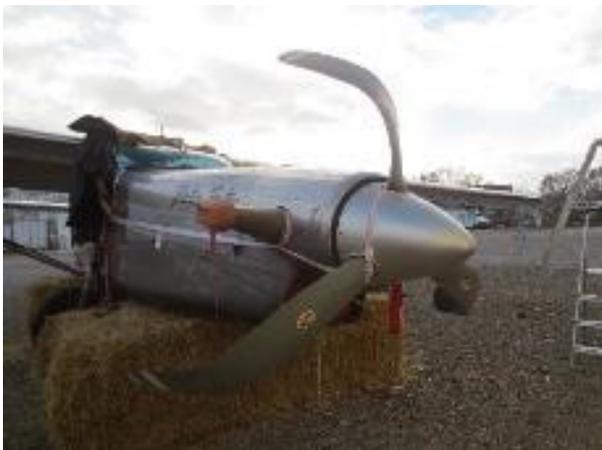
- Propeller:
  - o All three blades were deformed and bent backward at an angle of about 90°. Pitch confirmed to be low.

**Fotografía 6.** Deformación en hélice

- o One of the blades was deformed at the leading edge, in the part furthest away from the hub. There were also abrasions on the trailing edge.
- o One of the blades exhibited a loss of material on the leading edge, in the part furthest away from the hub, as well as abrasions on the trailing edge.

The damage to the propeller blades indicates that the engine was producing power at the moment of impact. The blades were in a low-pitch position, meaning the propeller was not feathered, as the pilot said when he provided his statement.

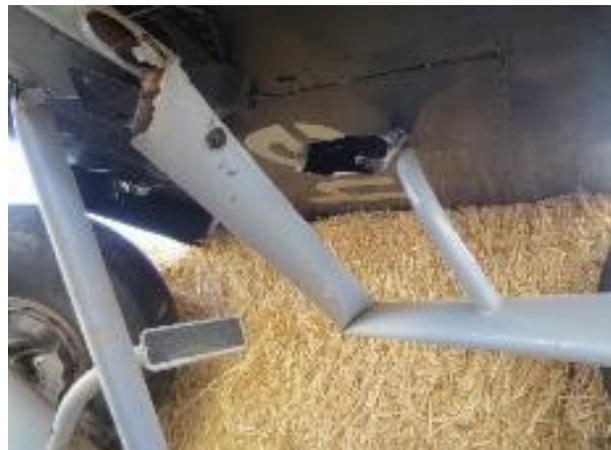
**Fotografía 7.** Daños en parte inferior del fuselaje

The abrasions and damage to the underside of the fuselage were caused as the airplane dragged along the ground before coming to a stop, a process that lasted some 18 m, which was the distance between the initial contact of the gear with the canal and the point where the aircraft stopped.

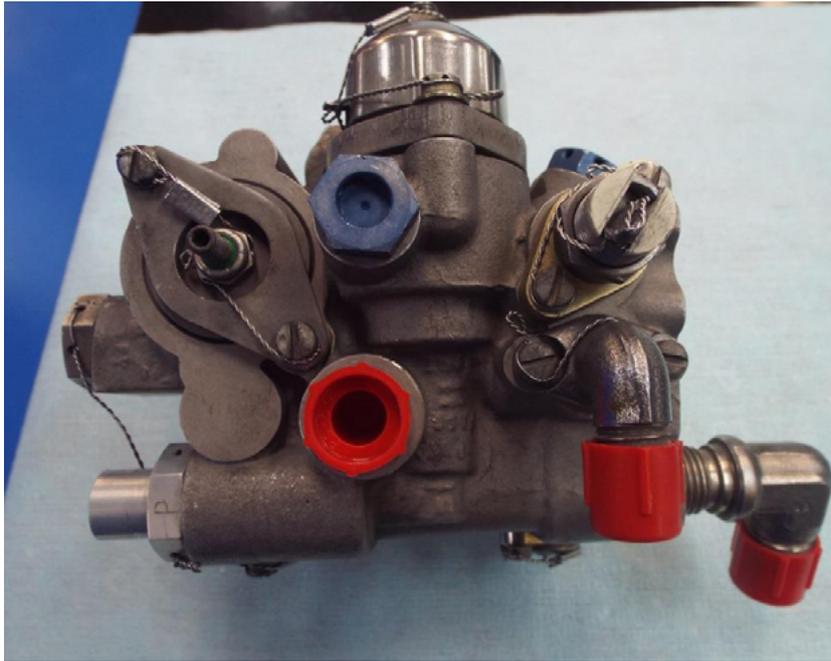
Photograph 8. FCU prepared for tests

The visual inspection revealed that the unit was in good condition, clean and with no apparent damage.

The functional test showed that some elements were outside the limits specified by the manufacturer, but that this did not result in any malfunctions. The fuel flow was a little less than required and the RPM tended to divert slightly at the limits.

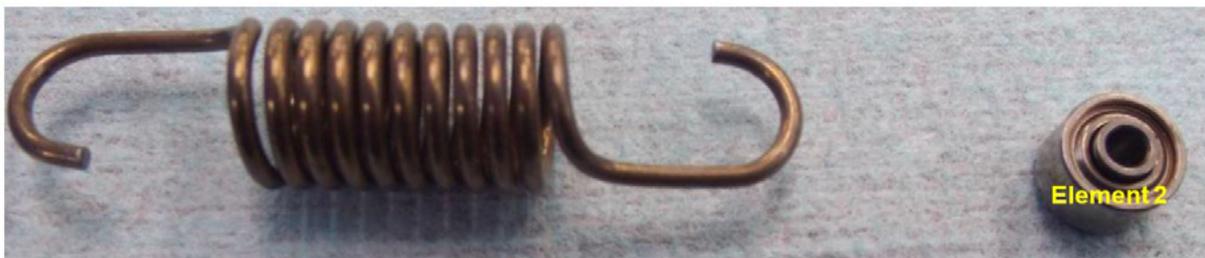
Photograph 9. FCU components: element 1 – governor spring, and element 2 – enrichment lever bearing

- o The governor spring was slightly stretched (photograph 8, element 1)
- o The bearing on the enrichment lever was rough on rotation (photograph 8, element 2)
- o The Teflon tube on the drive shaft was worn, though it was normal operational wear.

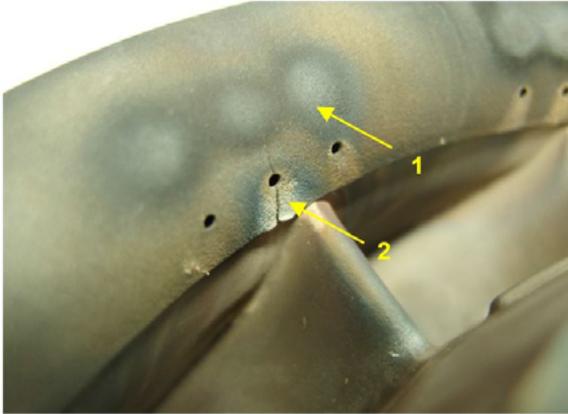
- Combustion chamber: inspected as a whole, which revealed that on the ring of fixed blades on the compressor turbine (photograph 11), the small exhaust holes on the housing cover had structural damage, and the material showed signs of overheating. The material in the large exhaust holes also showed signs of overheating (photograph 12).

Photograph 11. 1 – signs of overheating  
2 – damage to small exhaust hole

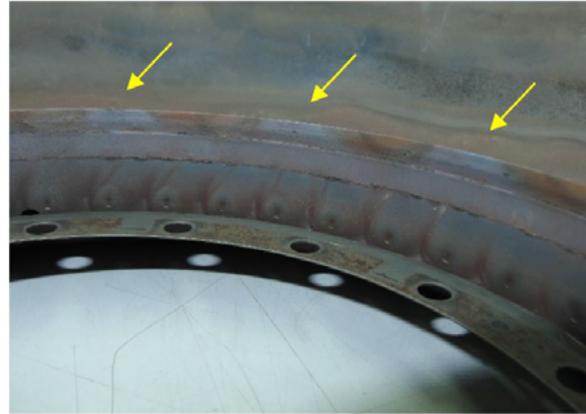
Photograph 12. signs of overheating in large exhaust holes
