Report A-029/2017

Accident involving a Boeing 737-800 aircraft, registration EI-FJJ, operated by Norwegian Air International, at FL190 in the vicinity of the CLS VOR/DME (Valencia) on 18 October 2017

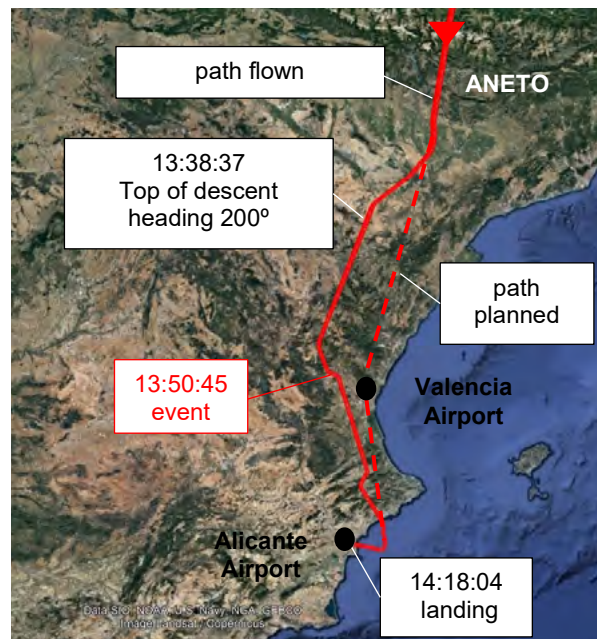
Figure 1. Flight path in the Barcelona ACC airspace

The planned route (dashed line in Figure 1) had the aircraft descend on a practically southerly course to Alicante over Valencia, but due to bad weather throughout the east and northeast of the Iberian Peninsula, the crew requested a change in route (solid red line in Figure 1), which ATC authorized.

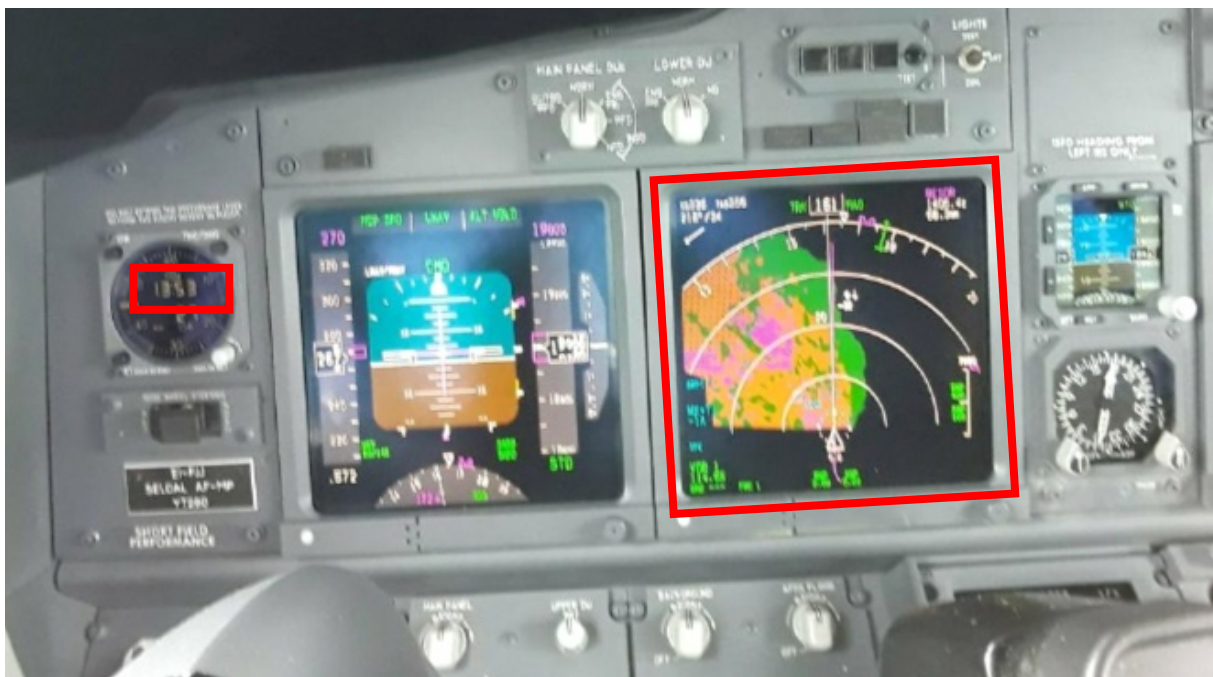
Figure 2. Photo taken by the crew at 13:53 (2 min after the event)

The information displayed on the aircraft's weather radar was, as per the crew's statement, similar to that shown in the photo in Figure 2 (right display). This photo was taken by the crew 2 minutes after the event, and it shows a radar return that indicates clouds with intense rain and turbulence³.

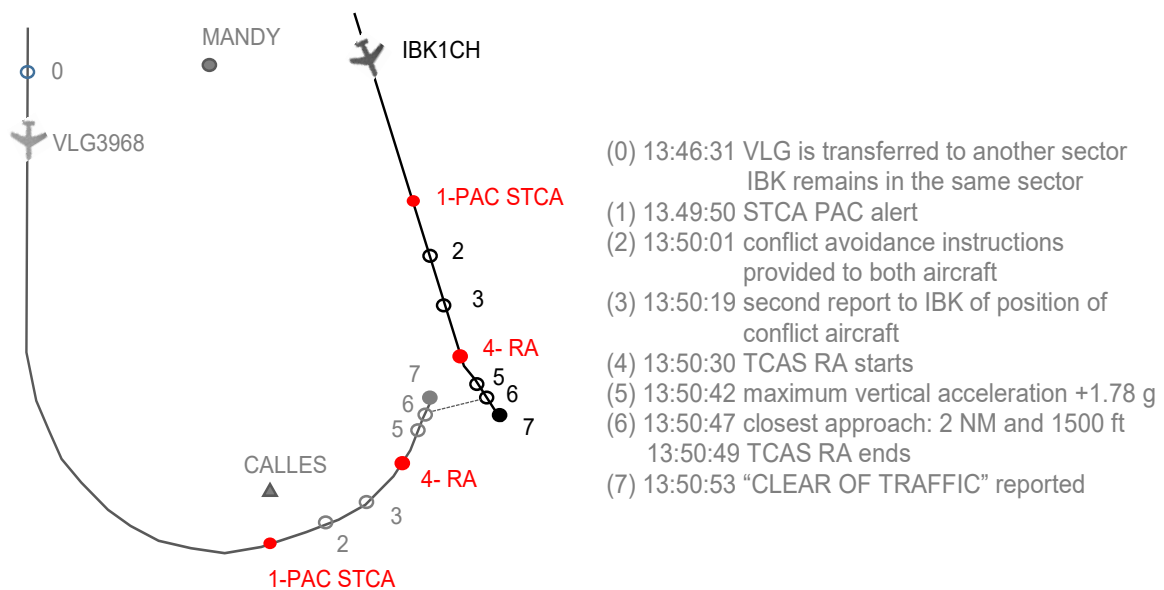
Figura 3. Relative positions of the aircraft during the event

The STCA PAC⁷ alert between the two aircraft was activated when they were 10.8 NM and 600 ft apart. Both were descending to FL210 (21700 ft and 21100 ft), with VLG above IBK. Each aircraft was in contact with a different sector.

At 13:50:13, the aircraft were 7.1 NM and 900 ft (21300 ft and 20400 ft) apart and descending, with VLG remaining above IBK, which was still on heading 163°. The controller amended his previous instruction to VLG to descend and instructed it to hold its current flight level ("Amend instructions and hold FL210, 210"), which the crew immediately acknowledged.

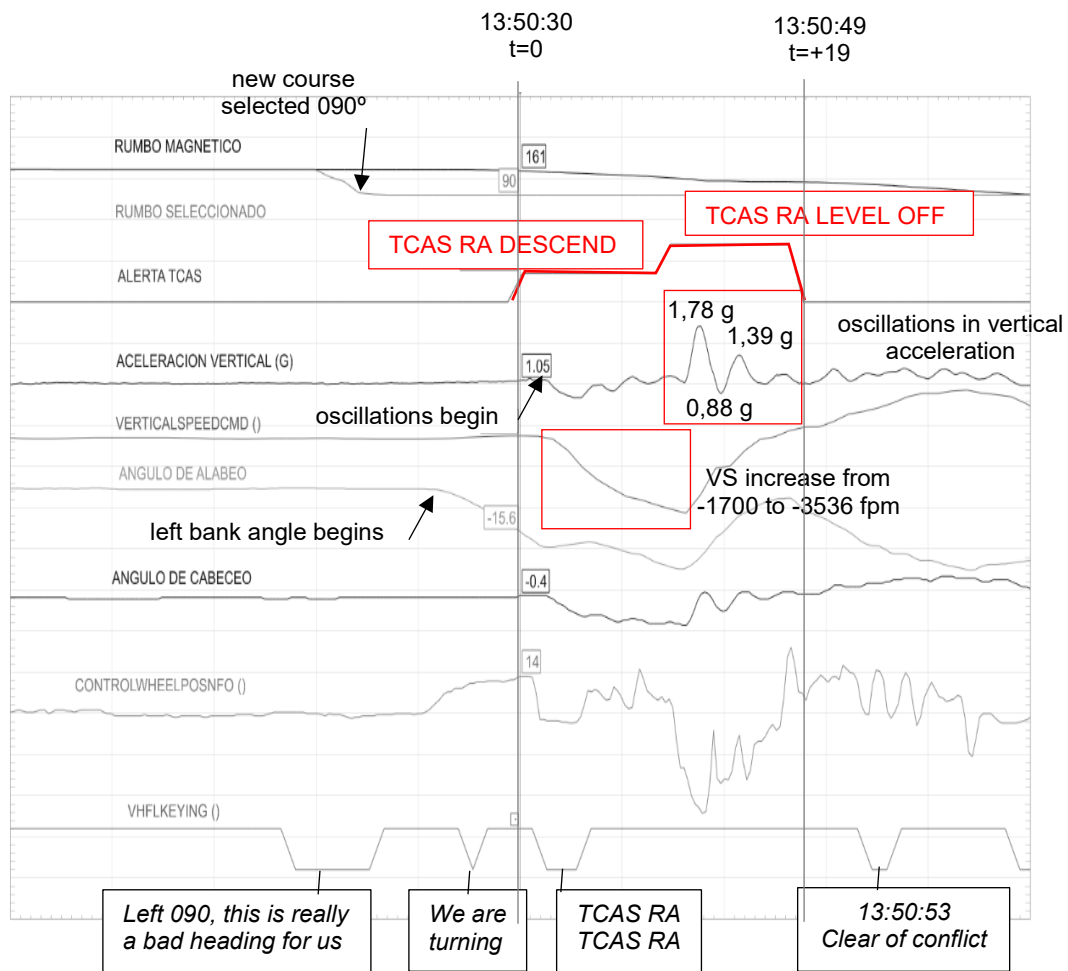
Figure 5. Timeline of TCAS RA

- t=0 Activation of the TCAS RA DESCEND DESCEND, which was active for 9 s. The aircraft was 4.5 NM and 700 ft away (20600 ft and 19900 ft) from VLG, which was above IBK. The aircraft was at 292 kt with a left bank angle of 18° and descending at 1656 fpm. The value of the vertical acceleration was in the normal range (1.04 g).

- t=+9 End of DESCEND DESCEND advisory. The aircraft had increased its vertical speed to -3336 fpm and its bank angle was -27.1°. Its speed was 294 kt and the pitch angle had recovered to -0.9°.

- t=+10 Activation of TCAS RA LEVEL OFF, which was active for 8 s. The maximum bank angle, -28.5°, was reached at this time. During the 8 s that the LEVEL OFF advisory was activated, the crew leveled the wings.

- t=+11 Maximum vertical speed of -3536 fpm registered, which would start to decrease from this moment on.
- t=+12 Maximum vertical acceleration recorded: 1.78 g (5). The aircraft were 2.3 NM and 1500 ft apart.

- t=+17 Point of closest approach: 2 NM and 1500 ft (6).
- t=+19 TCAS LEVEL OFF advisory cleared. The aircraft was on course 145° with a bank angle of -9°, a vertical speed of -1448 fpm and a CAS of 293 kt.
