A-029/2017

Accident involving a Boeing 737-800 aircraft, registration EI-FJJ, operated by Norwegian Air International, at FL190 in the vicinity of the CLS VOR/DME (Valencia) on 18 October 2017

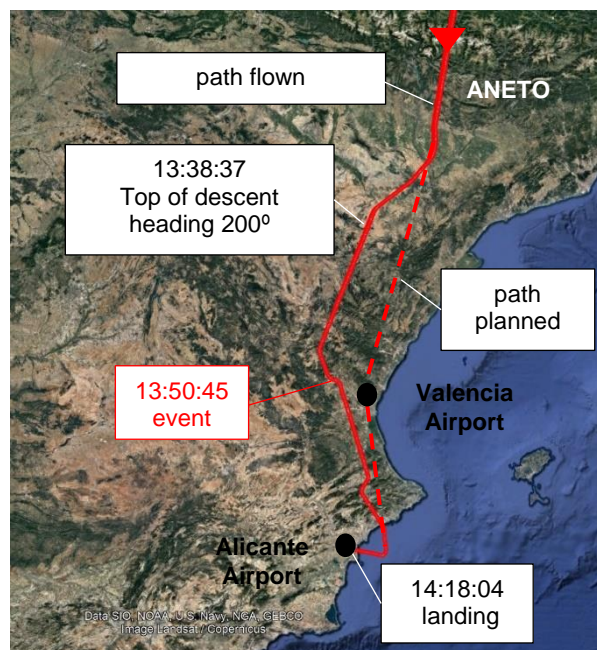
The planned route (dashed line in Figure 1) had the aircraft descend on a practically southerly course to Alicante over Valencia, but due to bad weather throughout the east and northeast of the Iberian Peninsula, the crew requested a change in route (solid red line in Figure 1), which ATC authorized.

Figure 1. Flight path in the Barcelona ACC airspace

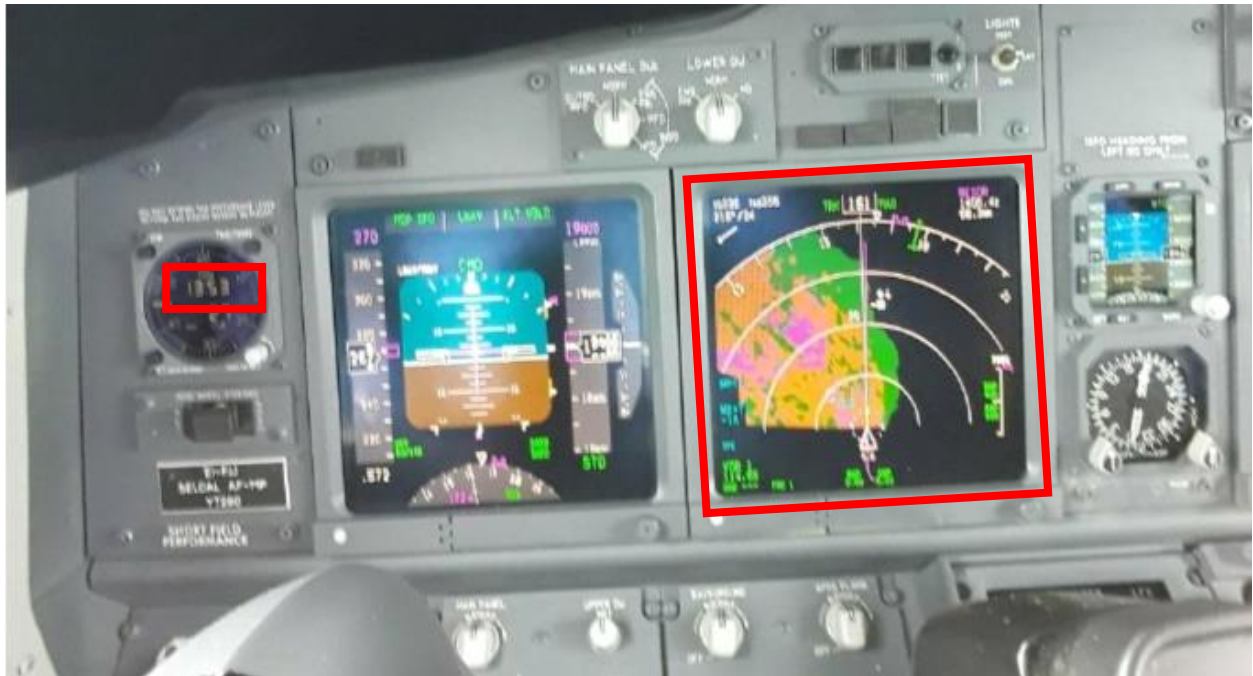
The information displayed on the aircraft's weather radar was, as per the crew's statement, similar to that shown in the photo in Figure 2 (right display). This photo was taken by the crew 2 minutes after the event, and it shows a radar return that indicates clouds with intense rain and turbulence³.

Figure 2. Photo taken by the crew at 13:53 (2 min after the event)

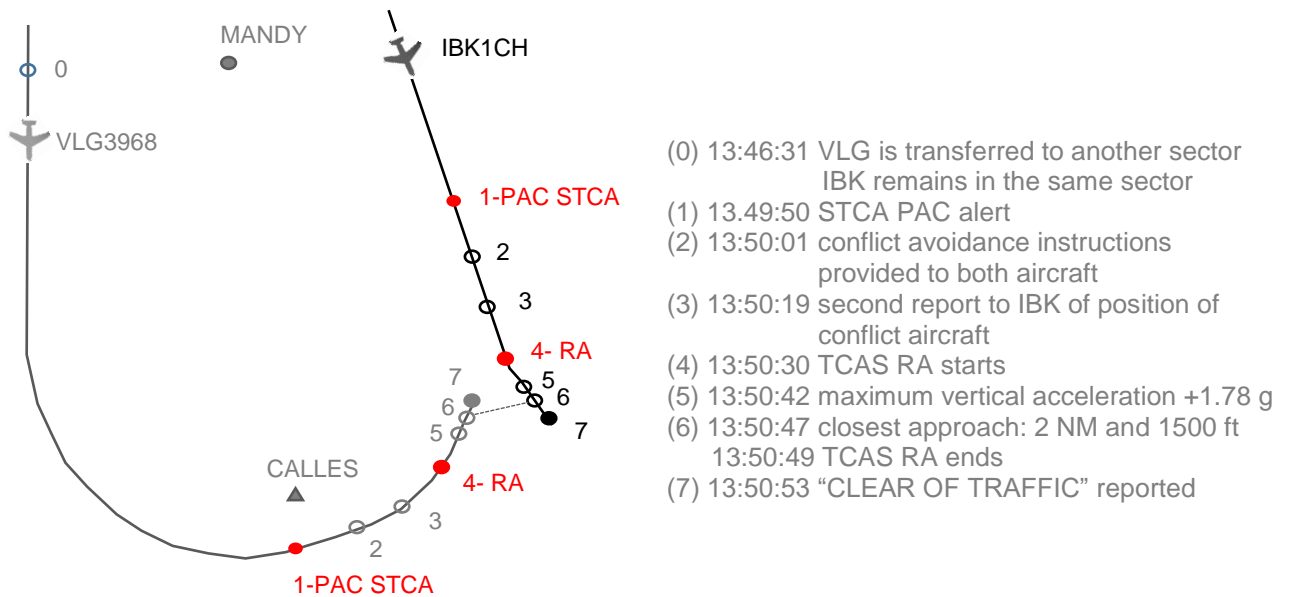
Figura 3. Relative positions of the aircraft during the event

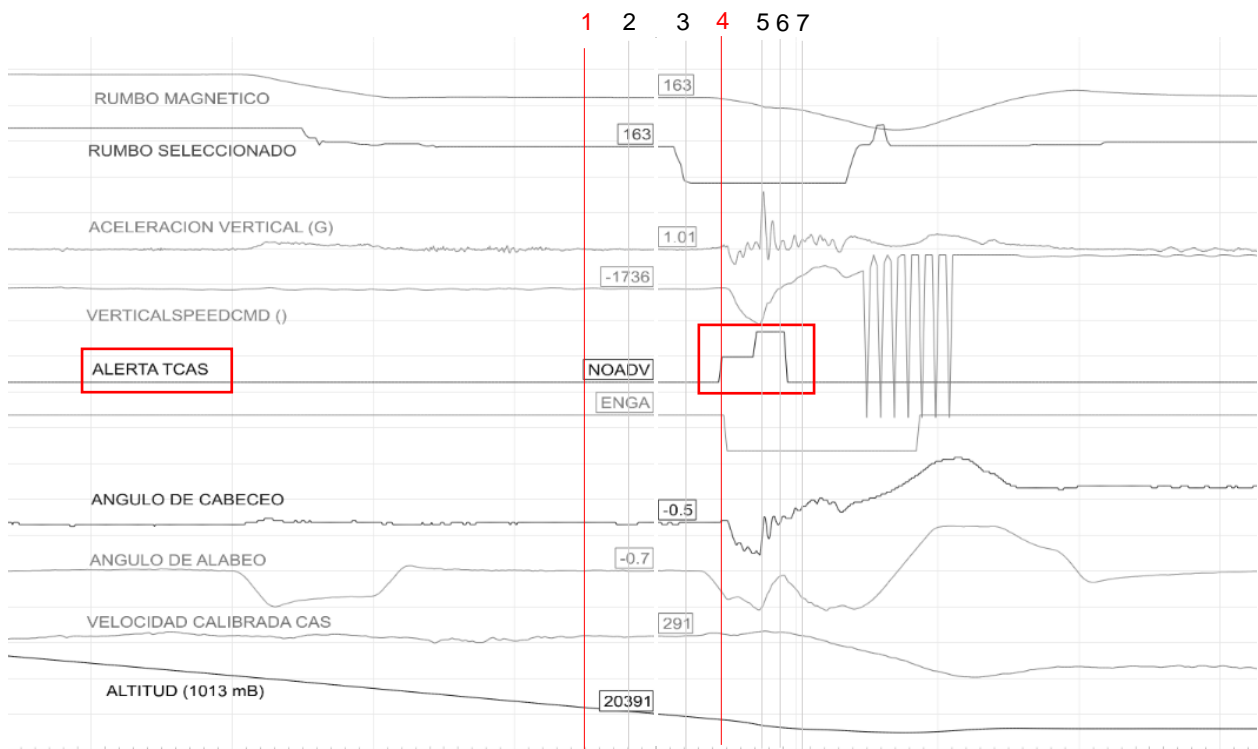
Figure 4. Parameters from IBK during the event

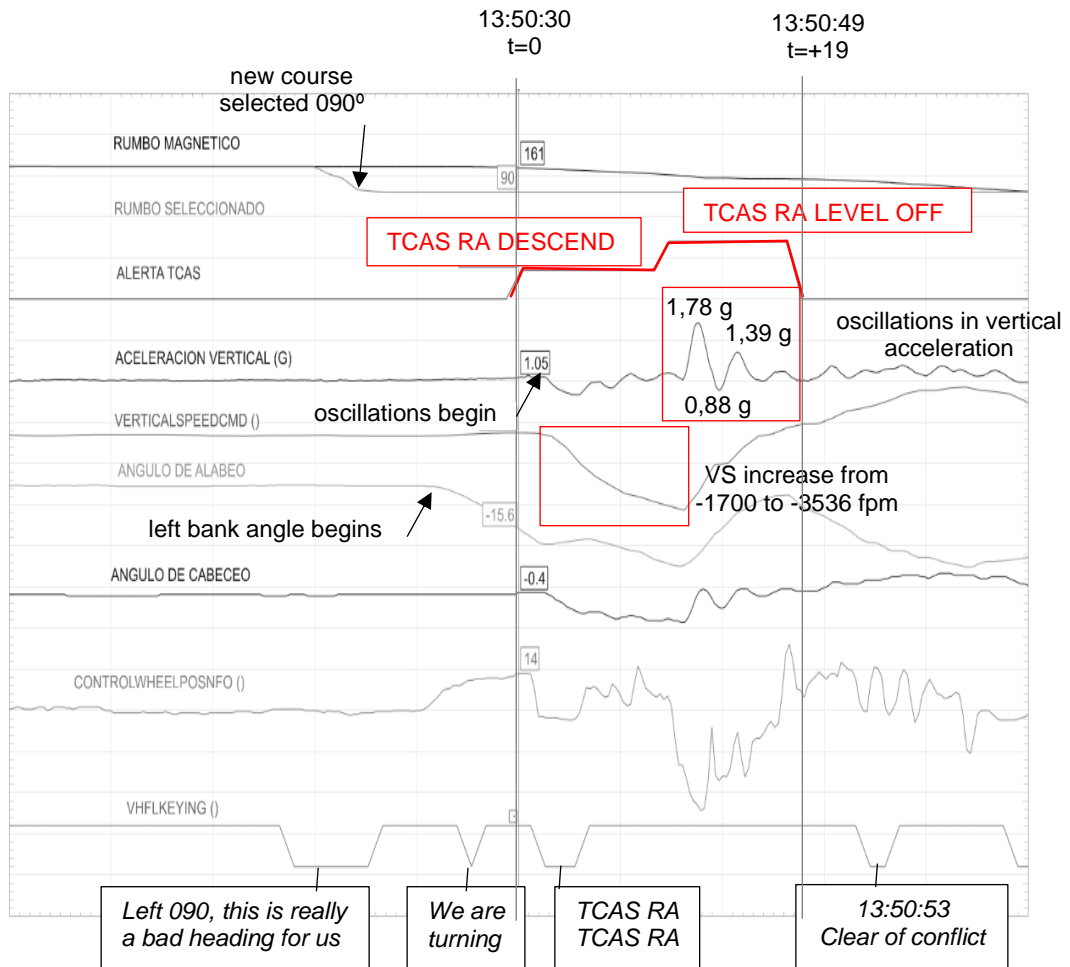
- t=0 Activation of the TCAS RA DESCEND DESCEND, which was active for 9 s. The aircraft was 4.5 NM and 700 ft away (20600 ft and 19900 ft) from VLG, which was above IBK. The aircraft was at 292 kt with a left bank angle of 18° and descending at 1656 fpm. The value of the vertical acceleration was in the normal range (1.04 g).

- t=+9 End of DESCEND DESCEND advisory. The aircraft had increased its vertical speed to -3336 fpm and its bank angle was -27.1°. Its speed was 294 kt and the pitch angle had recovered to -0.9°.

- t=+10 Activation of TCAS RA LEVEL OFF, which was active for 8 s. The maximum bank angle, -28.5°, was reached at this time. During the 8 s that the LEVEL OFF advisory was activated, the crew leveled the wings.

- t=+11 Maximum vertical speed of -3536 fpm registered, which would start to decrease from this moment on.
- t=+12 Maximum vertical acceleration recorded: 1.78 g (5). The aircraft were 2.3 NM and 1500 ft apart.

- t=+17 Point of closest approach: 2 NM and 1500 ft (6).
- t=+19 TCAS LEVEL OFF advisory cleared. The aircraft was on course 145° with a bank angle of -9°, a vertical speed of -1448 fpm and a CAS of 293 kt.

Figure 5. Timeline of TCAS RA
