Report A-029/2020

Accident on 30 July 2020,
involving a PC-28 CRUISER
operated by FLYBAI, S.L.,
registration EC-NAP, at Burgos
Airport (Villafría-Burgos, Spain)

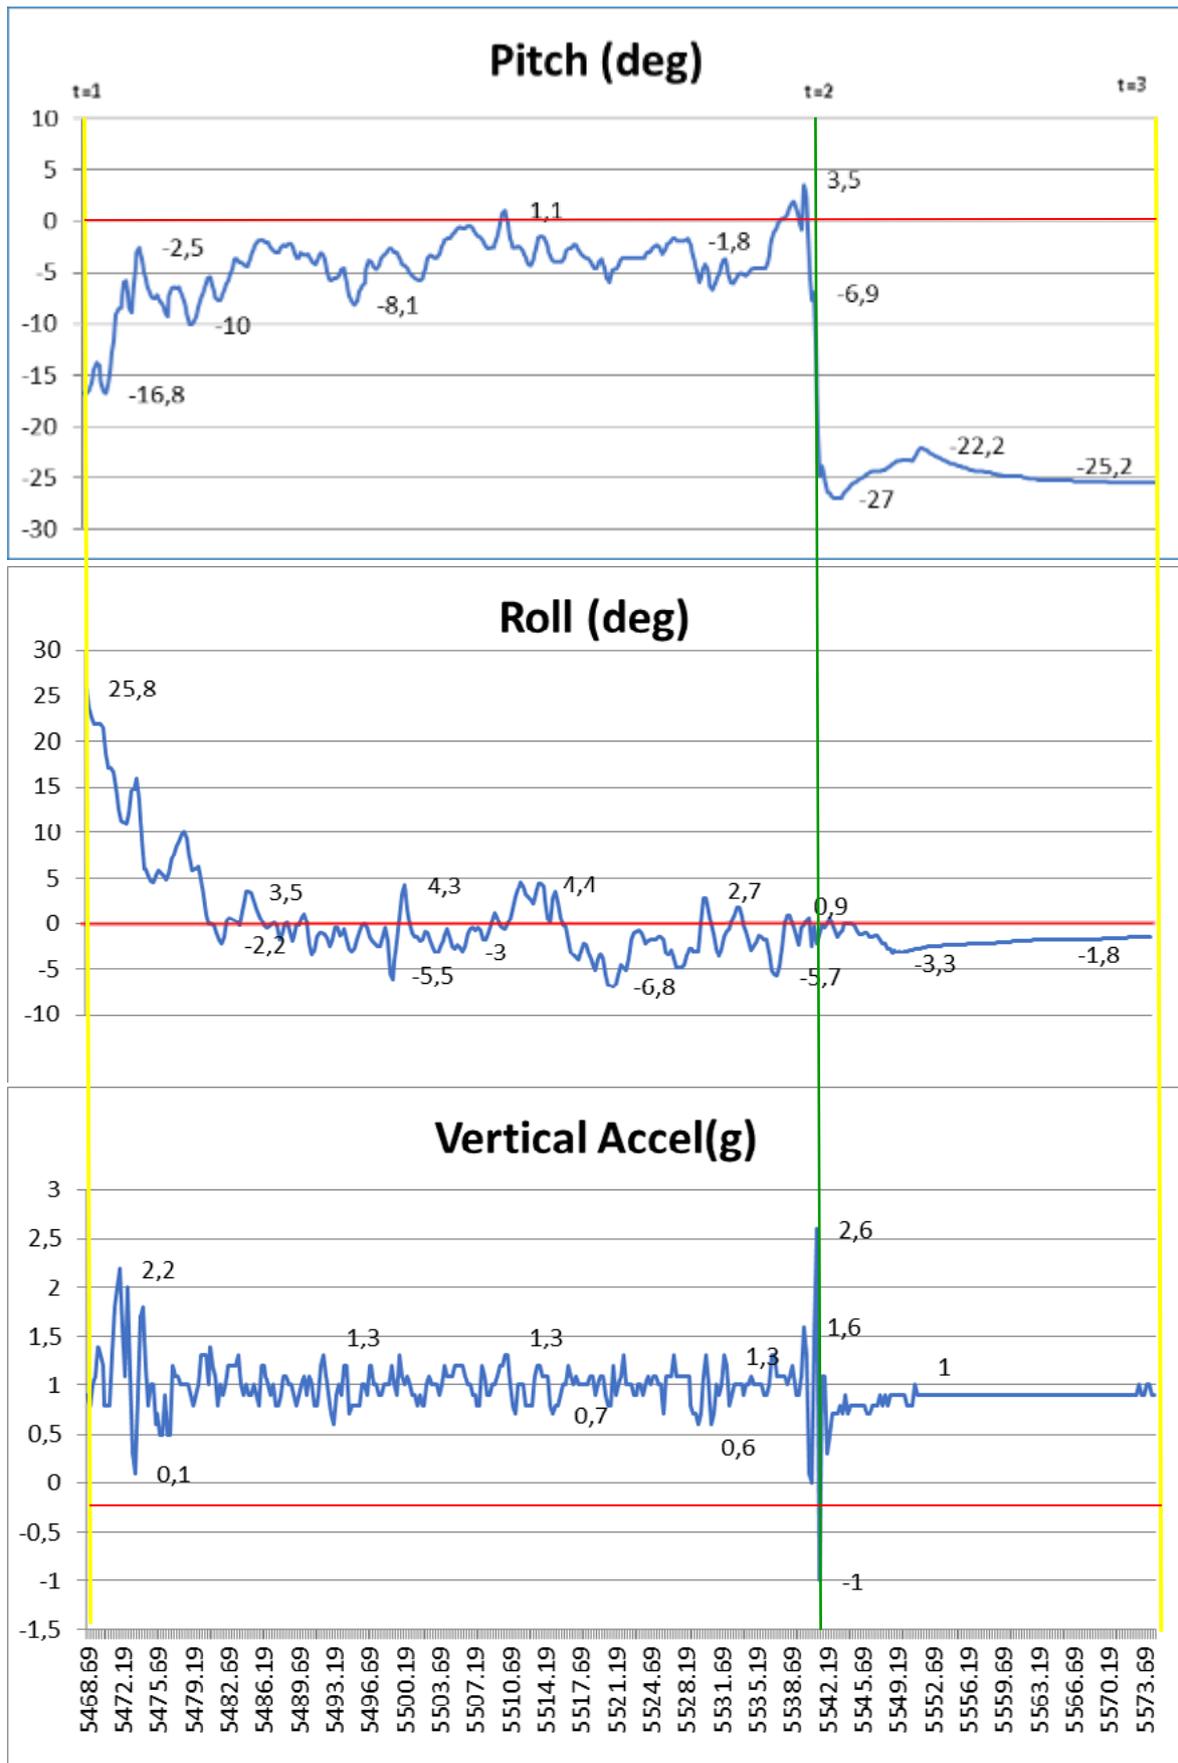
- The pitch data was between the maximum positive and negative limits of 3.5° and -27° at 10:36:10 and 10:36:13 UTC.
- The roll data was between 25.8° and -7° at 10:34:59 and 10:35:51 UTC.

- The engine rpm had its maximum value of 4345 rpm at 10:35:51 and a minimum value of 0 rpm from 10:36:12 UTC to the end of the analysis at 10:36:45 UTC.

- The wind direction was between 53° to 181°, with speeds of 5 to 11 kt. The aircraft landed on LEBG runway 22.
- The flaps were at 14° for the duration of the analysed period.

Graph 1. Flight data during touchdown

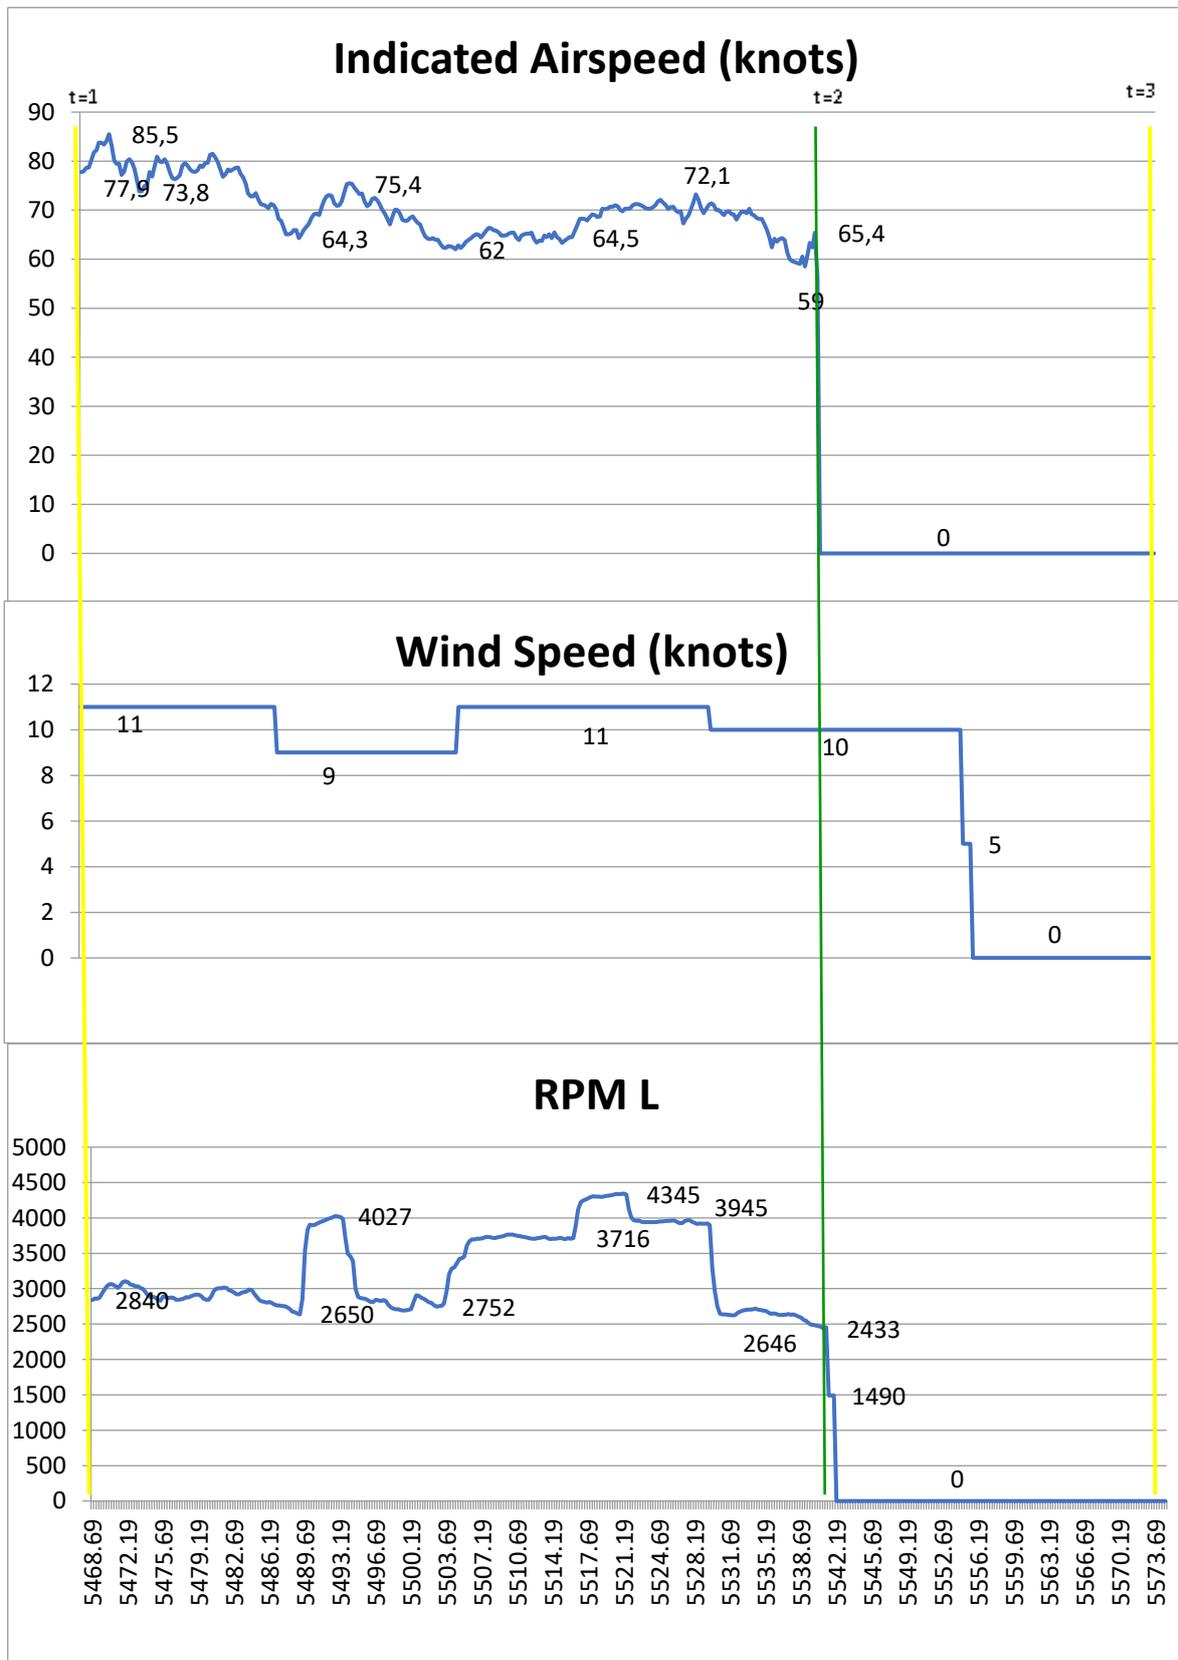
Graph 2. Flight data during touchdown (continued)

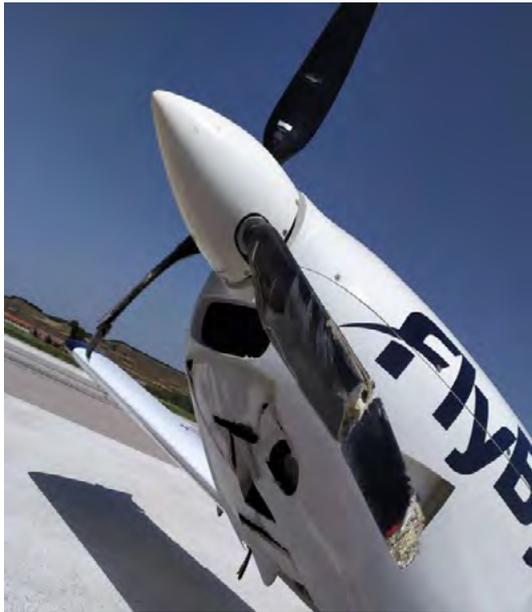
Photograph 2. Damage to the propeller

- Propeller: blades damaged, eroded at the blade tips and one of them, cross-sectioned without detachment, roughly at its middle point.
- Damaged exhaust manifolds.
- Nose gear assembly: destroyed with the fork and nose wheel being wholly detached.
- Underside of fuselage: deformed in the anchoring areas of the main landing gear and nose.
- Lower engine cowling, broken and deformed.

The damage to the propeller, nose gear and underside of the fuselage is consistent with the aircraft's nose impacting the runway after the wheel fork detached and the wheel leg buckled in the direction of travel.

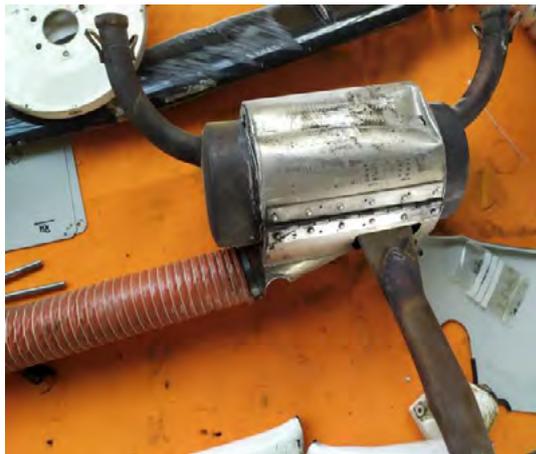
Photograph 3. Damage to the exhaust manifolds

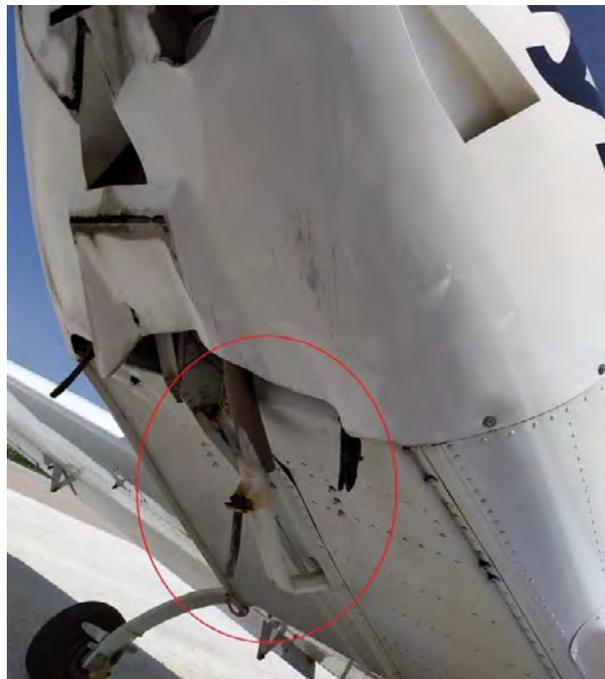
After the nose gear bounced on the runway several times, it collapsed. The nose gear fork detached, leaving the aircraft to slide along on its deformed nose leg until it came to a complete stop on the left side of the first third of runway 22.

Photograph 4. Damage to nose landing gear

The impact of the nose gear on the runway caused the wheel fork to detach. The aircraft then slid along on its nose leg and main gear until it came to a standstill.

The wheel fork's mounting bolts and the nose leg were bent in the direction of the nose's impact with the runway, but there were no signs of any flaws or damages to suggest they were in a questionable condition prior to the event. The nuts and washers came off as a result of the impact.

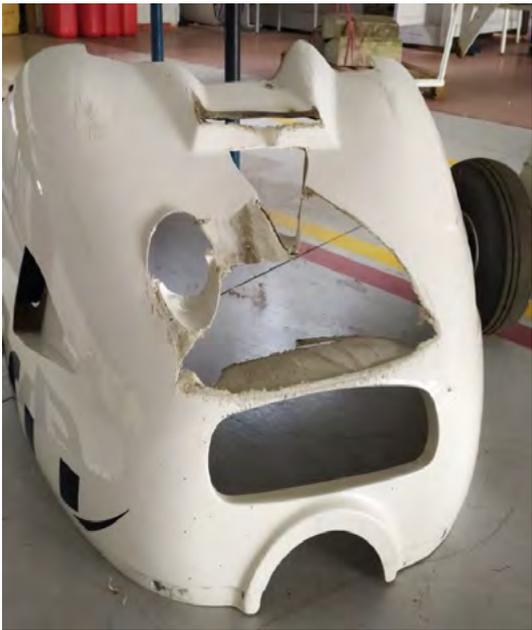
Photograph 5. Damage to lower engine cowlingr

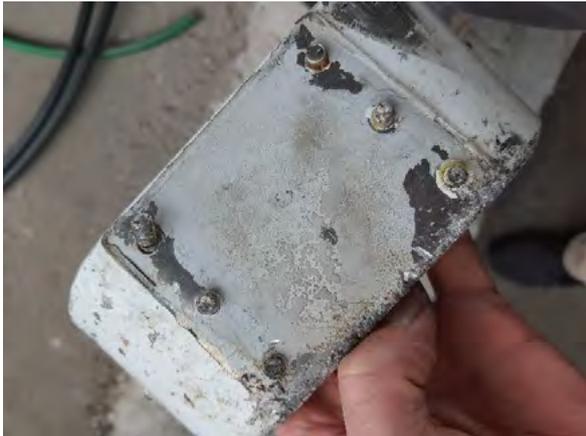
Photograph 7. Damage to lower engine cowling

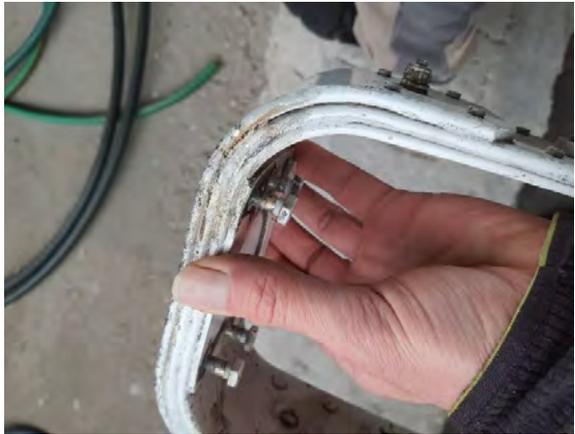
Photograph 8. Damage to lower engine cowling

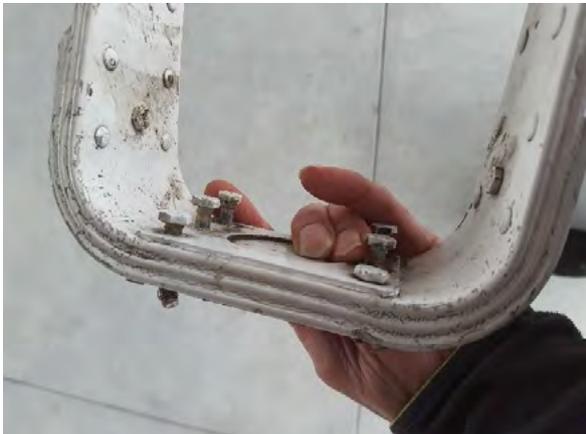
Photograph 9. Damage to lower engine cowling
