Technical report

A-029/2020

Accident on 30 July 2020,
involving a PC-28 CRUISER
operated by FLYBAI, S.L., registration EC-NAP,
at Burgos Airport
(Villafría-Burgos, Spain)

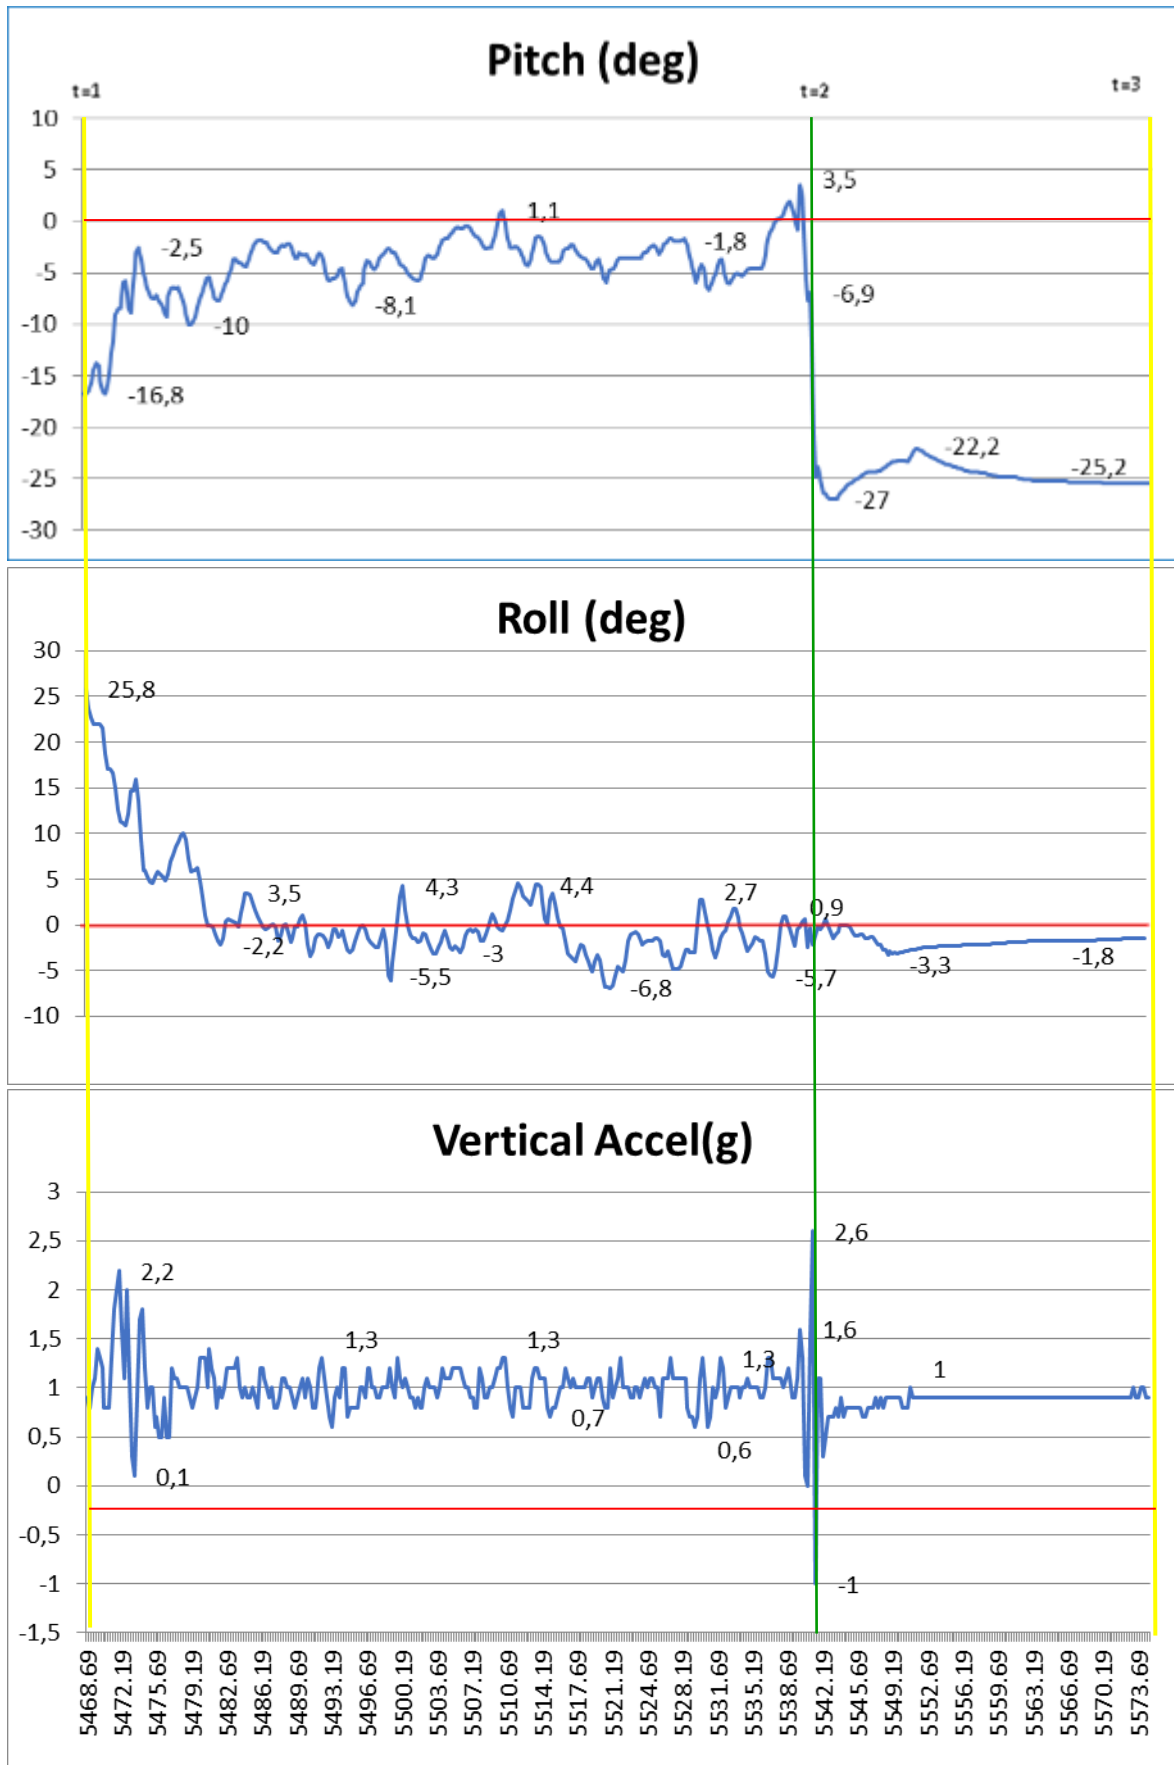
Graph 1. Flight data during touchdown

- The pitch data was between the maximum positive and negative limits of 3.5° and -27° at 10:36:10 and 10:36:13 UTC.
- The roll data was between 25.8° and -7° at 10:34:59 and 10:35:51 UTC.

- The engine rpm had its maximum value of 4,345 rpm at 10:35:51 and a minimum value of 0 rpm from 10:36:12 UTC to the end of the analysis at 10:36:45 UTC.

- The wind direction was between 53° to 181° , with speeds of 5 to 11 kt. The aircraft landed on LEBG runway 22.
- The flaps were at 14° for the duration of the analysed period.

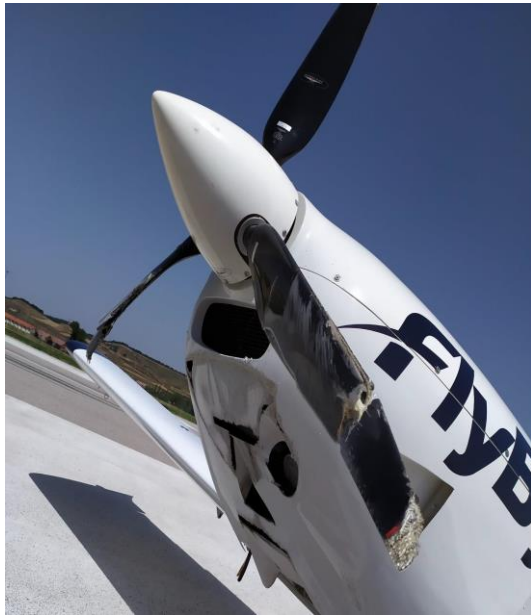
Photograph 2. Damage to the propeller

- Propeller: blades damaged, eroded at the blade tips and one of them, cross-sectioned without detachment, roughly at its middle point.
- Damaged exhaust manifolds.
- Nose gear assembly: destroyed with the fork and nose wheel being wholly detached.
- Underside of fuselage: deformed in the anchoring areas of the main landing gear and nose.
- Lower engine cowling, broken and deformed.

The damage to the propeller, nose gear and underside of the fuselage is consistent with the aircraft's nose impacting the runway after the wheel fork detached and the wheel leg buckled in the direction of travel.

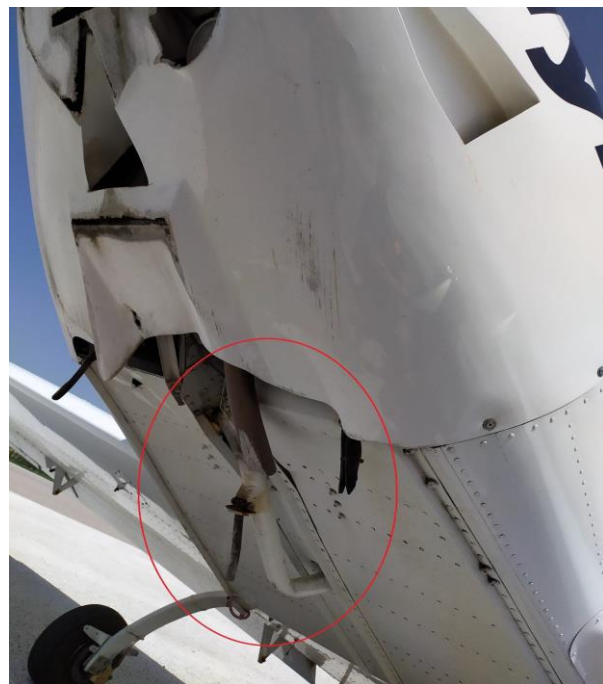
Photograph 4. Damage to nose landing gear

After the nose gear bounced on the runway several times, it collapsed. The nose gear fork detached, leaving the aircraft to slide along on its deformed nose leg until it came to a complete stop on the left side of the first third of runway 22.

The impact of the nose gear on the runway caused the wheel fork to detach. The aircraft then slid along on its nose leg and main gear until it came to a standstill.

The wheel fork's mounting bolts and the nose leg were bent in the direction of the nose's impact with the runway, but there were no signs of any flaws or damages to suggest they were in a questionable condition prior to the event. The nuts and washers came off as a result of the impact.
