CIAIAC

Report A-032/2019

Accident on the 19th of July
2019, involving a Piper PA 28-140
aircraft, registration EC-GDC, in
Villarrubia de Santiago (Toledo)

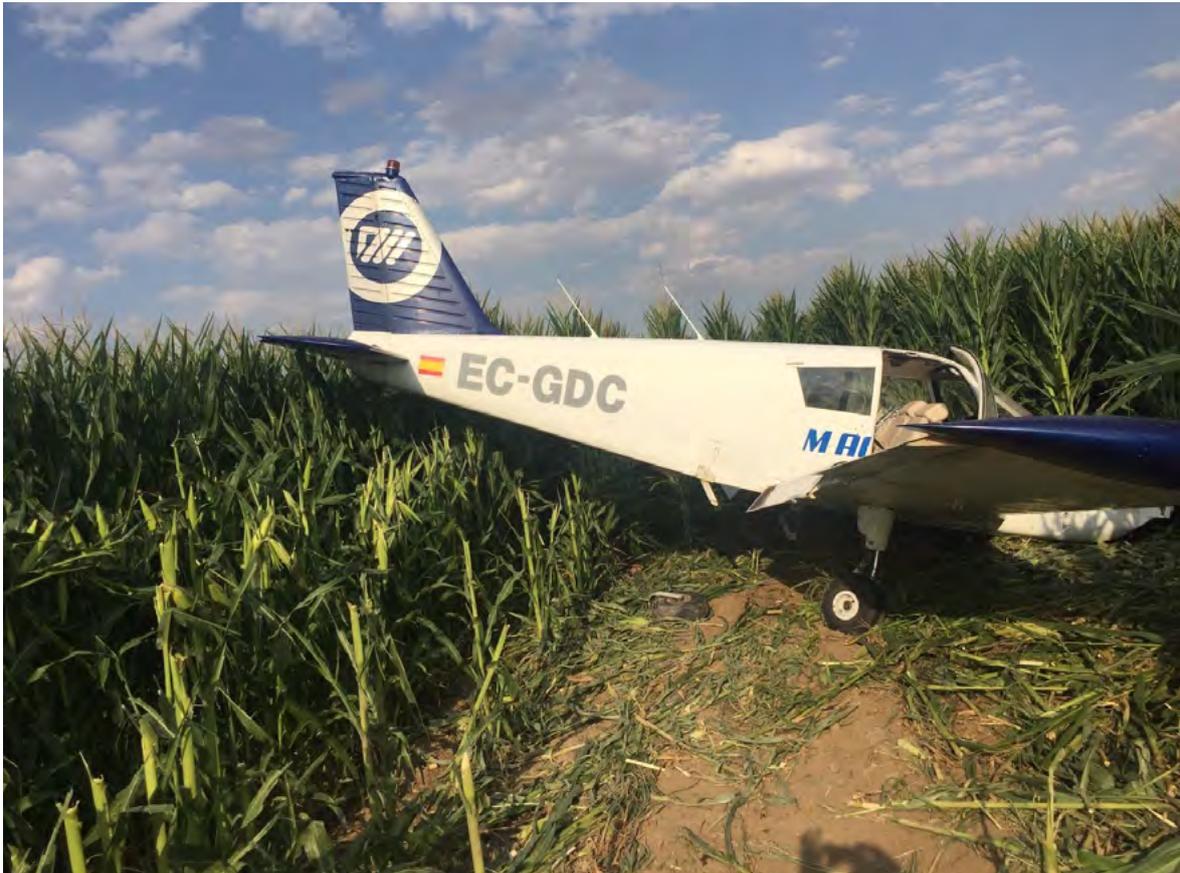
Photograph 1. Damaged aircraft at the accident site

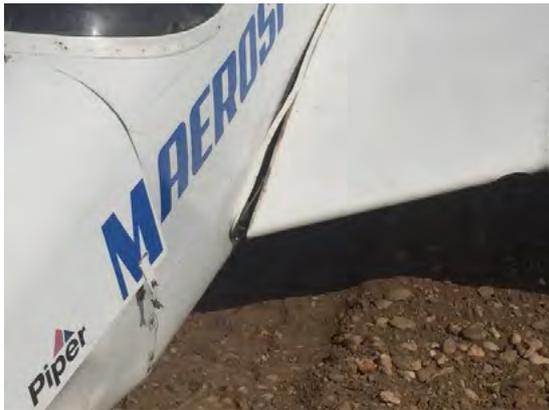
Photograph 5. Left fuselage-wing joint

- Deformation and breakage of anchors of the upper engine cowlings. Deformed and eroded propeller.
- Wing deformation and separation of the left fuselage-wing joint.
- Landing gear: the main gear was damaged and deformed and the nose gear destroyed.

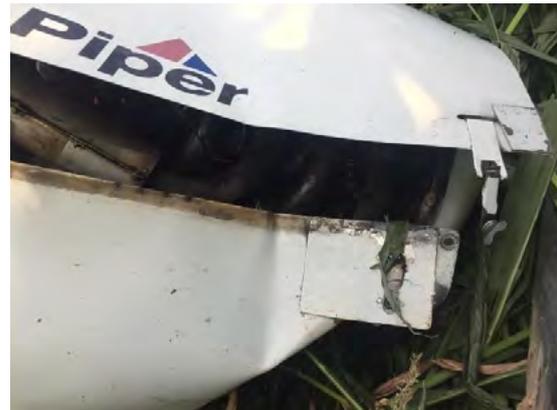
Photograph 6. Engine cowling

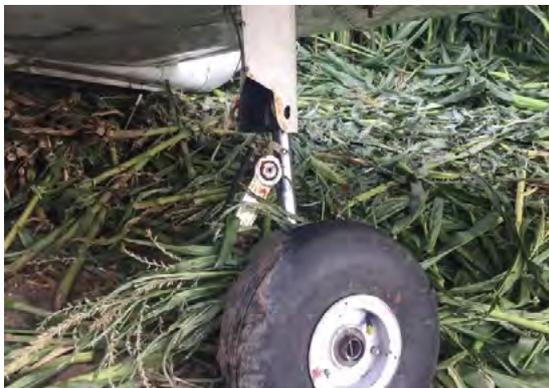
Photograph 7. Main landing gear

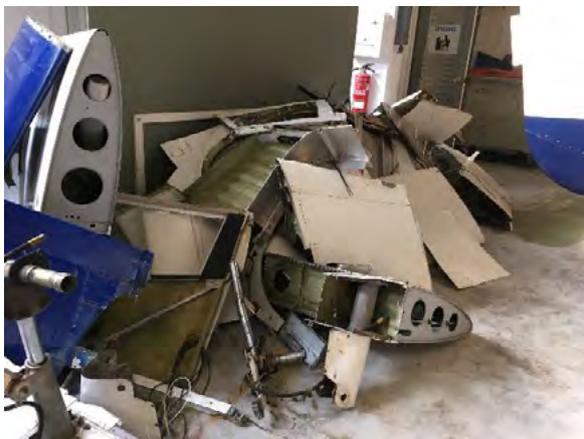
The only remaining part of the cabin was the lower fuselage, without the cover. The indicator panel was missing the instrumentation but did have the power controls.

Photograph 8. Aircraft wreckage after its fragmentation

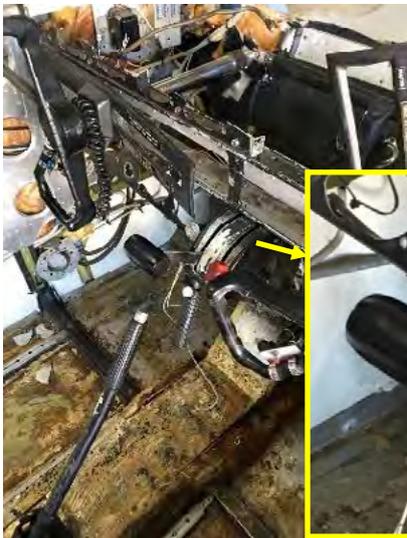
Photograph 11. Mixture knob in the flight cabin and detail

When the mixture knob was moved to the lean position, the cable offered no resistance and pulled the carburettor rod, making the mixture leaner. However, because the cable was not clamped and bent into a deformed position when the mixture knob was operated to the rich mixture position, the cable didn't push the connecting

rod forward to allow more fuel through and enrich the mixture. As a consequence, the mixture controller worked to make the mixture leaner but not to enrich it.

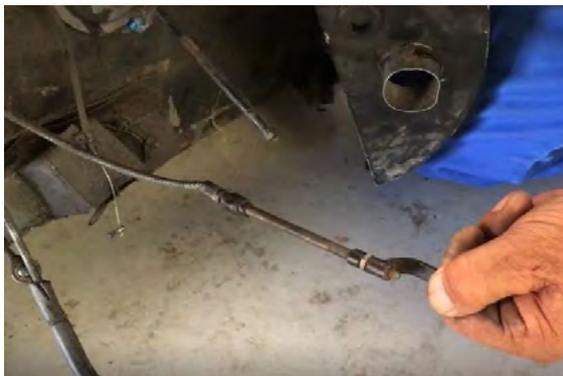
Photograph 12. Mixture controller cable in the lean mix position

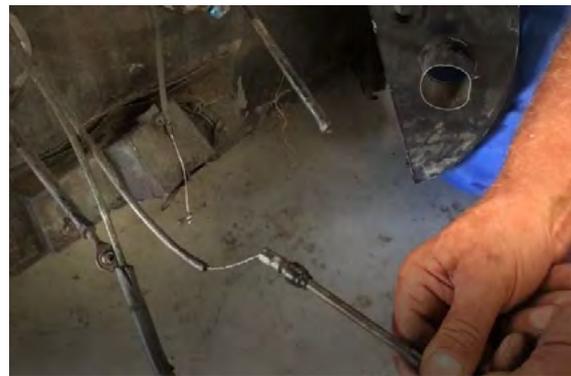
Photograph 13. Mixture controller cable in the rich mix position

However, when an enriched mixture was finally required, the mixture controller didn't work properly because the sleeve of the connecting cable between the controller and the carburettor had come loose, and the cable had been bent. This rendered the controller useless because it did not push the carburettor rod to inject more fuel. If this control had worked properly, the loss of engine power would probably have been recovered.

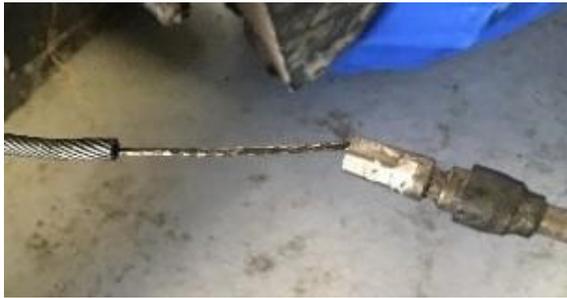
Photograph 14. Detail of the non-crimped mixture controller cable

Regardless, the engine would have provided power if the mixture controller had been connected and operated the fuel inlet on the carburettor. As it wasn't detected during the maintenance revision, the connecting cable probably became decrimped during the flight. It seems unlikely that the deterioration and eventual breakage of this cable could have occurred in such a short amount of flying time. However, it would have been impossible to foresee, even if preventive maintenance could have reduced the risk of it occurring.

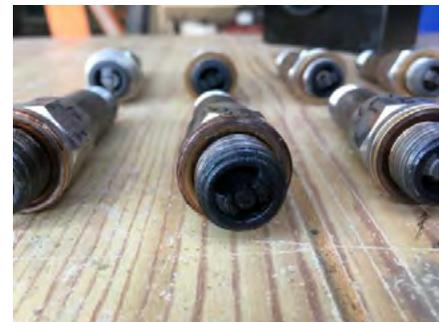
- The cylinder compression and operation of the intake and exhaust valves were checked and found to be acceptable in all four cylinders.
- The condition of the spark plugs was also checked. They were found to be new and in good condition except for those of cylinder number 3, where both the upper and lower spark plugs were blackened and had excess oil.

Photograph 15: Cylinder n.3 spark plug

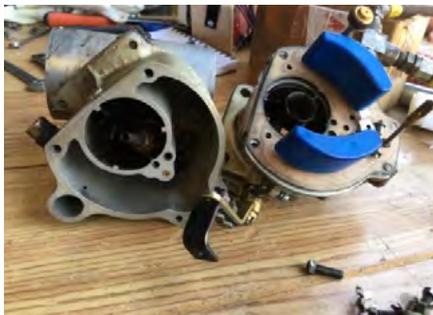
- The carburettor was dismantled, and it was confirmed there was no fuel inside. The floats were new and in good general condition, no dirt was detected, the venturi was clean, and the butterfly valve was unobstructed.
- The pipes could not be checked in their layout to the fuel tanks given the fragmentation of the aircraft.
- The fuel tanks were in good condition.
- An inspection of the remaining fuel did not reveal the presence of any water or contamination.

Photograph 16: Carburettor

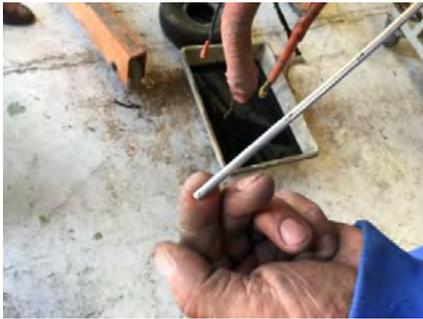
Photograph 17: Oil dipstick and remaining oil in the float bowl

- The oil level in the tank was checked; the rod was extracted completely clean; there was no oil and no evidence of possible leaks in the area.
- The oil filter was disassembled and metallic (steel) particles were observed inside.
- The remaining oil was drained from the sump. Approximately 2 litres of extremely dirty and dark-coloured oil were obtained.
- The condition of the engine oil lines was checked. There were small remnants of oil in the intake hoses but no obstructions. The insulating joints were in good condition.
- The condition of the radiator was checked. It appeared adequate, although it contained traces of soil from the scene of the accident.

However, the tests that could be performed during the engine inspection did not show compression failures or faulty operation. What it did show was a general lack of oil in the engine. Only 2 l was obtained from the sump. Although during the transfer of the aircraft and disassembly of the engine it was probably necessary to drain both oil and fuel, the amount of oil inside the engine was deemed insufficient for correct function.

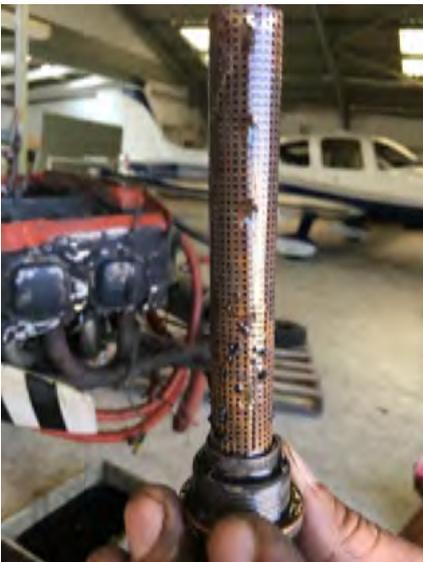
Photograph 19: Oil filter with metallic particles

Between this check and the time of the accident, the aircraft had flown for a total of 35 minutes on the previous day, and 2 hours 5 minutes on the day of the incident. The check included, among other things, changing the oil and the oil filter. This detail is not consistent with the engine oil found in the wreckage, which was very dark and dirty, or the condition of the oil filter, which was also deteriorated and contained metal particles.

Considering oil changes take place every 50 hours of flight, it's unlikely that recently changed oil could have deteriorated to such an extent in just 2 hours and 40 minutes flying time. As for the metal particles, it is not possible to specify how long they had been in the filter, but they indicate that an internal component of the engine was deteriorating as a result of a malfunction, probably due to a lack of lubrication.
