Technical report

A-033/2020

Accident involving a VANS RV-9A aircraft,
registration EC-XLF, on 22 August 2020 at Tiétar
Aerodrome, La Iglesuela (Toledo).

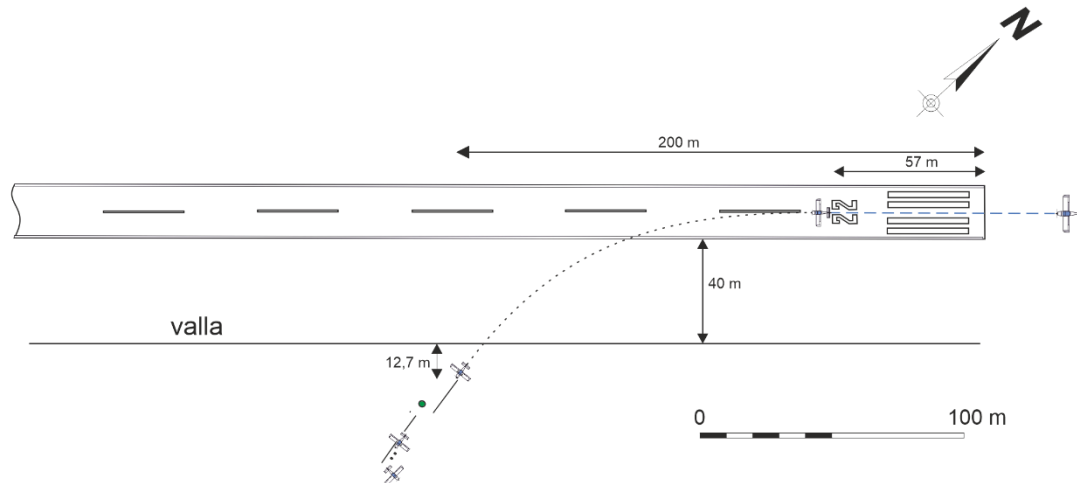
Fig. no. 1 - Diagram of the aircraft's trajectory

During the landing, on making contact with the runway just after the runway designation numbers, the aircraft bounced back into the air.

According to the pilot, when they bounced back into the air, he applied power in an attempt to fly the aircraft and land further along the runway. However, the aircraft veered to the left, and despite his attempts to correct the direction by applying pressure with his right foot, he was unsuccessful. As a result, the aircraft continued to veer to the left, deviating approximately 45° from its original path.

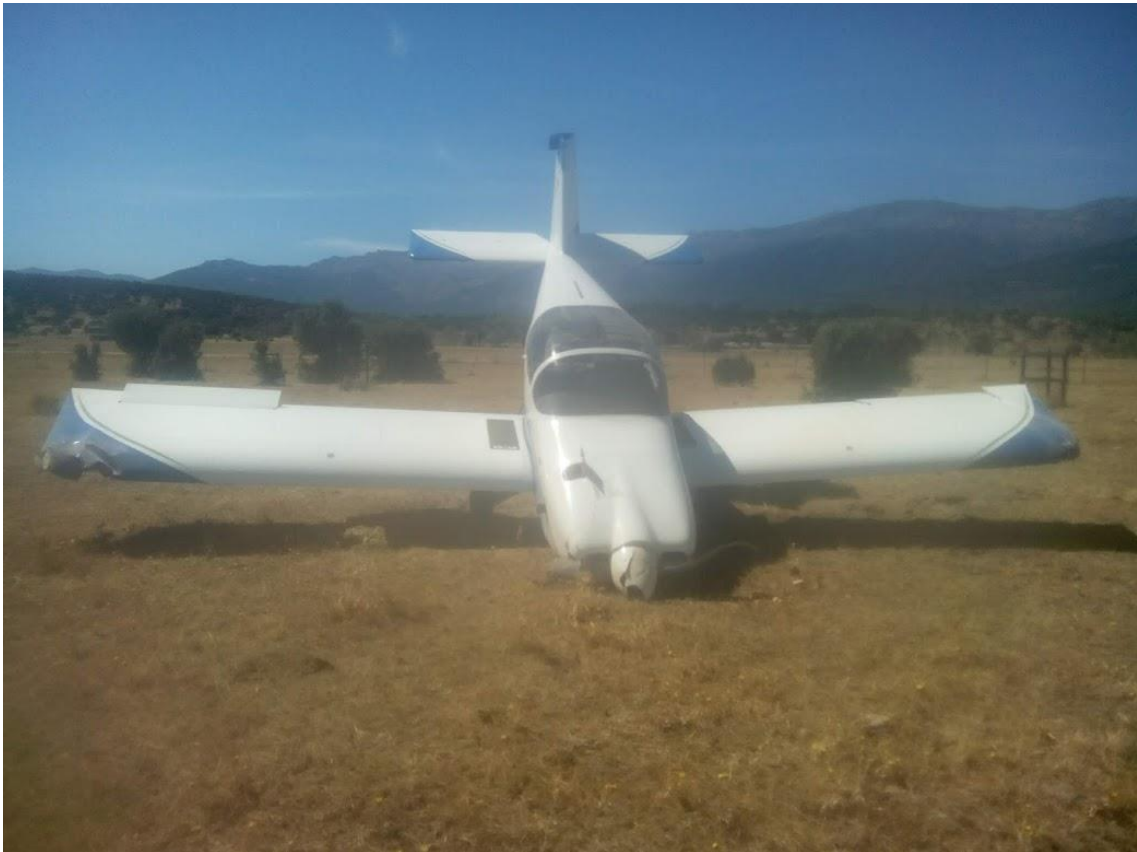
Fig. no. 2 - Aircraft in its final position

The aircraft then made it over the aerodrome's perimeter fence, making contact with the ground on an adjacent property with its left main gear wheel first, followed by its nose wheel and then the right main gear wheel. It finally came to a halt after a pronounced yaw to the left.

The pilot was unharmed and the passenger suffered minor injuries. The aircraft sustained damage to its fuselage, wings, landing gear, propeller and engine.

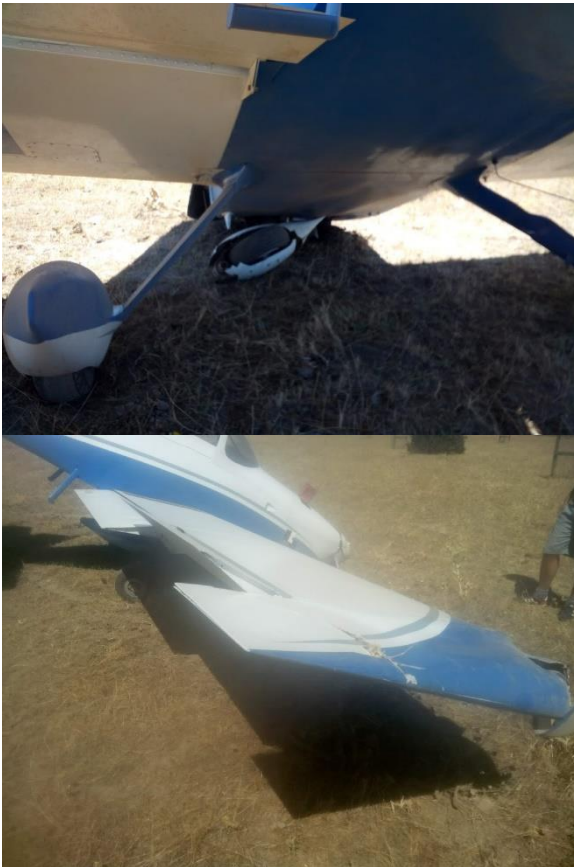
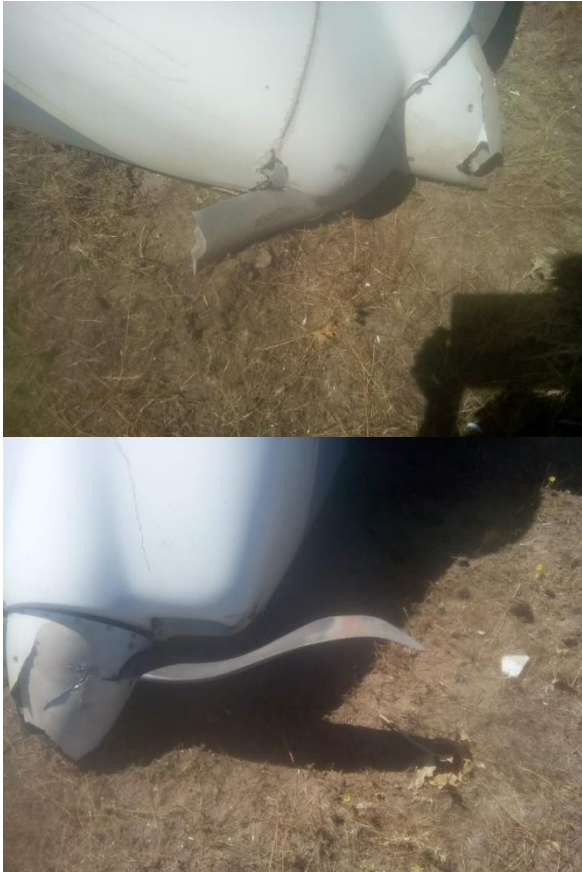
Fig. no. 3 - Detail of the damage to the aircraft

The aircraft sustained significant damage to its nose cone, landing gear and wingtips. The propeller hub and blades were also damaged.

The aircraft's propeller hub and blades were damaged and it also sustained significant damage to its nose cone, landing gear and wingtips.

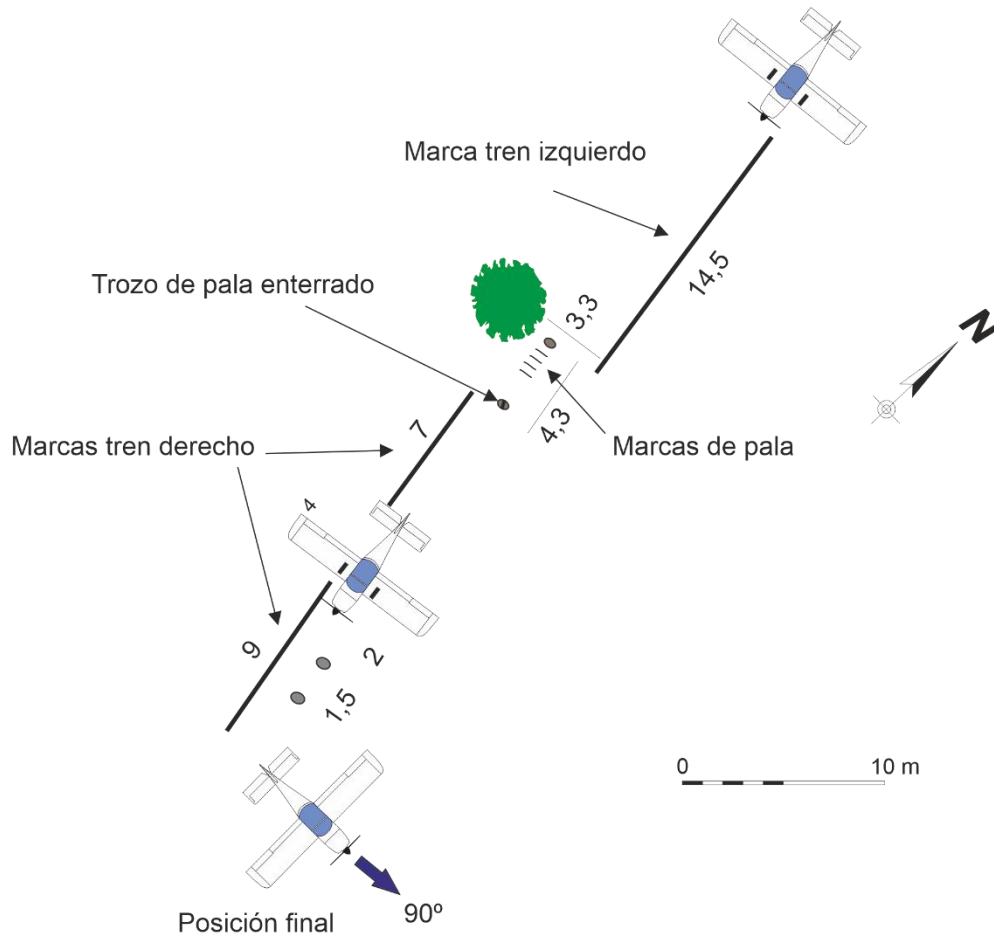
Fig. no. 4 - Diagram of the track marks and final position of the aircraft

After touching down on the runway, the aircraft rebounded into the air, following a curved trajectory to the left. After passing the aerodrome perimeter fence, it travelled for 12.7 m before returning to the ground, making initial contact with its left main landing gear wheel.

At the end and to the right (according to the direction of travel) of a 14.5 m-long track mark, four 4.3 m-long transverse marks with two small holes at either end were observed. The tip of one of the propeller blades was found in the last of the holes.

Further on and to the right, according to the direction of travel, there was another 7 m-long track mark which then disappeared for 4 m and reappeared for another 9 m. Parallel to and 2 m away from this last track mark were two small holes set 1.5 m apart.

Finally, turned about 90° to the left according to the direction of travel, the aircraft was found resting on its nose and landing gear with its tail pointing upwards.

The longitudinal 14.5 m-long track that begins 12.7 m from the fence suggests the aircraft made contact with the ground at that point and then rolled on its left main gear wheel, which would be consistent with the slight left-hand roll attitude the aircraft adopted after the bounce.

Subsequently, the 1.3 m-long transverse track marks are indicative of the propeller blades impacting the ground as the aircraft lost speed and its nose lowered as a result.

Further on and to the right, according to the direction of the previous track marks, there were two aligned longitudinal tracks measuring 7 m and 9 m, with an intermediate section of 4 m bearing no track marks. These would have been made by the right main gear wheel rolling over the ground with a 4 m-long bounce in the middle.

All of the above indicates a clearly unstable second landing and roll out, with the aircraft initially making contact with the left wheel only, then with the right wheel only, and with contact being lost completely at some intermediate points.
