Technical report

A-035/2021

Accident on 22 July 2021 involving a CESSNA FR172K aircraft, registration EC- DCP, in Almoguera (Guadalajara, Spain)

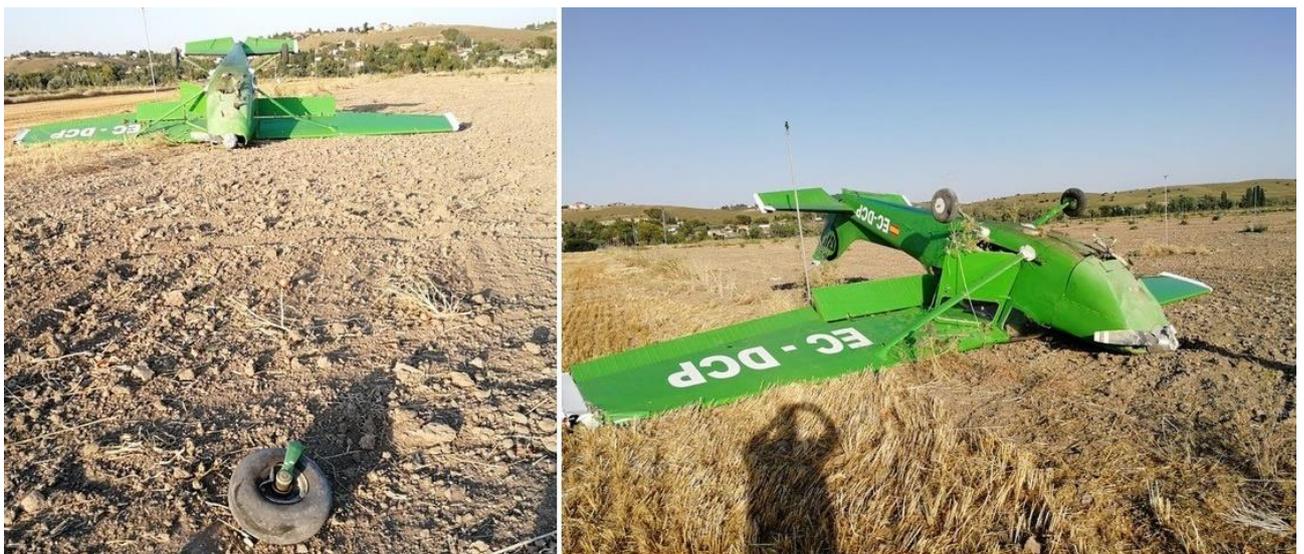
The passenger landed the aircraft on farmland in the municipality of Almoduena (Guadalajara), some 60 km from Cuatro Vientos Airport. The nature of the terrain caused the aircraft to flip over after landing, as shown in the two images in Figure 2.

Figure 2. Final position of the aircraft

The first picture shows the detached landing gear leg after it collapsed during the landing.

The pilot approached the chosen field and landed, but as he had not taken into account the unevenness of the terrain, the aircraft flipped over as soon as the nose landing gear met with resistance.

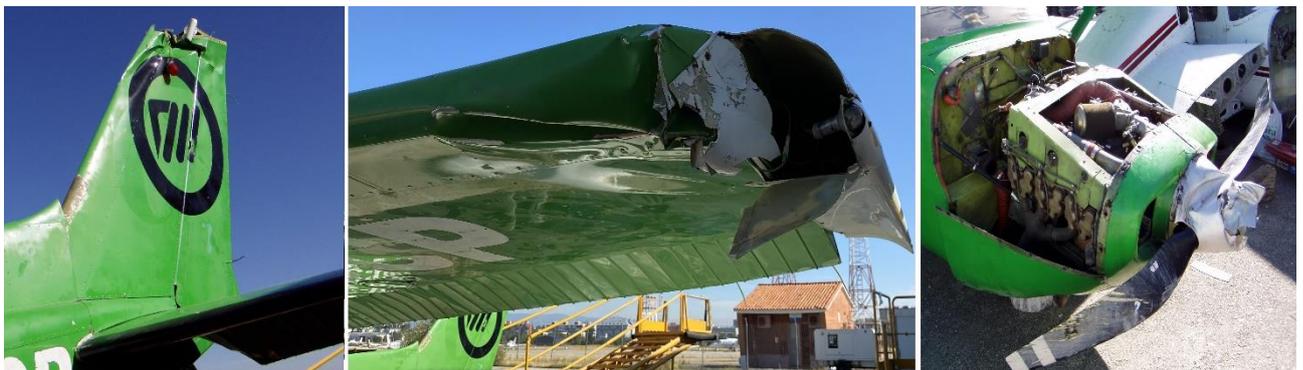
The aircraft was removed from the scene of the accident and transported to the 145 Centre responsible for its maintenance at Cuatro Vientos Airport, SINMA AVIACIÓN, S.L. (approval no. ES.145.113), to be examined. The nose leg had detached, and the vertical stabiliser, wings and propeller had been damaged during the impact, as shown in Figure 3.

Figure 3. Damage to the aircraft

The damage to the propeller suggests it was moving when the aircraft overturned. The engine cowling was removed to inspect the engine, finding that the baffles, intake pipes, air filter, exhaust ducts and electrical wiring were in good condition. No fuel leaks were found

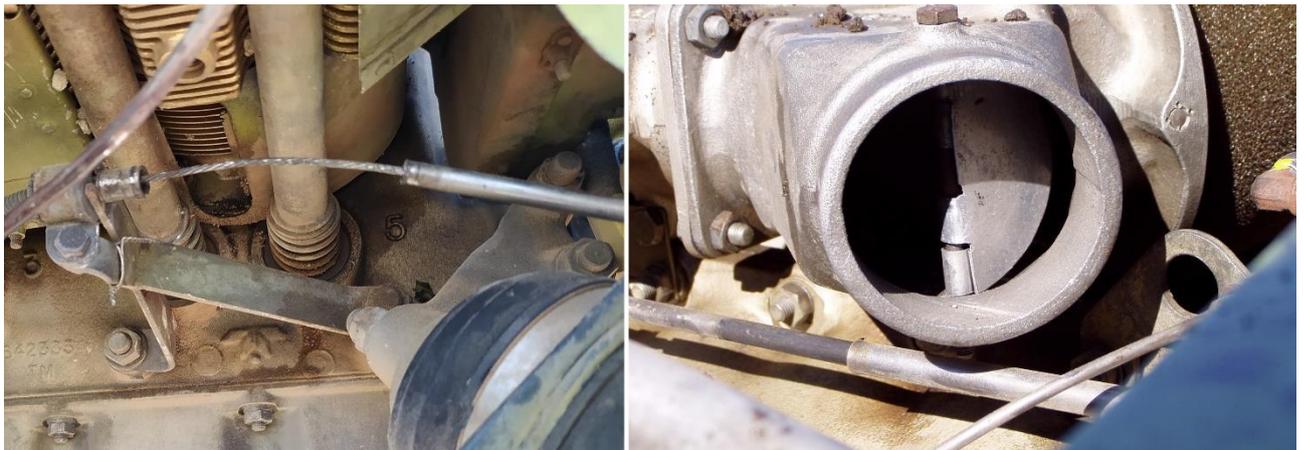
The mixture knob cable's jacket was also loose, and the alternative air butterfly valve was faulty and stuck in the open position. Figure 4.

Figure 4. Mixture cable jacket and alternative air valve

Although present before the accident, the anomalies observed during the subsequent engine examination (loose mixture cable jacket, worn spark plugs, faulty alternative air valve, slightly maladjusted ignition advance) would not have caused a loss of power. Furthermore, although the ignition timing values differed from the manufacturer's specifications (20°), this could have caused backfiring and overheating but not a drop in rpm. Finally, the inspection did not reveal any blockages or dirt in the fuel system pipes, and as a result, we have been unable to conclusively identify the cause of the incident.

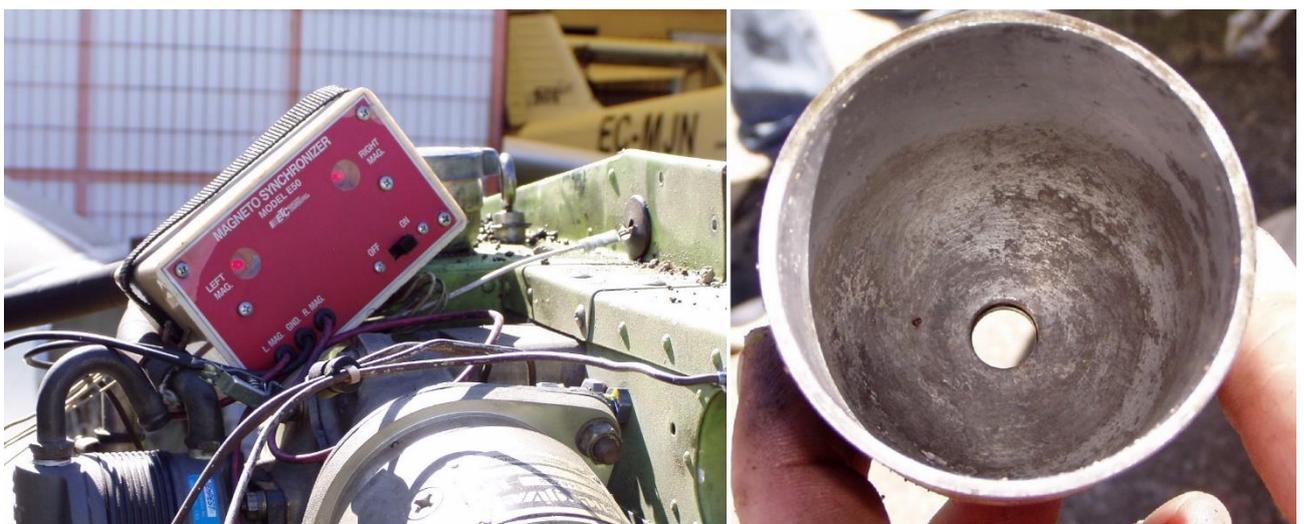
The throttle, mixture and propeller pitch controls were checked to ensure they worked correctly. The gascolator filter was disassembled, and no residue was found in the filter bowl, which was clean and free of obstructions, as shown in Figure 5.

Figure 5. Magnetos check and disassembly of the gascolator filter bowl

The magnetos were checked, finding that both provided voltage and a check of the ignition advance returned values of 24° for the left magneto and 23° for the right one.
