Report A-037/2020

Accident involving a Tecnam
P2008JC aircraft, registration
EC-NJX, at El Berriel Aerodrome
(Las Palmas-Spain) on 25 August
2020

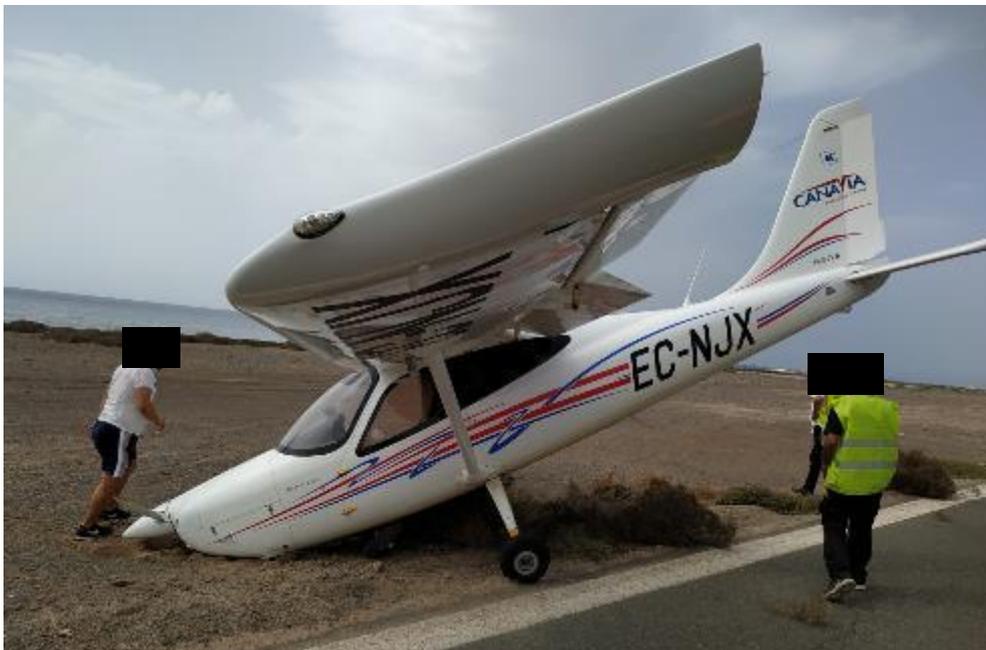
Figure 2. Final position of aircraft EC-NJX

After touchdown, which, according to the statements, was “very smooth”, the aircraft began to drift to the right. The crew were unable to regain directional control, and it veered off the runway onto the right-hand strip. The aircraft’s nose gear collapsed, and it came to a standstill, resting on the main gear and lower forward fuselage.

The photograph in figure 2 shows the vegetation in the transition zone between the asphalt runway and the strip.

Finally, with regard to the condition of the runway, the transition between the asphalt of the runway and the strip presented vegetation that probably affected aircraft as it ran off the runway.

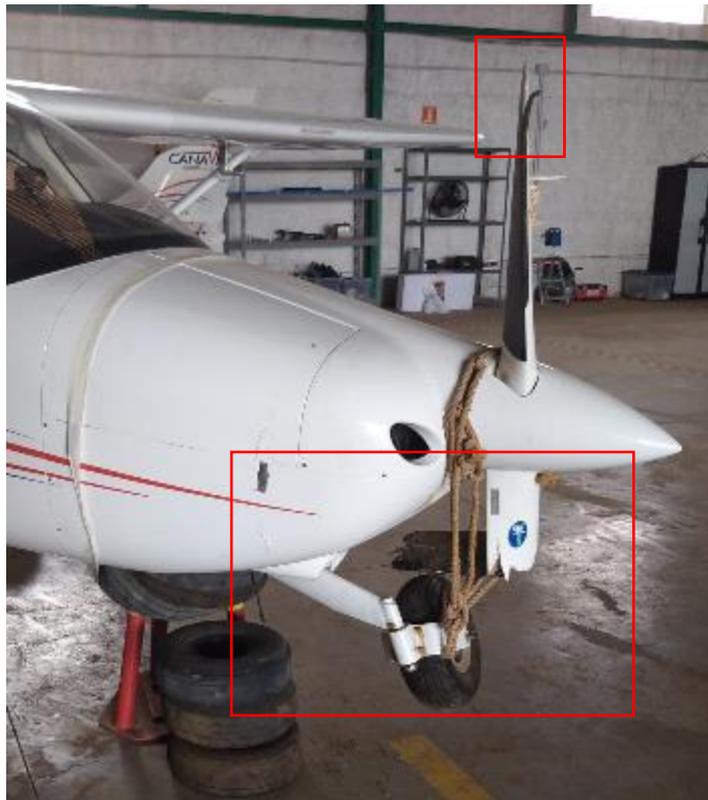
Figure 3. Damage to the aircraft

The aircraft came to a halt on the second-third of the runway, just before the right-hand strip of runway 07. It displayed damage to the nose gear, which had collapsed, the propeller and the lower forward fuselage. There were tracks in the earth under the aircraft.

A round-shaped mark and disturbed earth immediately below the propeller cone were identified at the aircraft's final resting position. There was no evidence of drag marks on the lower fuselage, indicating that this was where the nose gear had collapsed. The two-bladed propeller had damage to both blades, one of which was completely fractured 1/3 of the way along and bent back on itself. The damage to the other blade was less significant and located on the tip. The damage suggests that the propeller was already slowing down when it hit the ground.

The nose gear was still attached to the aircraft, although the structure was deformed and moved out of position. The structure of the main landing gear and the rest of the aircraft showed no apparent damage or deformations.

The lower forward fuselage displayed more minor deformation marks and cracks.

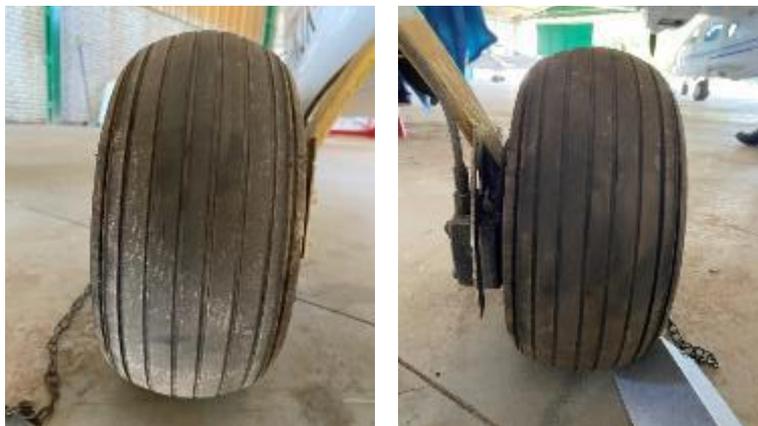
Figure 4. Marks on the right main gear tyre

The left main gear and nose gear tyres were unmarked. In contrast, the right main gear tyre showed black discolouration marks in two areas, as shown in Figure 4.

Although the condition of the tyres prior to the event is unknown, the fact that the left main and nose gear tyres did not display any signs of wear or marks and that, according to the crew, the aircraft veered to the right while braking, suggests that the discolouration marks identified on the right main landing gear wheel occurred during the event. These black discolouration marks are indicative of heat produced by the tyre's contact with the asphalt. They occur when a wheel is braked and, rather than turning freely, drags along the runway after making contact with it.

Therefore, it is considered that the immediate cause of the loss of control during the landing roll-out was an asymmetry in the braking action of the aircraft.

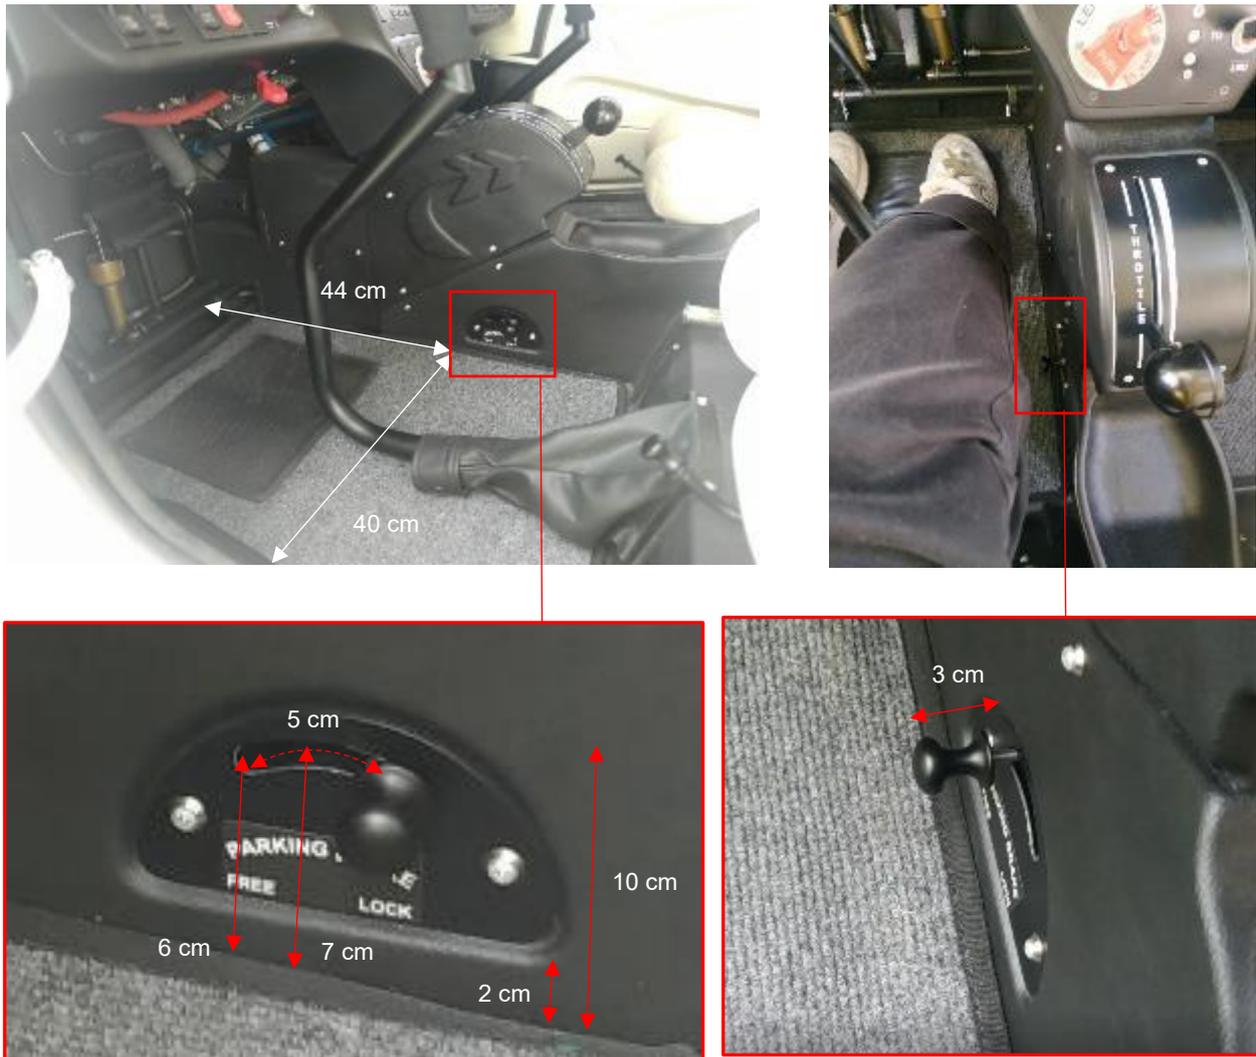
Figure 5. Position of the PARKING BRAKE lever in the cockpit

The whole assembly is located in the lower left-hand side of the pedestal, 2 cm from the floor. The lever is 6 cm above the ground at the lowest points of the arc and 7 cm above the ground at the top of the arc. The lever protrudes 3 cm from the pedestal. The entire assembly (pedestal-lever) is black.

- There were no issues with the condition of the brake system prior to the event.
- The location of the PARKING BRAKE lever within the cabin, as well as its dimensions and colour, makes it difficult to distinguish which position it's in from either of the two pilot seats.

REC 36/20. It is recommended that Costruzioni Aeronautiche Tecnam, as the organisation responsible for the design of the Tecnam P2008JC aircraft, should implement measures to improve the PARKING BRAKE lever so that its position can be identified from the pilot's seat.

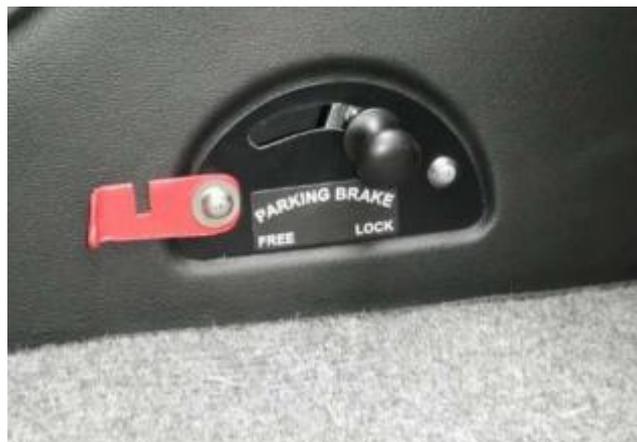
Figure 6. Catch installed by Canavia in aircraft EC-NJX

As a consequence, Canavia installed a red catch at the beginning of August (figure 6) to ensure that the PARKING BRAKE lever remains in the FREE position. The new catch ensured that two actions would have to be performed to activate the PARKING BRAKE: flipping the catch and then moving the lever. According to Canavia, notification of this new installation was carried out verbally. The new catch was not installed the last time the pilot flew the aircraft. The modification was made without consulting the manufacturer and without referring to approved maintenance data.

Canavia Líneas Aéreas modified the PARKING BRAKE lever, adding a catch to hold it in the FREE position. Given that this modification was made without consulting the manufacturer or being supported by approved maintenance data, the following recommendation is issued:

REC 40/20. It is recommended that Canavia Líneas Aéreas should regularise the installation of the red catch added to the PARKING BRAKE of its Tecnam P2008JC aircraft, either by submitting it for official approval or by uninstalling it.

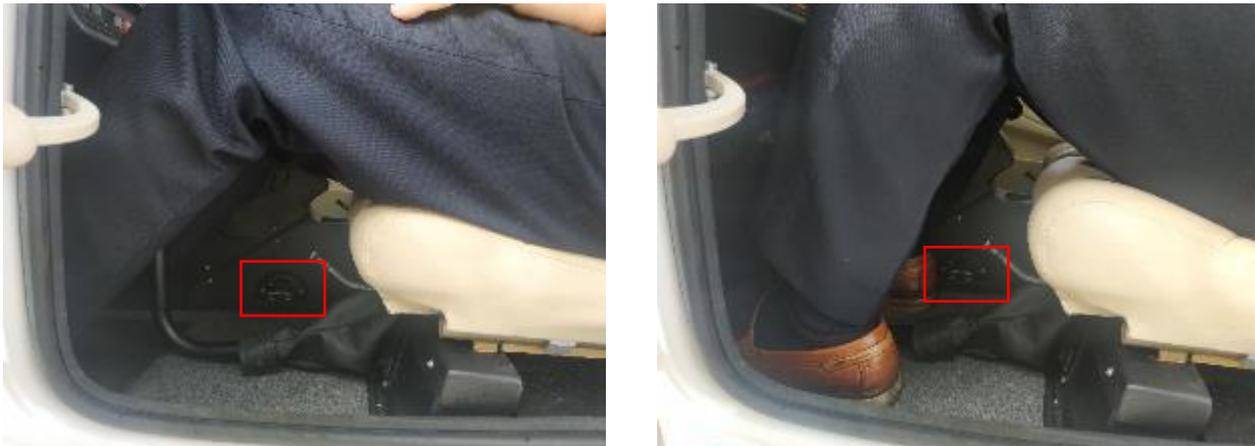
Figure 7. Position of the PARKING BRAKE lever in relation to the pilot

- the photograph on the left shows a normal flying position, with feet on the pedals.
- the photograph on the right shows a non-flying position, with feet flat on the ground, away from the pedals.

A pilot of a similar height and build to the one involved in the incident would have his seat in the position shown in the photograph. It can, therefore, be extrapolated for analysis. An attempt was made to inadvertently slide the PARKING BRAKE lever across the length of the arc from the FREE position (furthest from the pilot's seat) to the LOCK position (closest to the pilot's seat).

- The unintentional movement of the PARKING BRAKE lever with the foot is possible under certain conditions: feet off the pedals and bent knees (rest position en-route).

REC 37/20. It is recommended that Costruzioni Aeronautiche Tecnam, as the organisation responsible for the design of the Tecnam P2008JC aircraft, should implement measures to improve the PARKING BRAKE lever to prevent it from being inadvertently moved from the FREE position necessary to ensure directional control on the ground.
