## **A-037/2020**

Accident involving a Tecnam P2008JC aircraft, registration EC-NJX, at El Berriel Aerodrome (Las Palmas-Spain) on 25 August 2020

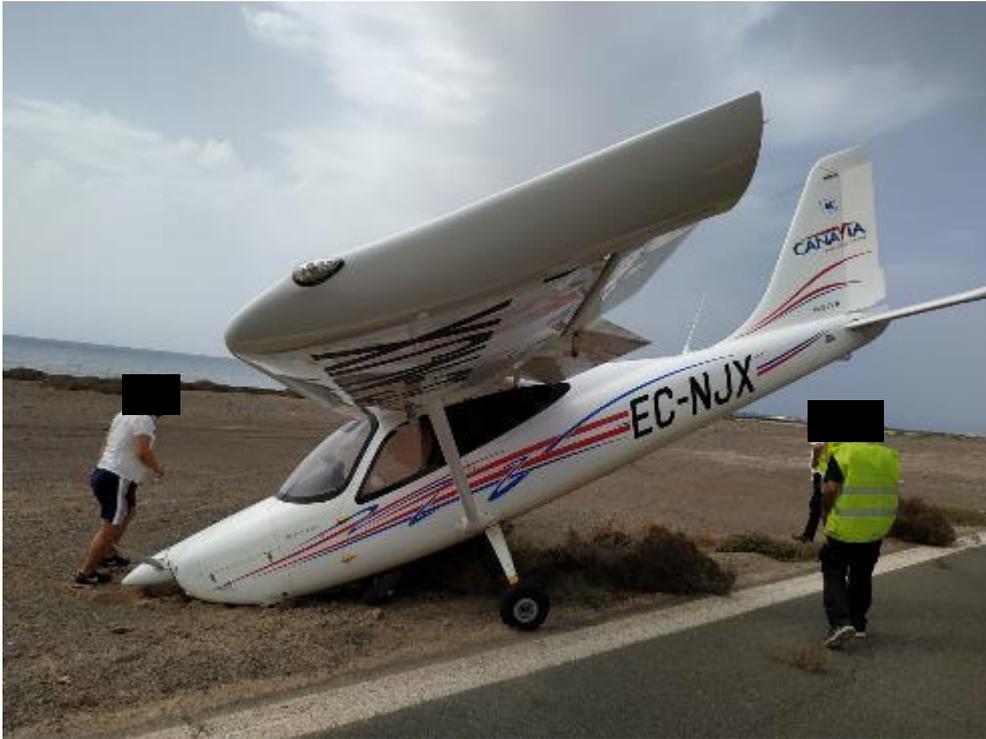
After touchdown, which, according to the statements, was "very smooth", the aircraft began to drift to the right. The crew were unable to regain directional control, and it veered off the runway onto the right-hand strip. The aircraft's nose gear collapsed, and it came to a standstill, resting on the main gear and lower forward fuselage.

Figure 2. Final position of aircraft EC-NJX

Finally, with regard to the condition of the runway, the transition between the asphalt of the runway and the strip presented vegetation that probably affected aircraft as it ran off the runway.

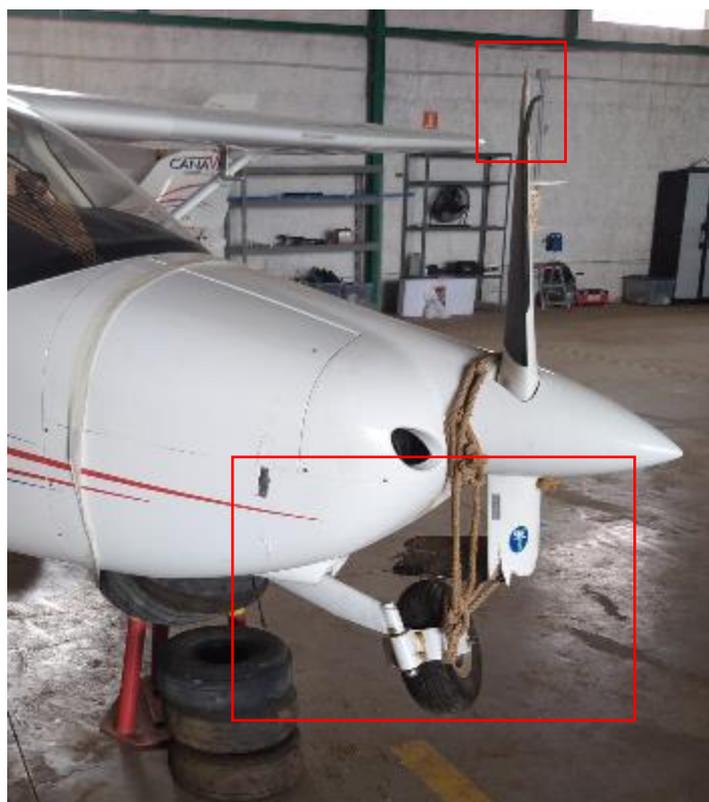
The aircraft came to a halt on the second-third of the runway, just before the right-hand strip of runway 07. It displayed damage to the nose gear, which had collapsed, the propeller and the lower forward fuselage. There were tracks in the earth under the aircraft.

A round-shaped mark and disturbed earth immediately below the propeller cone were identified at the aircraft's final resting position. There was no evidence of drag marks on the lower fuselage, indicating that this was where the nose gear had collapsed. The two-bladed propeller had damage to both blades, one of which was completely fractured 1/3 of the way along and bent back on itself. The damage to the other blade was less significant and located on the tip. The damage suggests that the propeller was already slowing down when it hit the ground.

The nose gear was still attached to the aircraft, although the structure was deformed and moved out of position. The structure of the main landing gear and the rest of the aircraft showed no apparent damage or deformations.

The lower forward fuselage displayed more minor deformation marks and cracks.

Figure 3. Damage to the aircraft

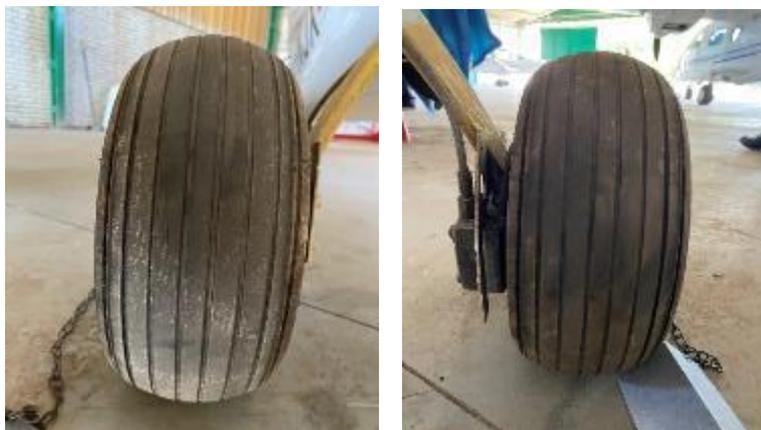
The left main gear and nose gear tyres were unmarked. In contrast, the right main gear tyre showed black discolouration marks in two areas, as shown in Figure 4.

Figure 4. Marks on the right main gear tyre

Although the condition of the tyres prior to the event is unknown, the fact that the left main and nose gear tyres did not display any signs of wear or marks and that, according to the crew, the aircraft veered to the right while braking, suggests that the discolouration marks identified on the right main landing gear wheel occurred during the event. These black discolouration marks are indicative of heat produced by the tyre's contact with the asphalt. They occur when a wheel is braked and, rather than turning freely, drags along the runway after making contact with it.

Therefore, it is considered that the immediate cause of the loss of control during the landing roll-out was an asymmetry in the braking action of the aircraft.

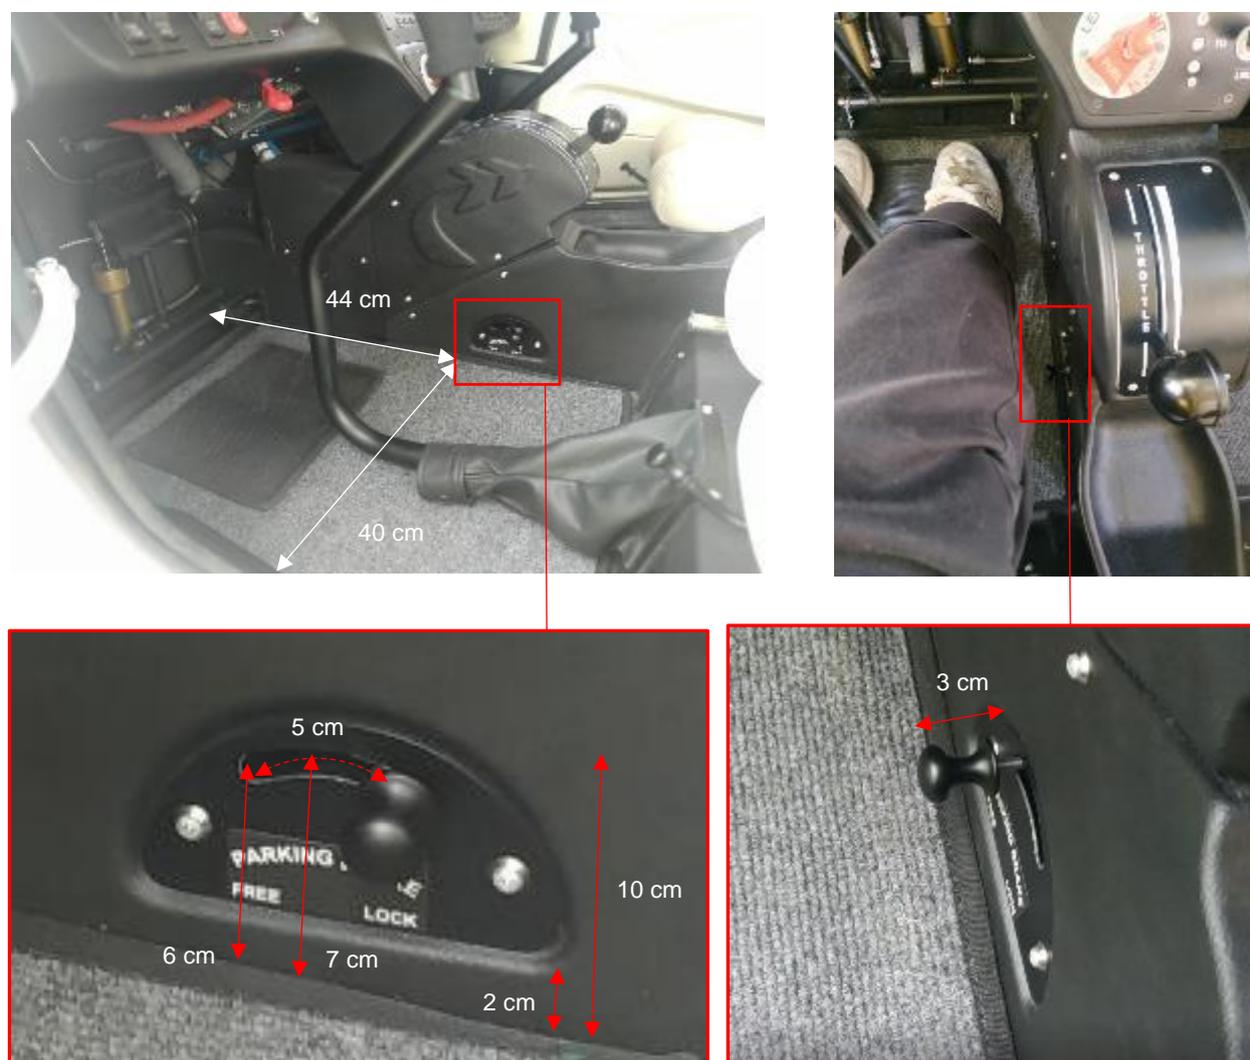
The whole assembly is located in the lower left-hand side of the pedestal, 2 cm from the floor. The lever is 6 cm above the ground at the lowest points of the arc and 7 cm above the ground at the top of the arc. The lever protrudes 3 cm from the pedestal. The entire assembly (pedestal-lever) is black.

Figure 5. Position of the PARKING BRAKE lever in the cockpit

- There were no issues with the condition of the brake system prior to the event.
- The location of the PARKING BRAKE lever within the cabin, as well as its dimensions and colour, makes it difficult to distinguish which position it's in from either of the two pilot seats.

REC 36/20. It is recommended that Costruzioni Aeronautiche Tecnam, as the organisation responsible for the design of the Tecnam P2008JC aircraft, should implement measures to improve the PARKING BRAKE lever so that its position can be identified from the pilot's seat.

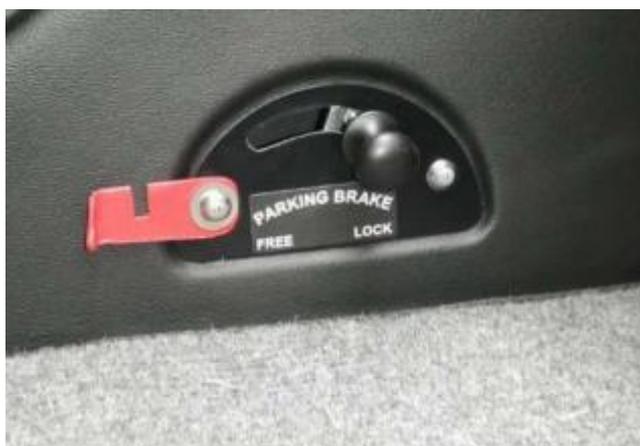
As a consequence, Canavia installed a red catch at the beginning of August (figure 6) to ensure that the PARKING BRAKE lever remains in the FREE position. The new catch ensured that two actions would have to be performed to activate the PARKING BRAKE: flipping the catch and then moving the lever. According to Canavia, notification of this new installation was carried out verbally. The new catch was not installed the last time the pilot flew the aircraft. The modification was made without consulting the manufacturer and without referring to approved maintenance data.

Figure 6. Catch installed by Canavia in aircraft EC-NJX

REC 40/20. It is recommended that Canavia Líneas Aéreas should regularise the installation of the red catch added to the PARKING BRAKE of its Tecnam P2008JC aircraft, either by submitting it for official approval or by uninstalling it.

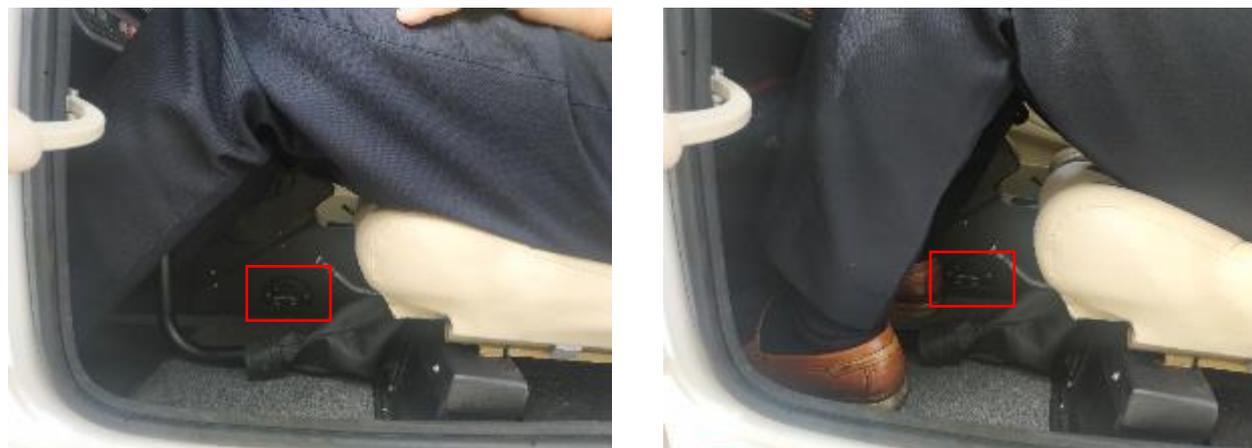
Figure 7. Position of the PARKING BRAKE lever in relation to the pilot

A pilot of a similar height and build to the one involved in the incident would have his seat in the position shown in the photograph. It can, therefore, be extrapolated for analysis. An attempt was made to inadvertently slide the PARKING BRAKE lever across the length of the arc from the FREE position (furthest from the pilot's seat) to the LOCK position (closest to the pilot's seat).

- The unintentional movement of the PARKING BRAKE lever with the foot is possible under certain conditions: feet off the pedals and bent knees (rest position en-route).

REC 37/20. It is recommended that Costruzioni Aeronautiche Tecnam, as the organisation responsible for the design of the Tecnam P2008JC aircraft, should implement measures to improve the PARKING BRAKE lever to prevent it from being inadvertently moved from the FREE position necessary to ensure directional control on the ground.
