Technical report

A-037/2021

Accident on 31 July 2021 involving a Boeing 737-8AS aircraft, registration number EI-EPC, while on approach to Barcelona Airport

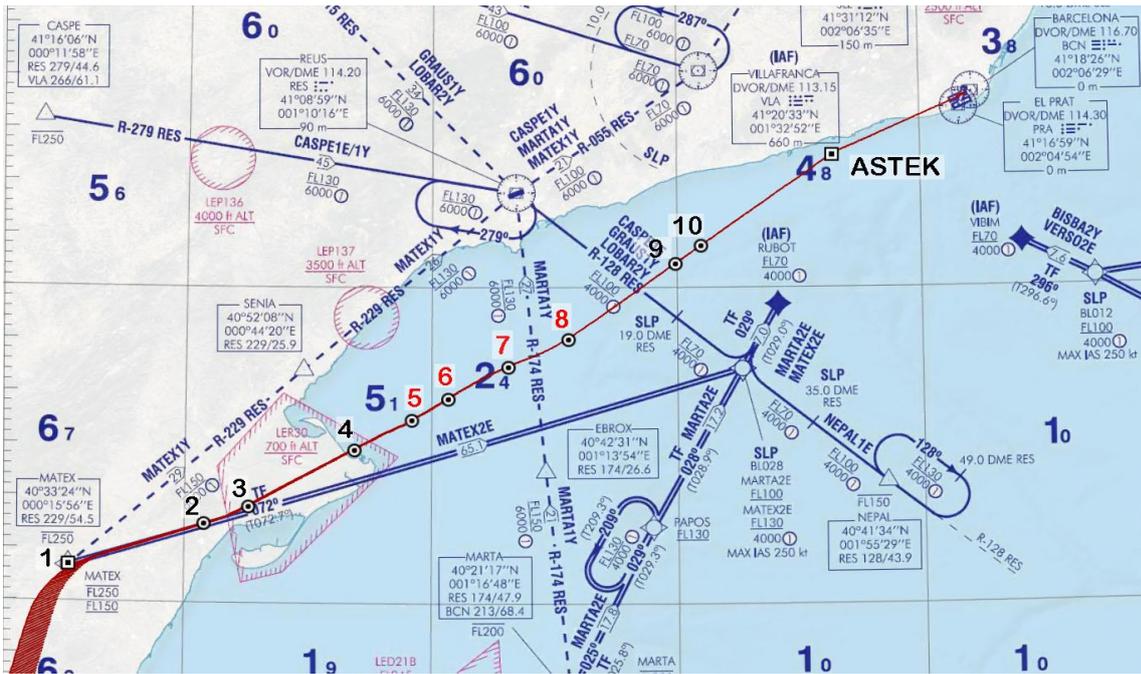
Image 2: Path of the aircraft during the descent

1	13:56:00	FL310	CAS 290 kt	The aircraft overflies MATEX.
2	13:57:32	FL270	CAS 305 kt	The aircraft begins its diversion onto a heading of 065°.
3	13:58:03	FL250	CAS 314 kt	The captain warns the cabin crew of likely turbulence during the approach.
4	13:59:18 – 13:59:24	FL210	CAS 318 kt	ATC authorises the aircraft to proceed to ASTEK and the speed brakes are extended.
5	14:00:07	FL180	CAS 325 kt	The aircraft enters the area of turbulence.
6	14:00:38	FL170	CAS 334 kt	Autopilot disengaged; vertical acceleration of +3.09 g.
7	14:01:30	FL160	CAS 289 kt	Autopilot re-engaged.
8	14:02:24	FL130	CAS 296 kt	The aircraft exits the area of turbulence.
9	14:04:21	FL90	CAS 276 kt	Call from the cabin crew, advising that crew members have been injured.
10	14:04:53	FL80	CAS 259 kt	The flight crew contacts ATC to request an ambulance upon arrival

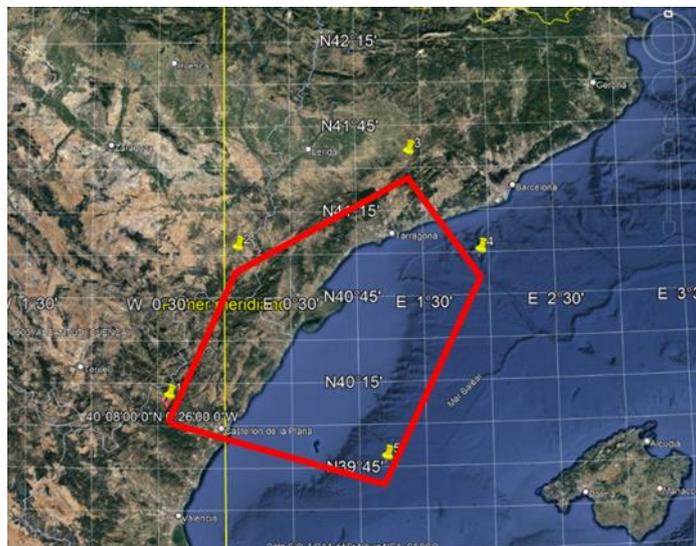
Image 3: Area in which storms were forecast, as delimited in the SIGMET

The SIGMET message indicated a forecast of storms between 11:00 UTC and 15:00 UTC in the area delimited by the red polygonal line (see the image on the right), which comprised the aircraft's arrival and approach path

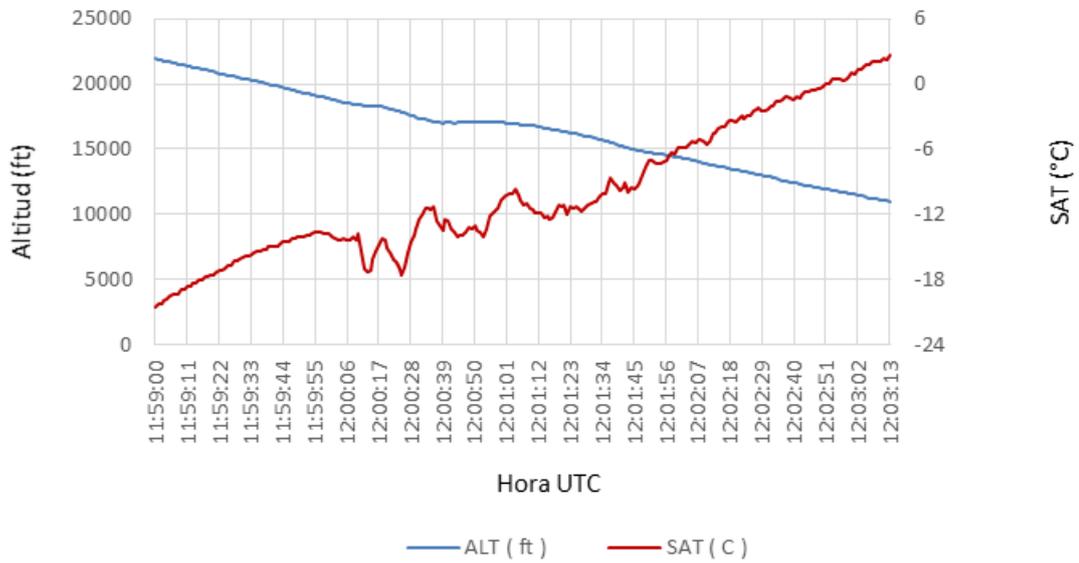
Image 4: Graph showing the variation in SAT with altitude in the area of turbulence

During this period, changes were recorded in wind direction and intensity, along with oscillations in the figures for static air temperature (SAT). These variations are shown in the following graphs:

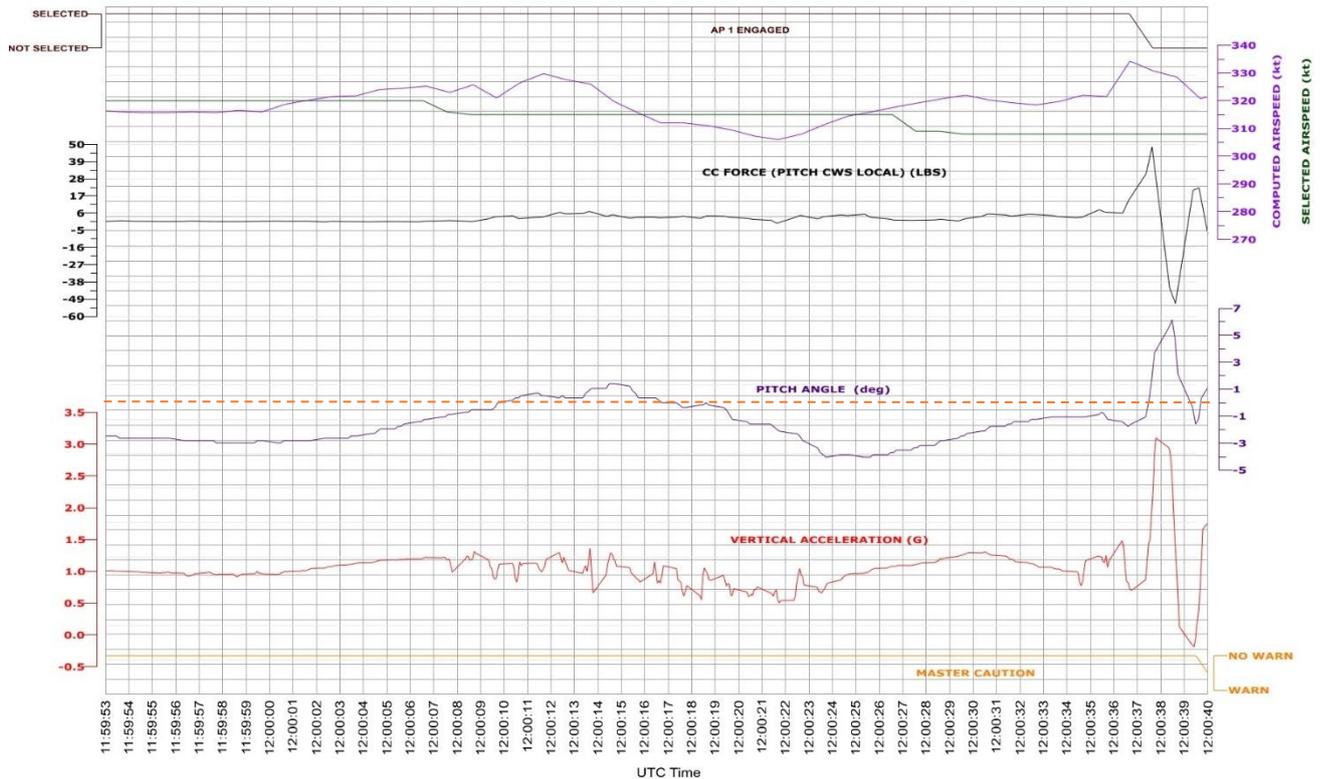
Image 6: Flight parameters from the start of the turbulence to the disengagement of the autopilot

Over the next 29 seconds the speed selected was reduced to 308 kt. During this period, the aircraft's CAS ranged from 306 kt to 329 kt. Fluctuations in vertical acceleration of between +0.50 g and +1.36 g were recorded, with changes that, on occasion, reached up to 0.7 g within the space of one second.

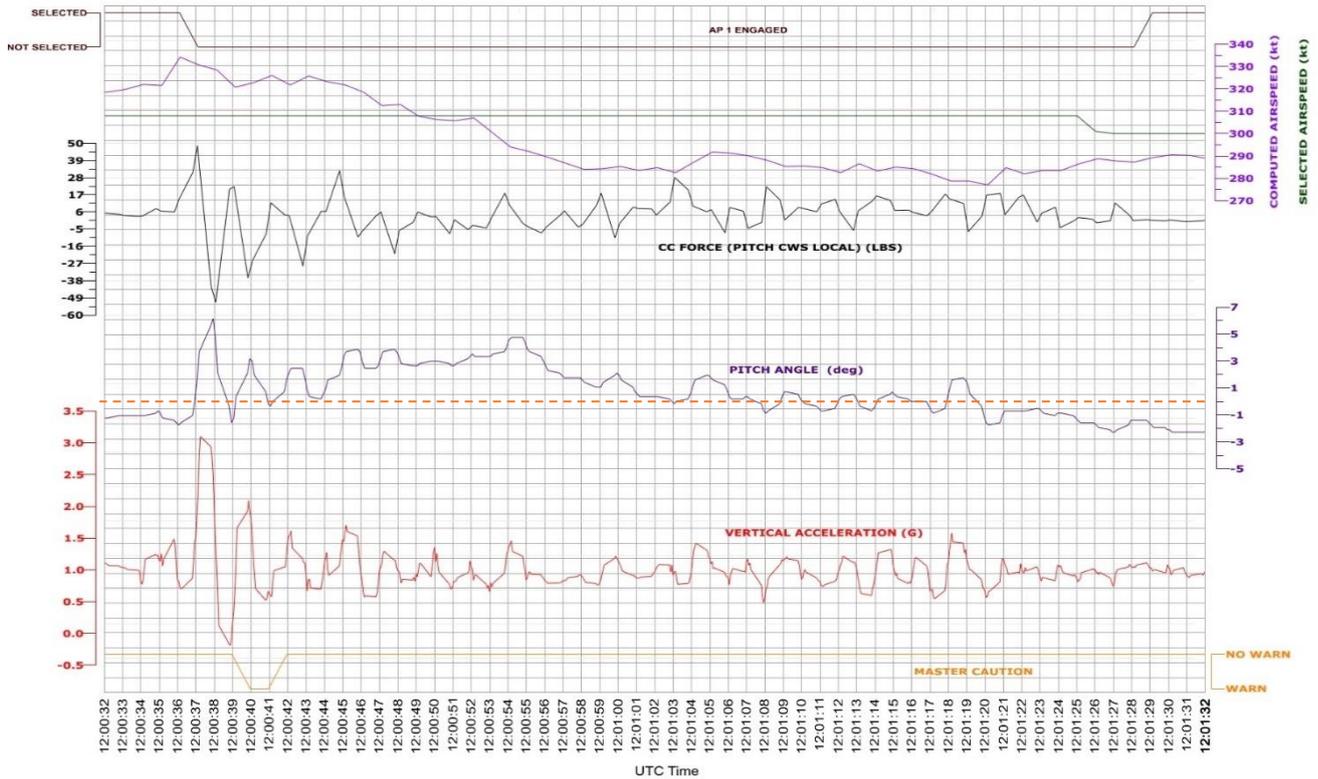
Image 7: Flight parameters for the interval in which the autopilot was disengaged

For the next 21 seconds, the aircraft remained practically level at FL170 and the force exerted on the control column varied between +32 lb and -36 lb.

Positive pitch angles were recorded, while the CAS began to fall. At 14:01:00 h, the CAS was 283 kt and the aircraft resumed its descent.

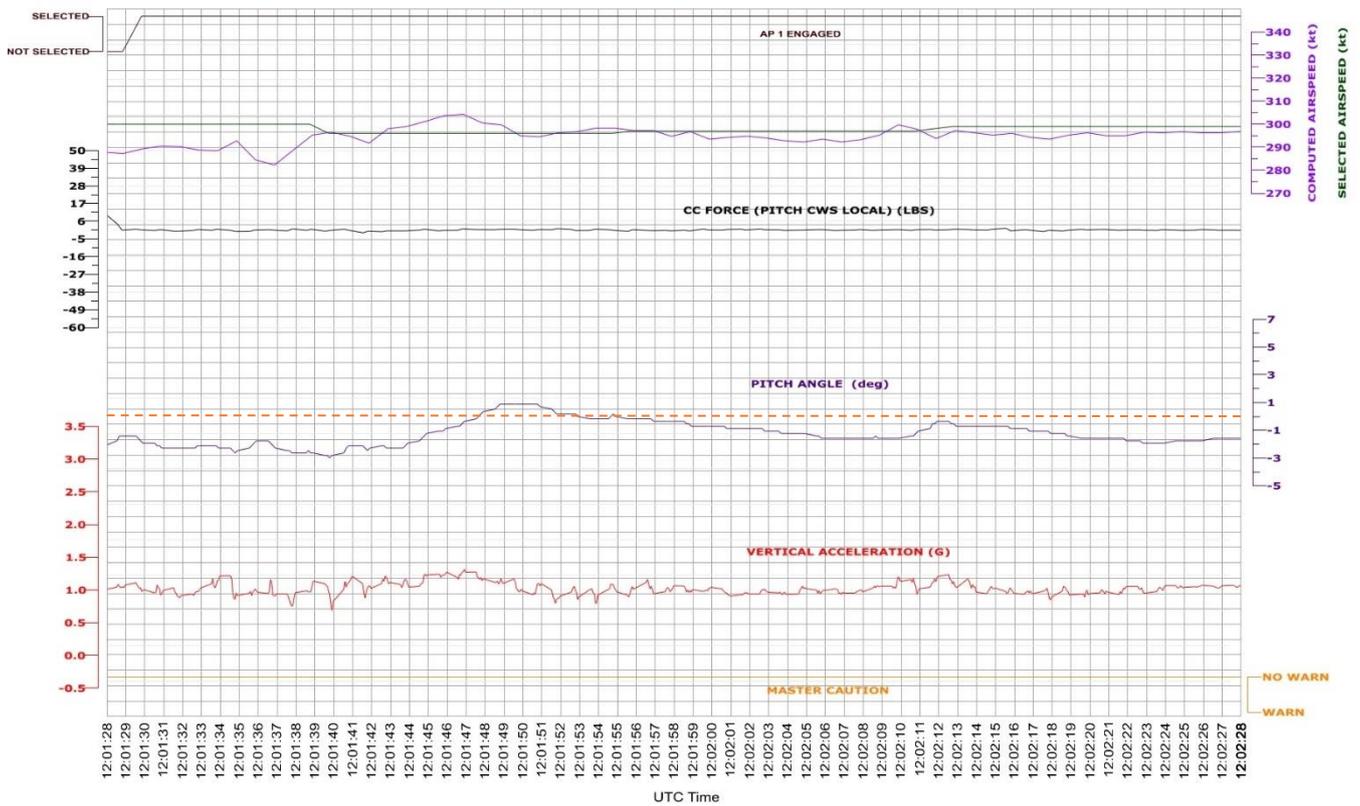
Image 8: Flight parameters for the period from the re-engagement of the autopilot to the aircraft's exit from the area of turbulence

During this period, vertical acceleration reached a maximum of +1.31 g and a minimum of + 0.68 g, with changes that, on occasion, reached 0.4 g within the space of one second.

At 14:02:24 h, the aircraft exited the area of turbulence.

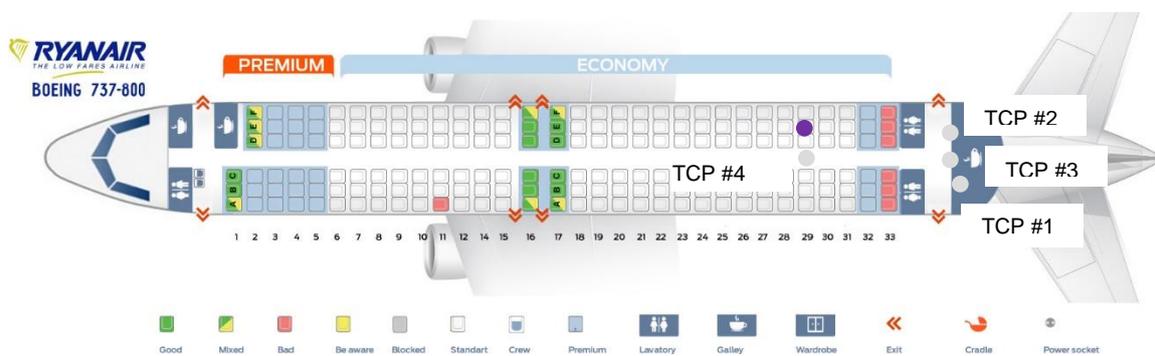
Image 9: Diagram showing the position of the cabin crew members and the passenger who was injured during the event

The following diagram shows the position of each cabin crew member, marked with a light grey circle. The position of the passenger who suffered serious injuries is marked with a purple circle.

When the event occurred, all of the passengers were seated. The injured passenger was sitting in seat 29 E. When the aircraft landed, the cabin crew advised that the passenger had been injured.
