Report A-042/2019

Accident involving the aircraft
SPORTINE AVIACIJA LAK 17B FES
18M, registration D-KSEO, on
11 August 2019 at the Garray
aerodrome (Soria)

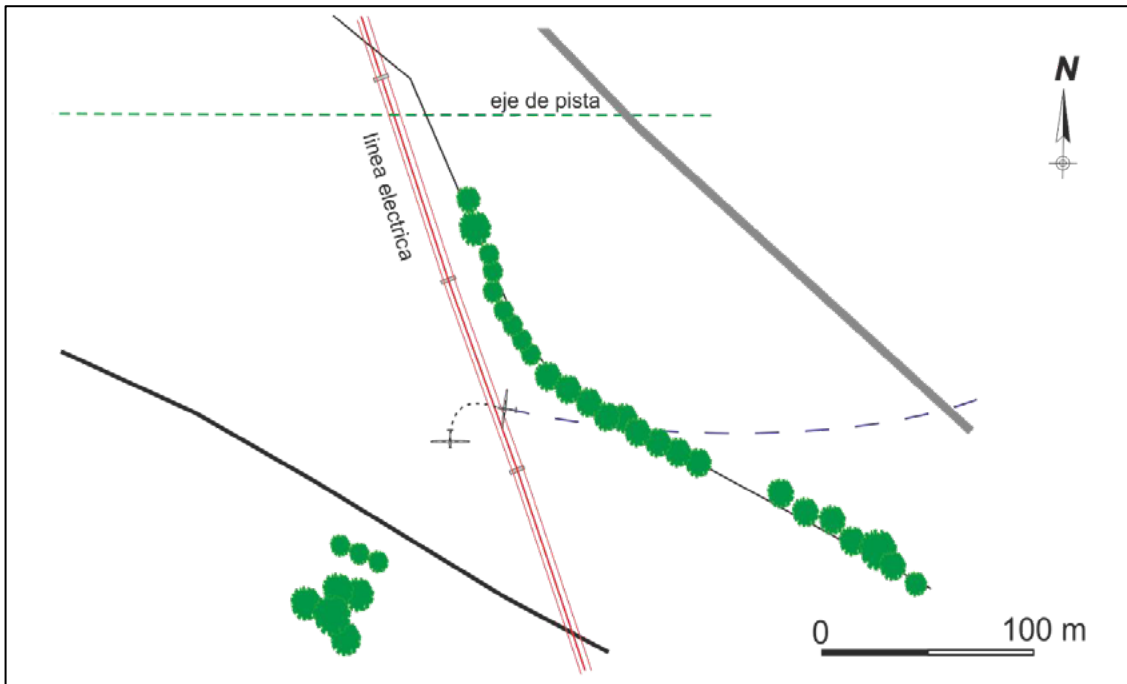
Moments before the accident, the aircraft was practically aligned with the approach to said runway but didn't have enough altitude to reach it. As a result, the pilot decided to land in a nearby field. When he was a few meters from the ground, the left wing caught the power line, and the aircraft struck and slid along the ground, having turned 180° by the time it came to a halt. It's estimated trajectory before coming to a halt is shown in the following diagram.

Illustration 5: Manoeuvres and final position of the aircraft

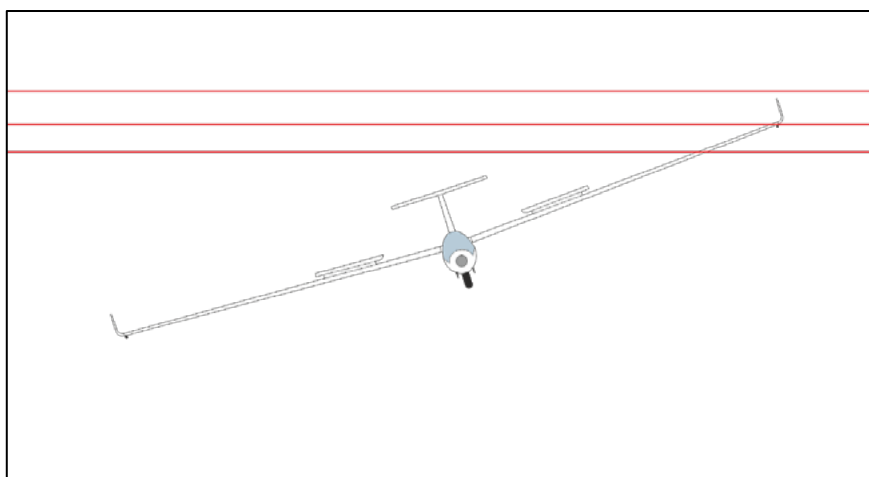
The estimated angle of the aircraft at the moment of impact is shown in Illustration 6: Estimated angle of the aircraft at the moment of impact Illustration 6.

Illustration 6: Estimated angle of the aircraft at the moment of impact

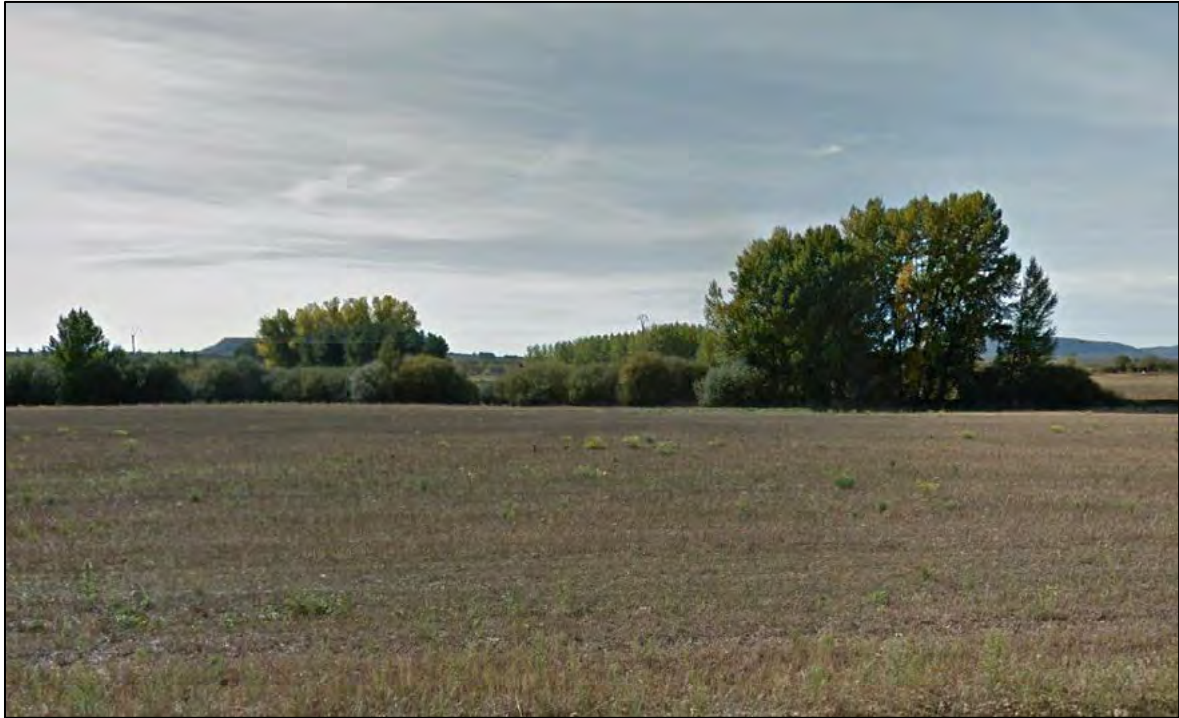
The pilot declared he didn't see the power lines until he passed the line of trees partially obscuring it. The line of trees was lower than the height of the poles in several sections but also higher in others, as can be seen in Illustration 7, which is the view from the estimated trajectory of the aircraft (Northeast), at ground level.

Illustration 7: View of the line of trees and the power line poles behind them, from the northeast

The pilot stated he didn't see the power lines because the trees (growing along the boundary of the field chosen for the landing) blocked the view of the poles. He also stated that once he flew over the trees and saw the power line, he tried to dive the aircraft under it. It's evident, therefore, that the pilot made a mistake with his choice of

landing site because his view of it was obscured, preventing him from identifying possible obstacles.

REC 06/21 It is recommended that details of nearby power lines be included in the Garray aerodrome information.

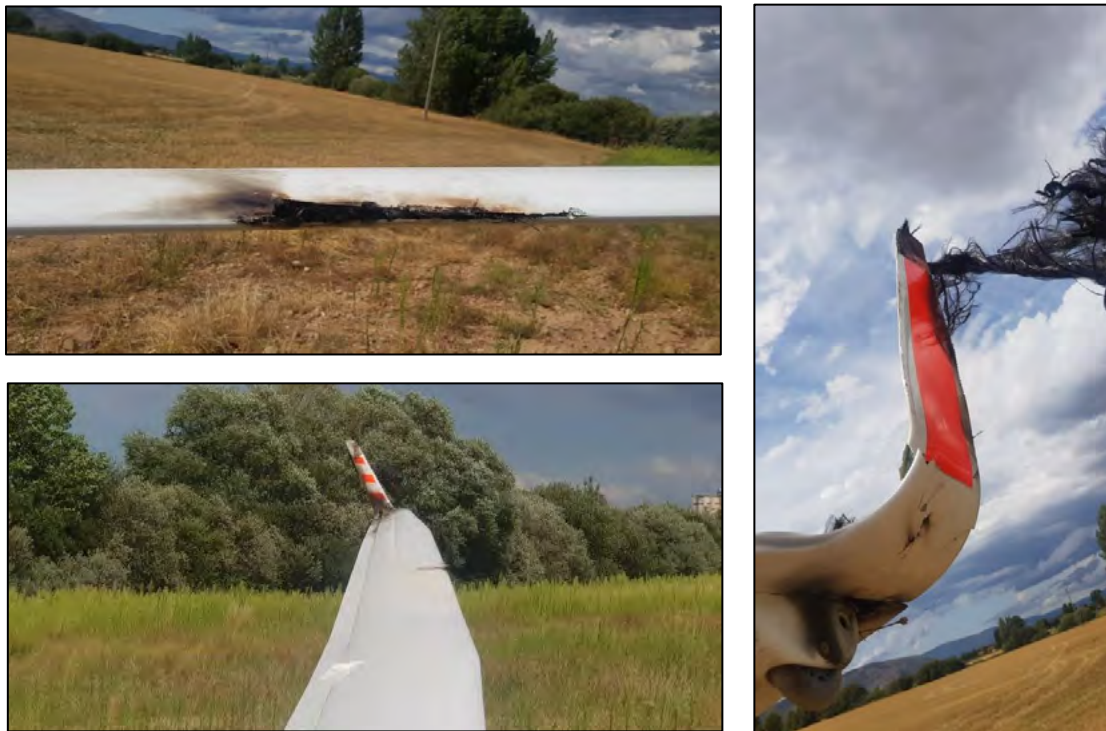
The aircraft's left wing was lacerated and burnt at both the tip and approximately three-quarters of the way along the wingspan. (see Illustration 8). The damage was compatible with having made contact with at least two different cables of the medium-voltage line and the electric arc that would have been produced as a result.

Illustration 8: Evidence of striking the cable and the resulting electric arc

Based on the pilot's testimony that he attempted to dive the aircraft under the cables when he saw them, and the damage to the left wing which is compatible with striking the cables, we conclude that the aircraft was banking to the right at the time of the impact (shown in Illustration 6). The cable dragged along the leading edge of the left wing until at one point it snagged, causing the aircraft to pivot, yawing to the left. This is consistent with the marks on the ground, which suggest the aircraft slid to the right.

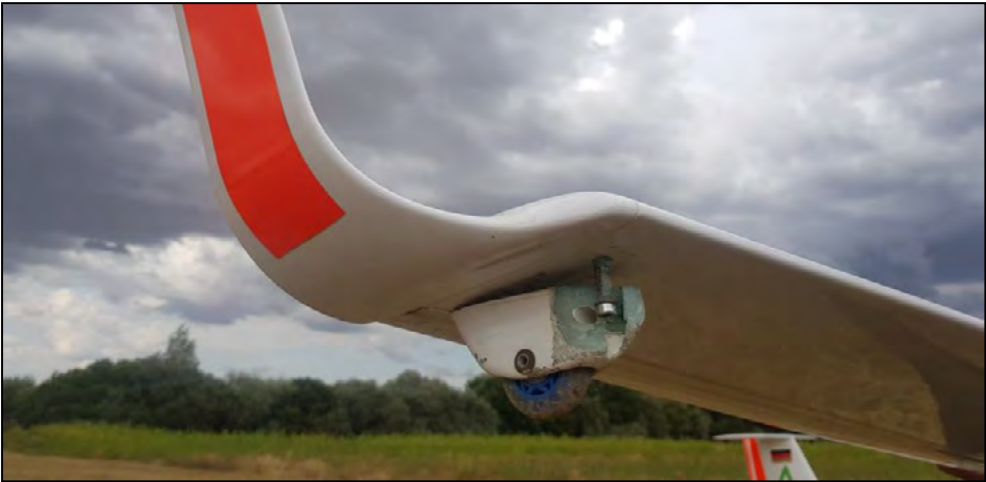
The right wing had scratches along the leading edge, and the wheel fairing at the end of the wingspan was split around one of the wing's anchor bolts (see Illustration 9).

Illustration 9: Damage to the wheel at the tip of the right wing

The wheel at the end of the right wing was split around one of the wing anchor bolts (see Illustration 9). Given that it would have taken a considerable amount of force to split it, we can conclude that the tip of the right wing was probably the first part of the aircraft to make contact with the ground. Furthermore, based on the orientation of the fracture surface, the impact came from the right as the aircraft was travelling sideways. This is compatible with the aircraft yawing to the left when snagged on the cables and, through inertia, continuing to move forward while yawing. For these reasons, we estimate the aircraft had an orientation of approximately 270° when it hit the cables (shown in Illustration 5), almost in alignment with runway 27 of the Garray aerodrome.

Because the significant damage at the end of the right wing was concentrated in the wheel, it's probable the roll angle and dive position of the aircraft on impact was not especially pronounced. If it had been, considering the small size of the wheel, the tip of the wing would also have hit the ground and incurred damage.

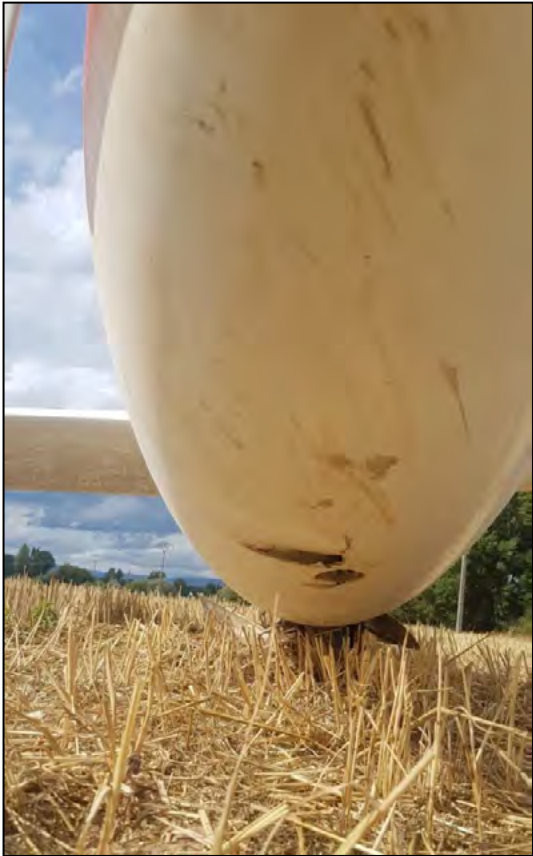
The undercarriage of the fuselage was dented in some places and had scratches compatible with a short forward-right drag along the ground (relative to the aircraft).

Illustration 10: Front underside view of the fuselage

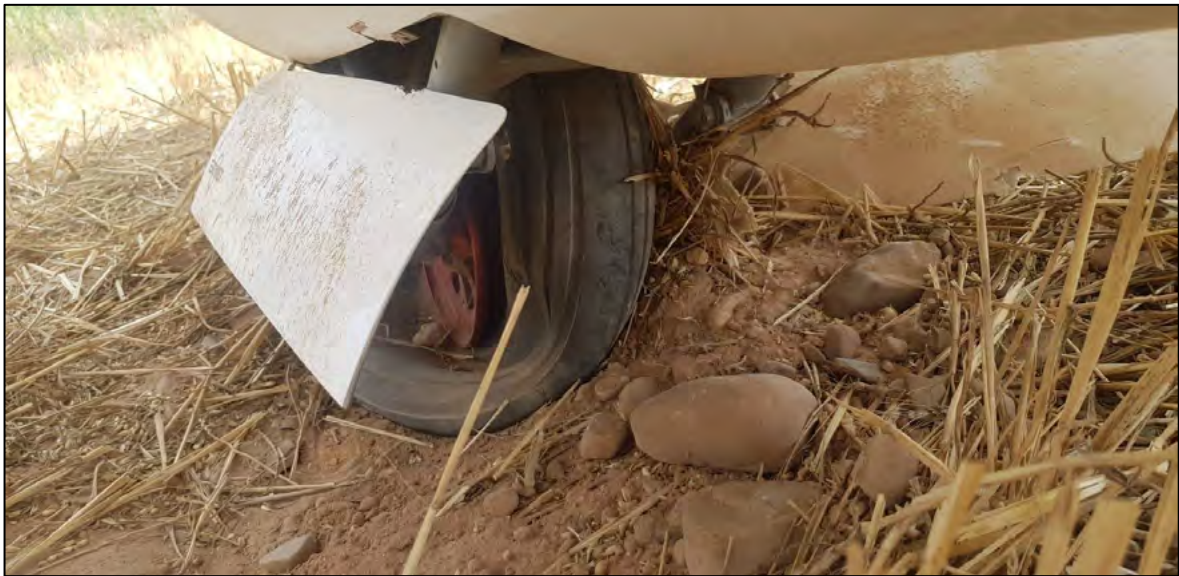
The damage to the main landing gear and its cover, as well as the marks left on the field, confirm that the aircraft slid to its right once on the ground (see Illustration 11).

Illustration 11: Main landing gear
