Report A-043/2019

Accident involving a mid-air collision between a Bell 206 L3 aircraft operated by Roterflug, registration D-HOTT, and an Aeroprakt A22L aircraft, registration EC-GU1, on 25 August 2019 in the vicinity of Inca (Mallorca)

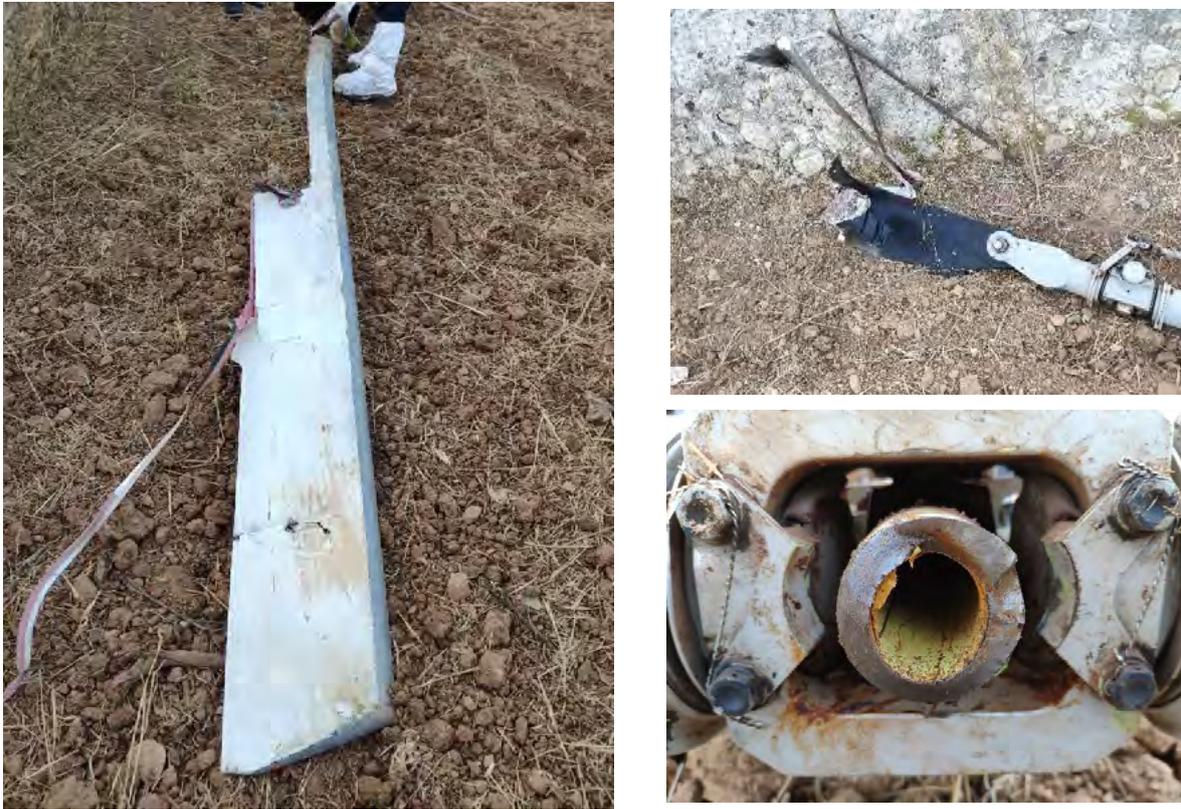
Fig. no. 2 - Detail of the rotor head and damage to parts of the blades.

Two more pieces of the same blade were found 150 m to the west of the main wreckage area, which, together with two more small pieces located 64 m to the south-southeast of the main wreckage (one of them the blade tip), accounted for the entire surface of the blades.

The fact that the main rotor head and different pieces of the blades were found more than 90 m from the main wreckage and more than 240 m away from each other is consistent with the blades impacting powerfully against the ultralight aircraft and the uncontrolled trajectory of the helicopter on its descent.

As for the main rotor blades, after the impact, one of the blade tips flew off and hit the ultralight. The others, which were already deformed, came loose and were ejected when the helicopter went into a spin after losing its tail rotor.

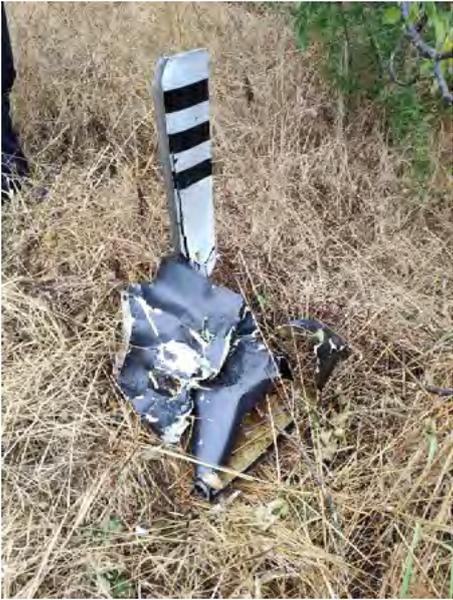
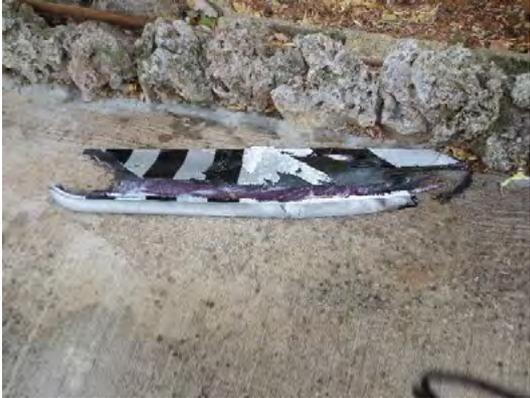
Fig. no. 3 - Detail of the tail rotor.

The tail rotor lay further away, 185 m to the southeast, between the two main wreckage sites. One of its blades was still attached, and the other had broken off and was found a further 110 m to the south.

The pieces of the main and tail rotor blades all displayed creases, scratches, breakages and deformations consistent with impacting both the aircraft and the ground. Furthermore, white paint marks were observed on the helicopter's vertical stabiliser and the blades and shaft of the tail rotor.

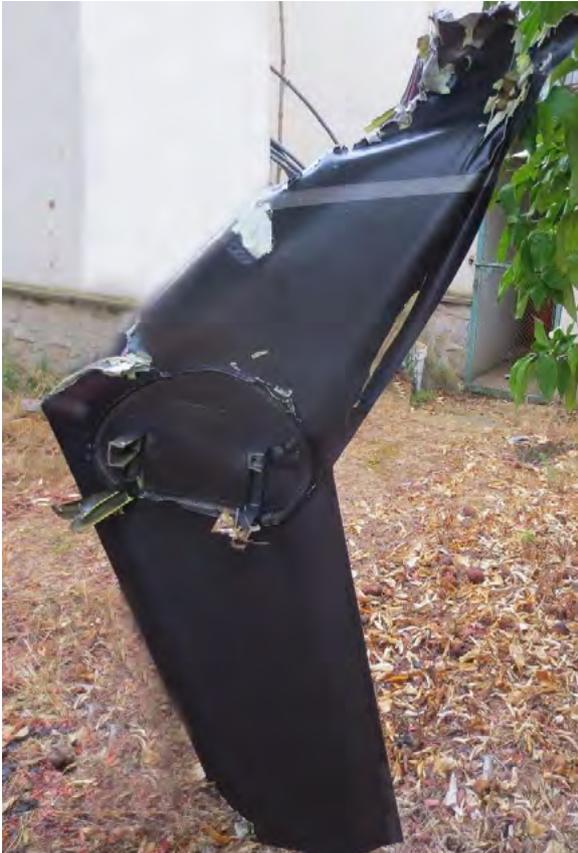
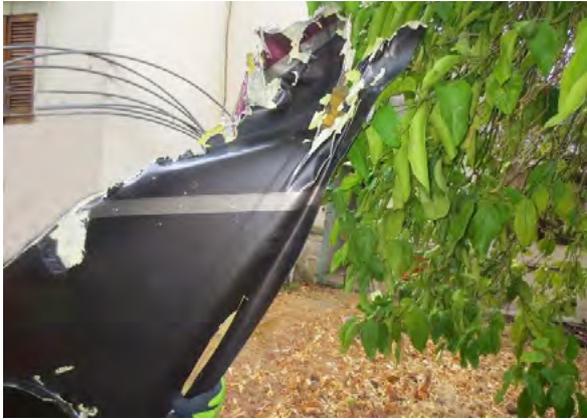
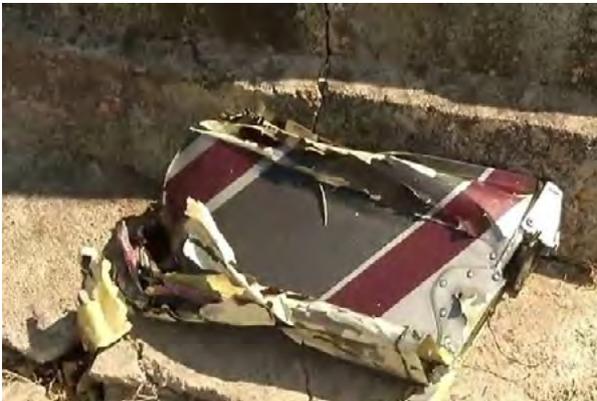
Fig. no. 4 - Helicopter's stabiliser: main body and detached upper part

The vertical stabiliser was found 37 m to the west of the tail rotor. About a quarter of its upper half had broken off. Both the main body of the stabiliser and the severed part showed significant deformations and signs of having been crushed on their front side.

Additionally, the detachment of the vertical stabiliser and tail rotor, and their distance from the two main groups of debris, is consistent with the aircraft colliding in mid-air. The white paint transferred from the aircraft to those parts also corroborates the contact between the aircraft.

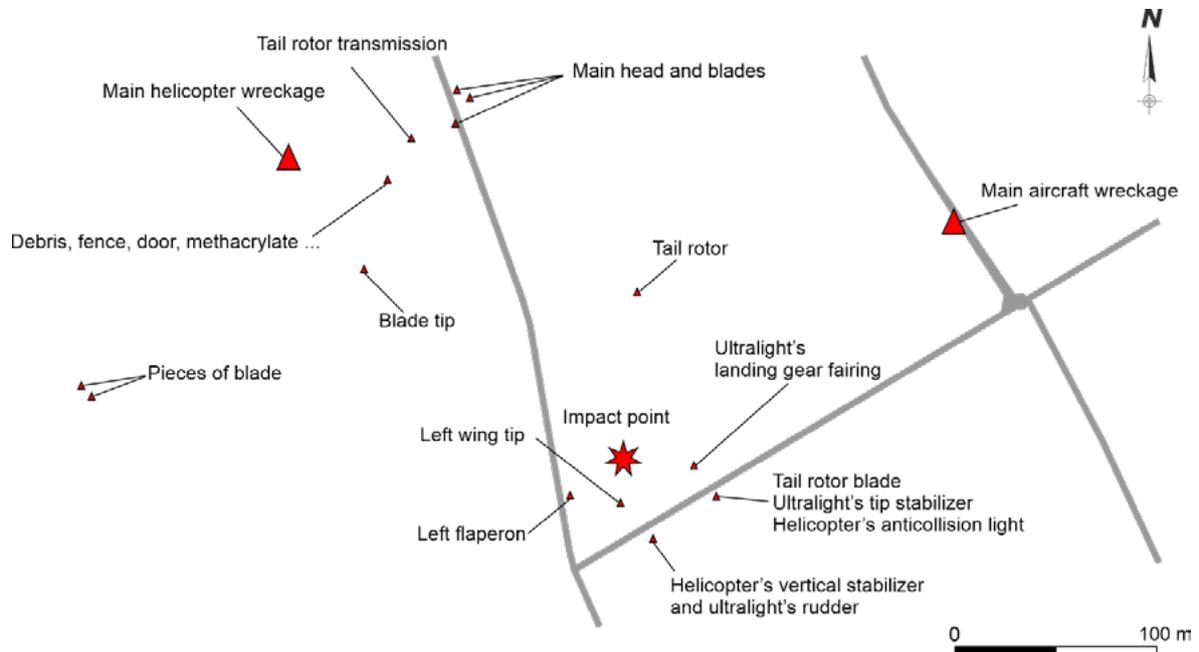
Fig. no. 5 - Sketch of the distribution of the wreckage.

The wreckages of the helicopter and the ULM were primarily located at two points approximately 340 m apart. In addition, separate pieces of both aircraft were found scattered throughout the area.

The bulk of the aircraft wreckage was concentrated at the crash site. However, the main rotor, vertical stabiliser, tail rotor (which had lost its transmission and a blade), passenger and luggage compartment doors, engine fairings, and other miscellaneous debris were found separated from the main aircraft wreckage.

The following components were found in the area immediately to the east of the main wreckage: at about 50 m, two doors; at 64 m, the tail rotor's transmission, and at about 90 m, the main rotor head (whose mast showed signs of torsion damage), with part of its blades still attached and two other separate pieces nearby, spaced 12 m, 15 m and 6 m apart.

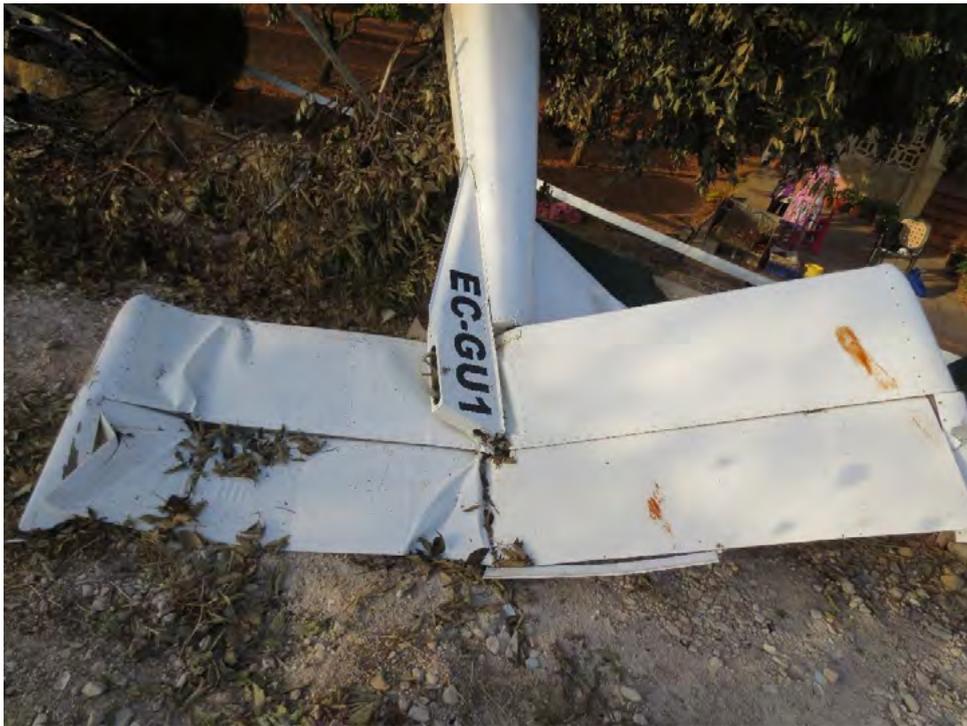
Fig. no. 6 - Detail of the tail assembly.

The tail assembly was separated from the main body of the aircraft, resting on the road and the retaining wall in an inverted position. Both the horizontal stabilisers were creased and deformed and the left one had splashes of lubricating oil from the main rotor yoke (reddish in colour) on its underside.

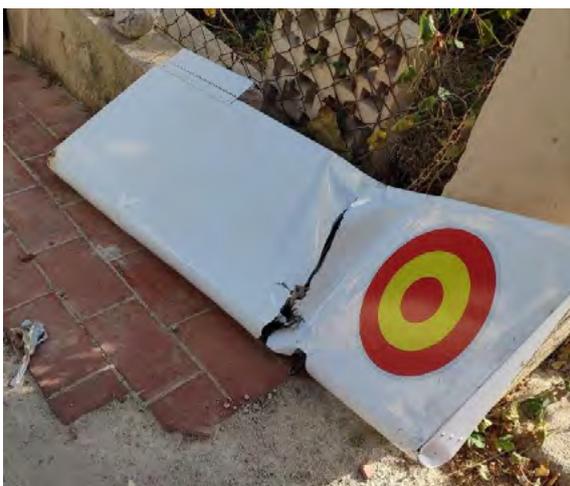
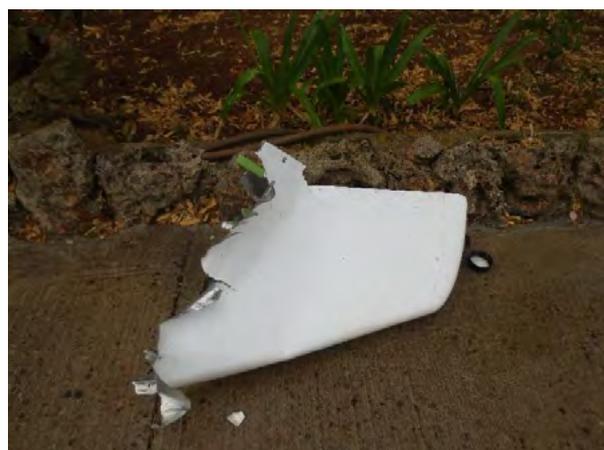
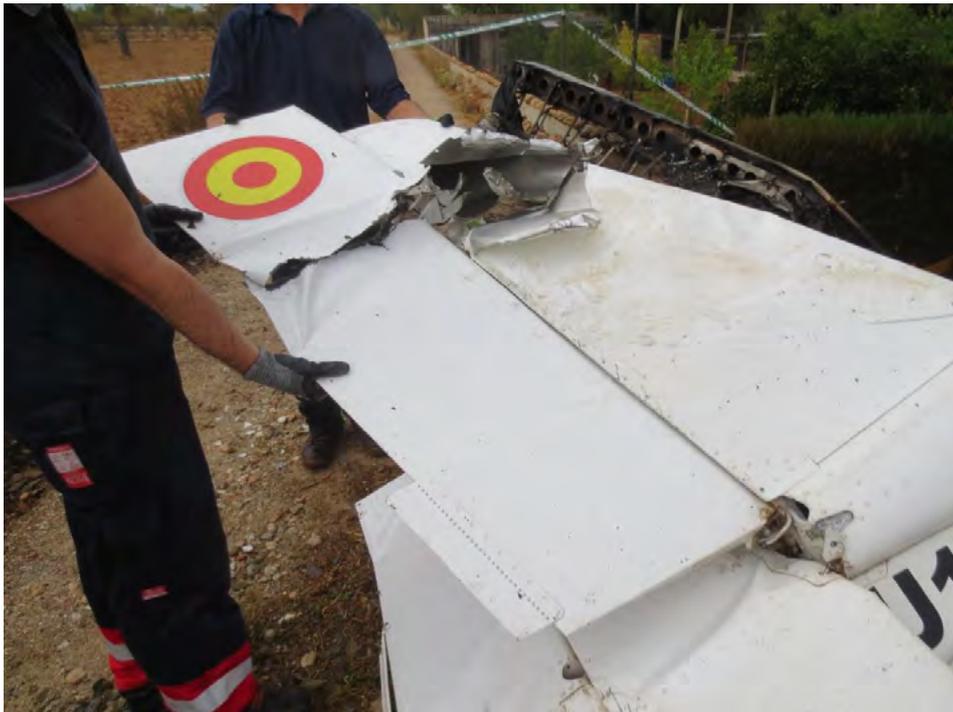
Fig. no. 7 - Detail of the rudder, stabiliser end and the two components together

The upper section of the vertical stabiliser was incomplete, with a left to right laceration running almost parallel to its upper edge (according to the aircraft's direction of travel). The detached upper section was found with its corresponding riser 180 m away. The rudder was found in the same place and also had a laceration at the same height going in the same direction, starting from the part closest to the stabiliser and extending almost to the furthest edge (going from left to right according to the aircraft's direction of travel).

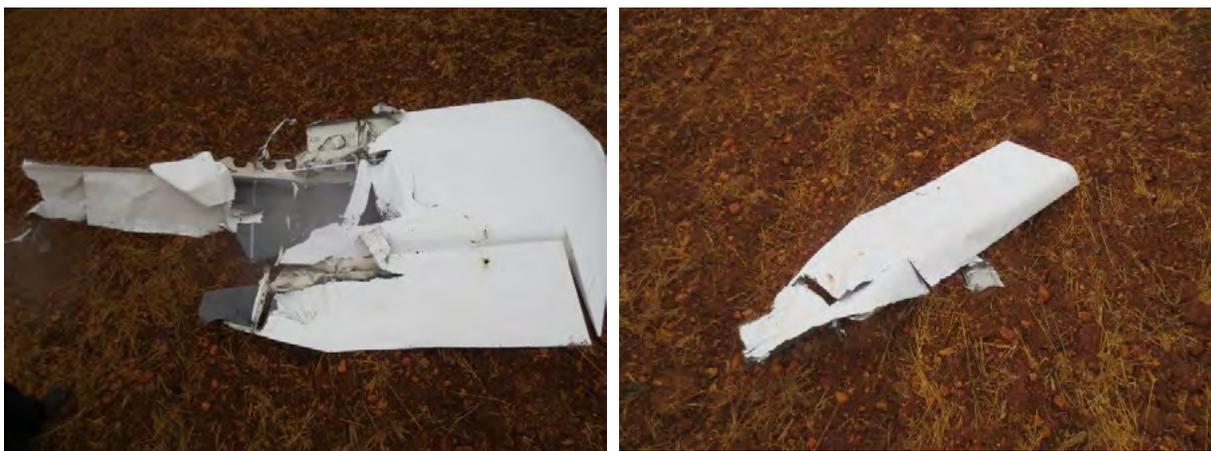
Fig. no. 8 - Detail of the left wingtip and flaperon.

The separated part of the left wing accounted for approximately one-third of the whole wing. Its underside was split open in the direction of the chord, one metre from the tip. It was torn and lacerated throughout.

Part of its flaperon had broken off and was found 25 m away. It was also was torn and lacerated.

The severed part of the left wing accounted for approximately one-third of the whole wing. Its underside was split open in the direction of the chord, one metre from the tip. It was torn and lacerated throughout. The flaperon belonging to said wingtip, which was found about 25 m away, was also torn and lacerated.

Having studied the lacerations and deformations observed on both parts, we have concluded that they could have been caused by the helicopter's main rotor blade. Given the relative proximity of the two pieces on the ground, they were probably both damaged by the same action.

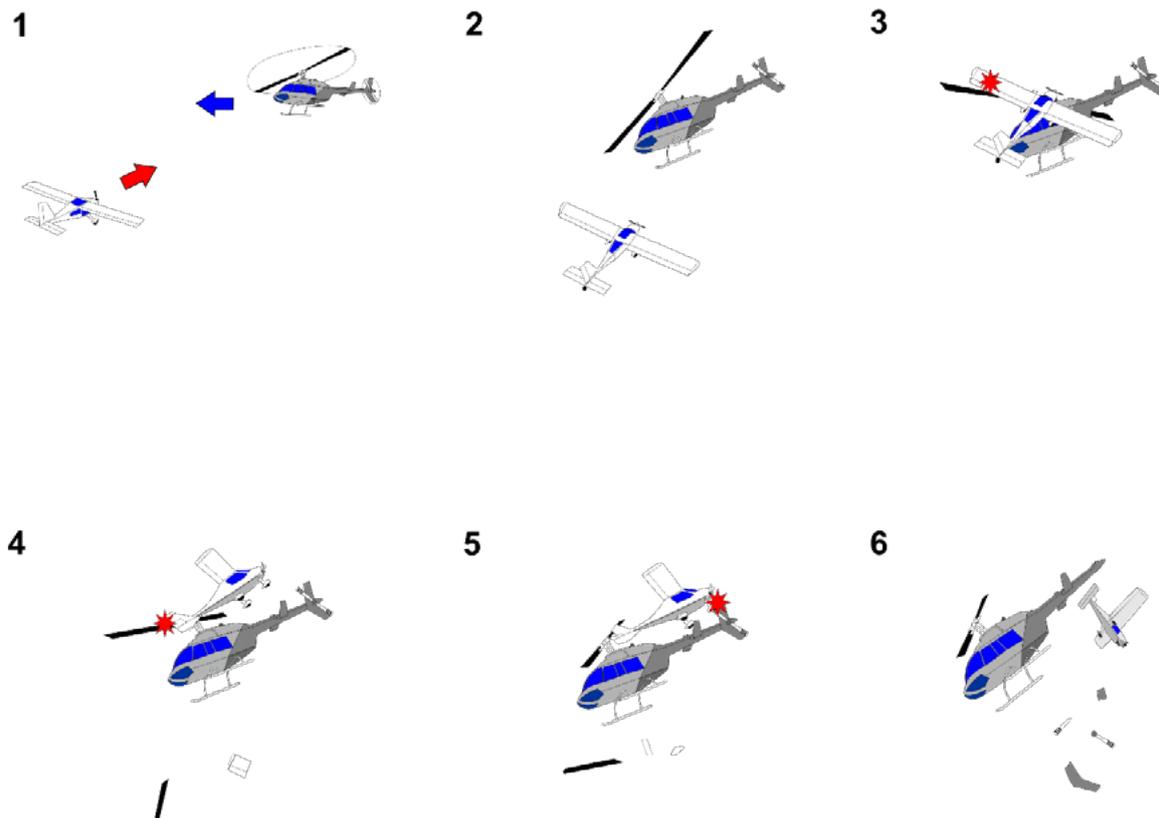
Fig. no. 11 - Impact sequence

The aircraft were on converging trajectories travelling in opposite directions, with the ultralight slightly below and to the left of the helicopter, according to the latter's direction of travel.

Up until the instant before the collision, the pilots were unaware of the presence of another aircraft in their surroundings. At the last moment, the pilots became aware of the imminent collision and performed an evasive manoeuvre: the helicopter lowering its nose and turning to the right, causing the main rotor blades' plane of rotation to be practically vertical, and the ultralight applying power to rise slightly above the helicopter.

At that moment, the blade that rotates in an anti-clockwise direction hits the ultralight's left wing, severing the tip and its flaperon.

Subsequently, and as a consequence of losing lift from its left wing, the ultralight veers sharply to the left, moving its stabiliser and rudder towards the side of the helicopter and, more specifically, towards the main rotor's plane of rotation, which results in the next blade completely severing the top of the stabiliser and partially severing the rudder. At the same time, the ultralight's forward momentum causes its front underside to hit the helicopter's vertical stabiliser, which houses the tail rotor, causing it to break into two parts and subsequently fall off.

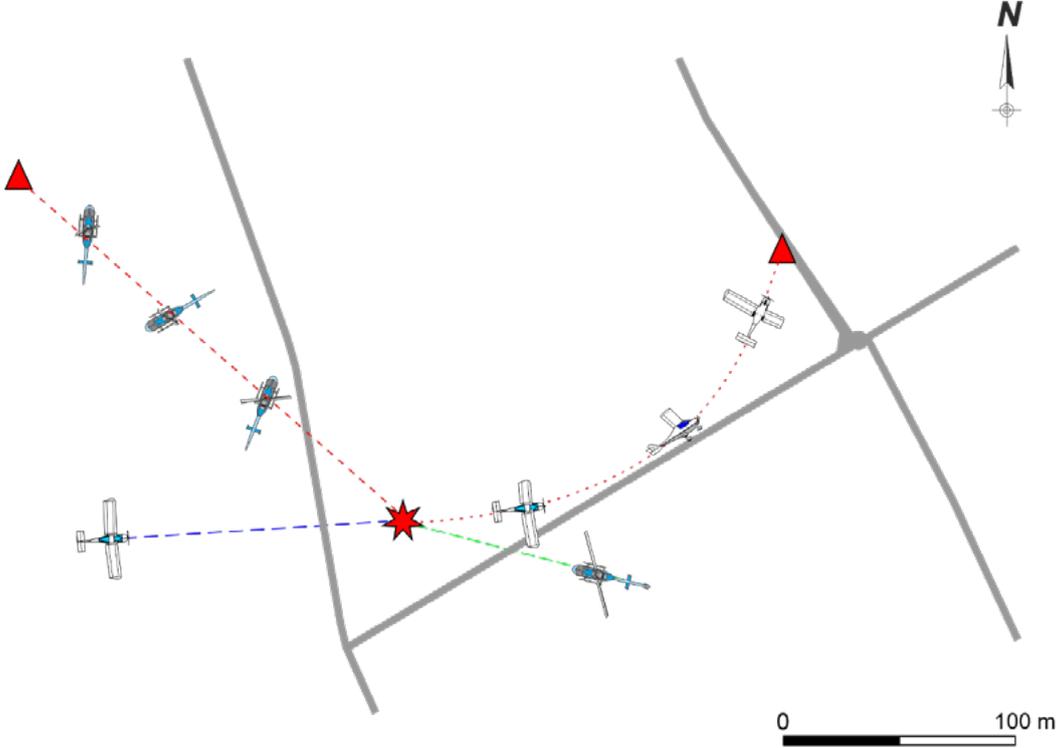
Fig. no. 12 - Sketch of the impact trajectories

The ultralight, which is now missing part of its left wing and its stabiliser, enters a left-hand spin, causing it to impact the ground in an inverted position.

The helicopter, with its main rotor blades damaged and without a tail rotor or vertical stabiliser, begins to spin out of control in a clockwise direction, descending until it finally crashes into the ground.
