## Report A-045/2018

Accident involving a Eurocopter  
AS-350-B2 aircraft,  
registration EC-MVV,  
in the vicinity of Montan de Tost  
on 20 November 2018

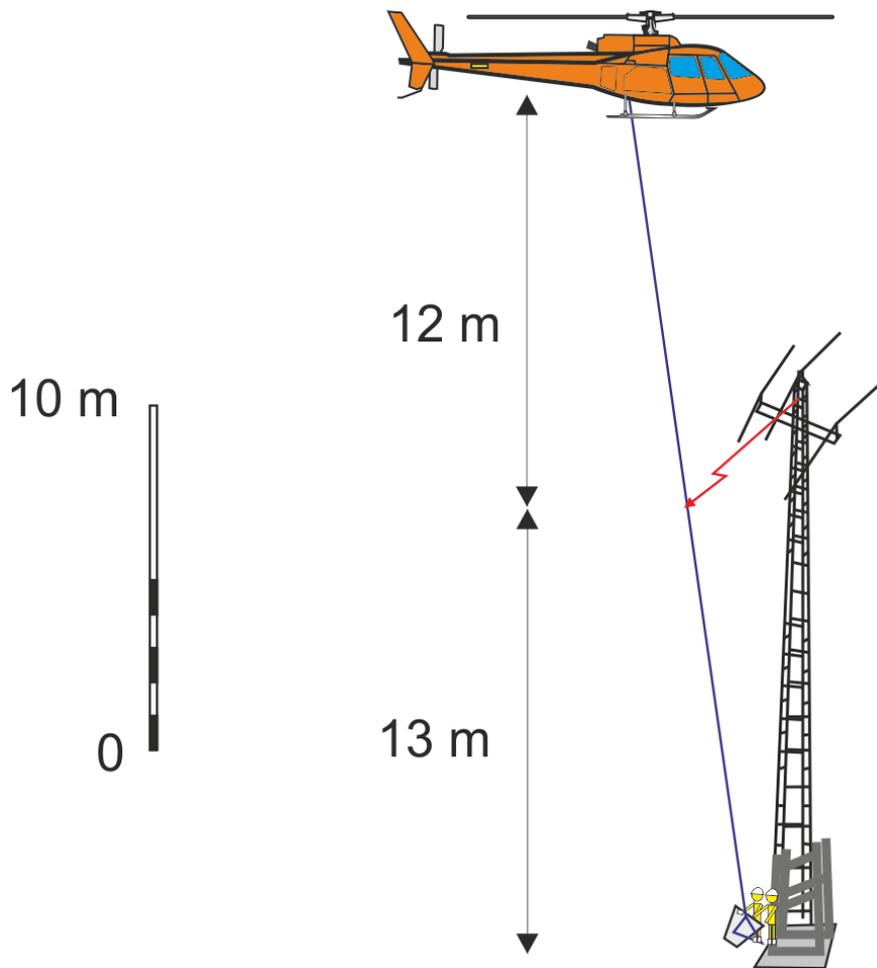
The helicopter hovered perpendicular to the power line, some 12 meters above it, leaving a safety buffer between the sling and the power line to keep the sling from breaching the danger zone of the power line. Once the bucket was close to the ground, two operators on the ground unloaded the concrete by actuating the associated mechanism. The concrete was then poured in the foundation for the new tower. Once the concrete was unloaded, the helicopter climbed again and moved backward to gain enough altitude to clear the existing line, and then proceeded to the staging area.

Fig. 3 – Diagram of the aircraft's position

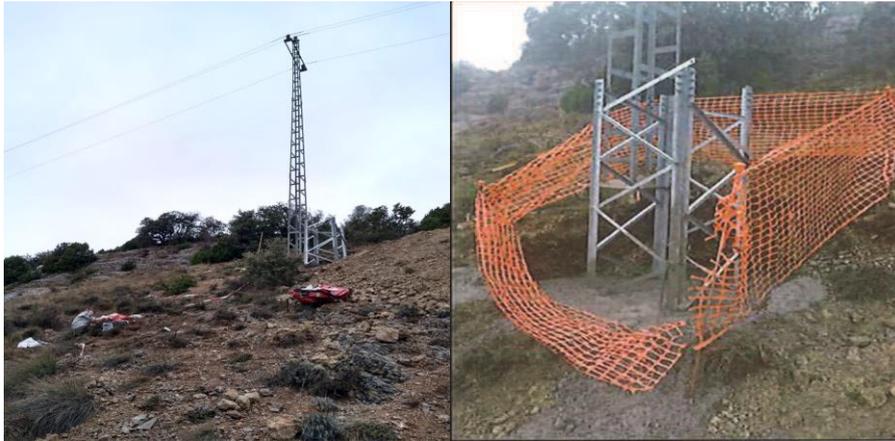
The accident occurred in a mountainous region with a considerable slope. The tower under construction was located a short distance away from the existing tower, which was in service. The two towers were 64 cm apart at the closest point and 125 cm apart at the most distant point.

Fig. 4 – General and close-up view of the position of the towers

The perpendicular distance between the power line of the existing tower and the last area where concrete was poured is 3 m.

The work being done involved concreting the foundation of a transmission tower so it could replace the existing tower that supported the power lines. The towers were separated by 64 cm at their closest points.

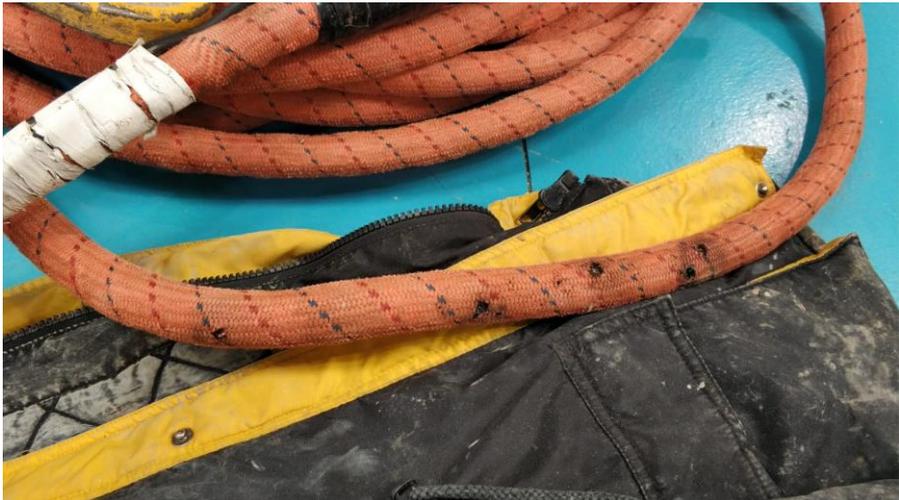
The sling had three distinct points: one where it attached to the bucket, another where it attached to the helicopter and parts with burn marks. The sling measured a total of 22.20 m. The segment between the point where the bucket was attached and the burned part measured 10.10 m. The burned area, 28 cm long, had three punctures, with the punctures on either end being separated from the central puncture by 15 and 13 cm.

The layers that cover the internal core of the sling were uncut and undamaged, but the burn marks on the surface polyester layer revealed that there had been a short circuit.

Fig. 5 - Close-up of burn marks on the sling

Therefore, the prevailing humidity conditions throughout the morning, and, of course, the appearance of drizzle, caused so much moisture to build up on the sling that it lost its dielectric qualities.

The presence of moisture on the surface of the sling is conducive to the appearance of flashover in the vicinity of a voltage source, and since the sling was grounded, it caused the current to flow to an area of lower voltage.

As concerns the sling used in the operation, burn marks were found 10.10 m away from the attachment point for the bucket. This is consistent with the formation of flashover at the height of the power line. Also, considering the total length of the sling of 22.20 m, this indicates that the helicopter was about 12 m above the line, which is appropriate.

The inspection of the sling also revealed that the layers that cover the central core were not cut or damaged, but the burns on the surface polyester layer had caused a short circuit, which is consistent with a spark propagating to the ground through the wet surface on the sling.

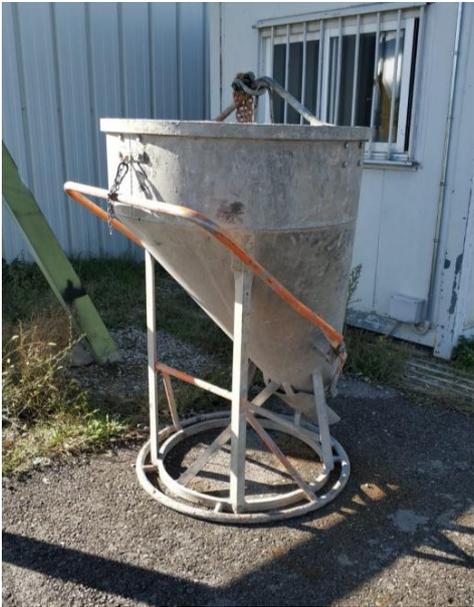
The bucket used to transport the concrete was outside the hangar. There were burn marks on one side. The bucket is 145 cm long, and on top of the bucket is a triangular metal structure measuring 20 cm that is used to fasten the anchors. The chain that goes between the triangular piece and the hook on the sling is 1 m long.

Fig. 6 - Bucket
