CIAIAC

Report A-045/2020

Accident involving an Airbus Helicopters MBB BK117 D-2/H145 aircraft operated by Eliance Helicopter Global Services, registration EC-MJK, on 16 November 2020 in the municipality of Piera (Barcelona, Spain)

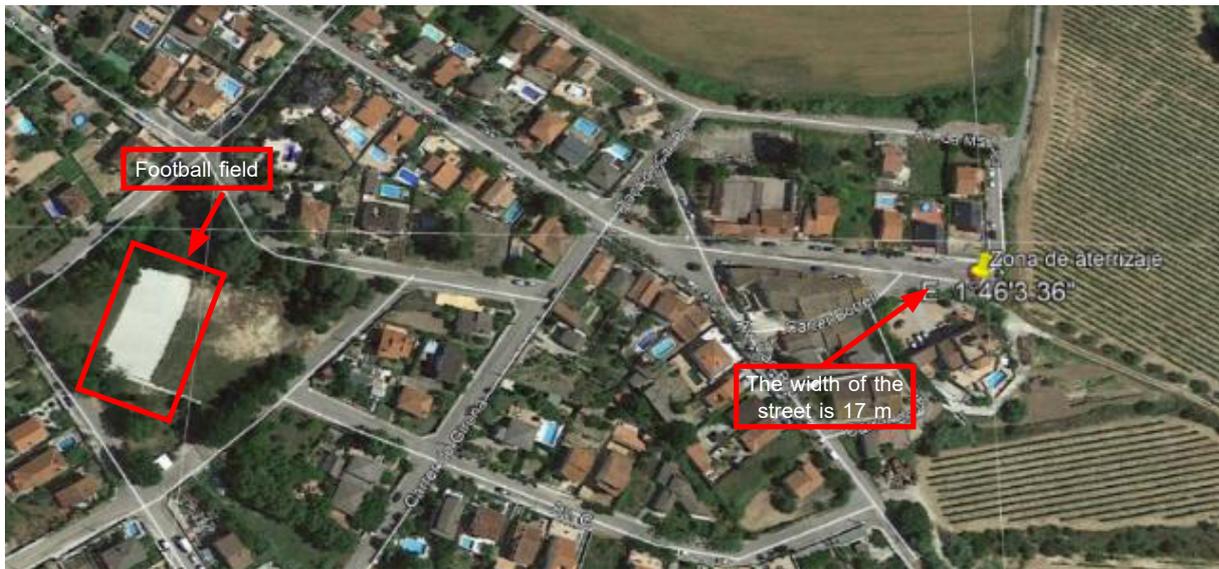
Illustration 5: Helicopter landing zone and location of football field

The landing site has been marked in yellow in the image below. The GPS coordinates are: 41° 29' 10.32" N, 1° 46' 3.00" E. The street is about 17 m wide. In addition, a football field close to the home of the person requiring medical assistance has been marked in red. It was about 300 m away. The coordinating centre suggested this location as a potential landing site:

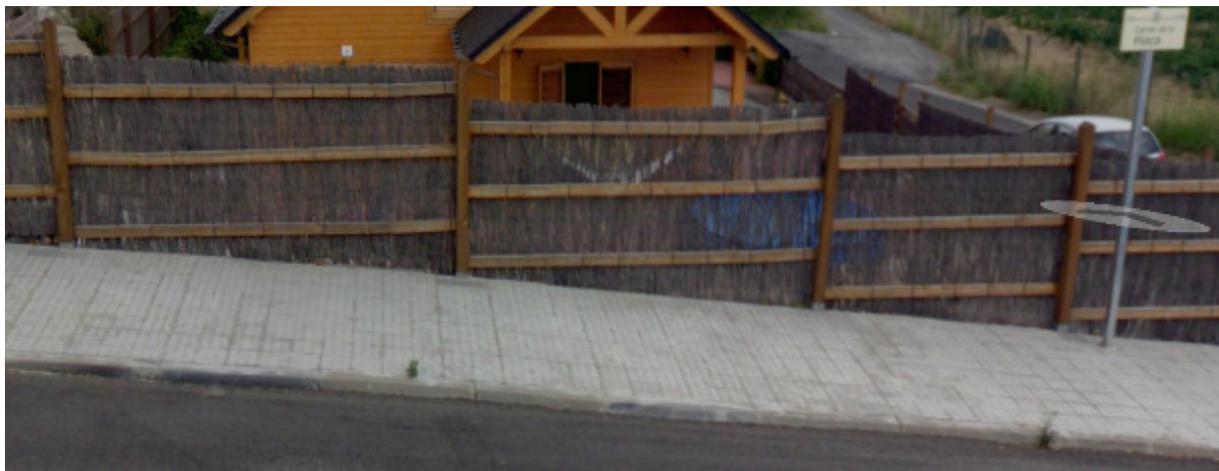
Illustration 6: Slope at the helicopter landing site

The helicopter pilot selected a landing site close to the home of the patient they were to assist. The slope in the chosen area exceeded the established limits³, causing one of the main rotor blades to hit the upper cable cutter when the pilot lowered the collective to settle the aircraft after touch down.

The following image illustrates the slope at the landing site, which has been calculated with the help of the parameters recorded by the data recorder, as explained in the following section:

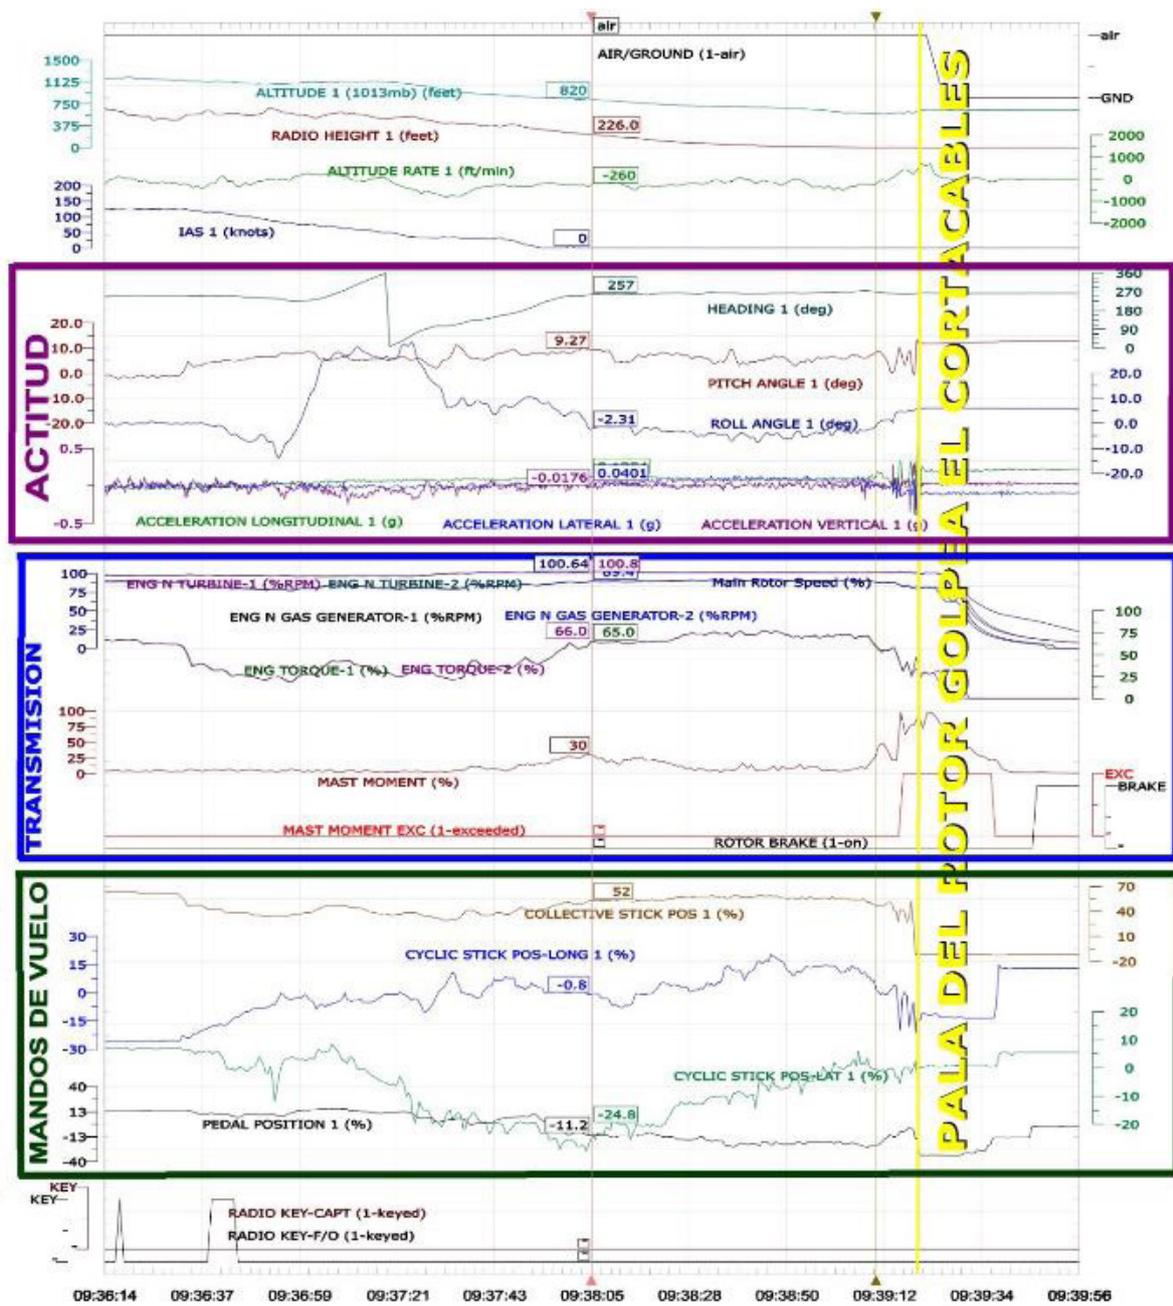
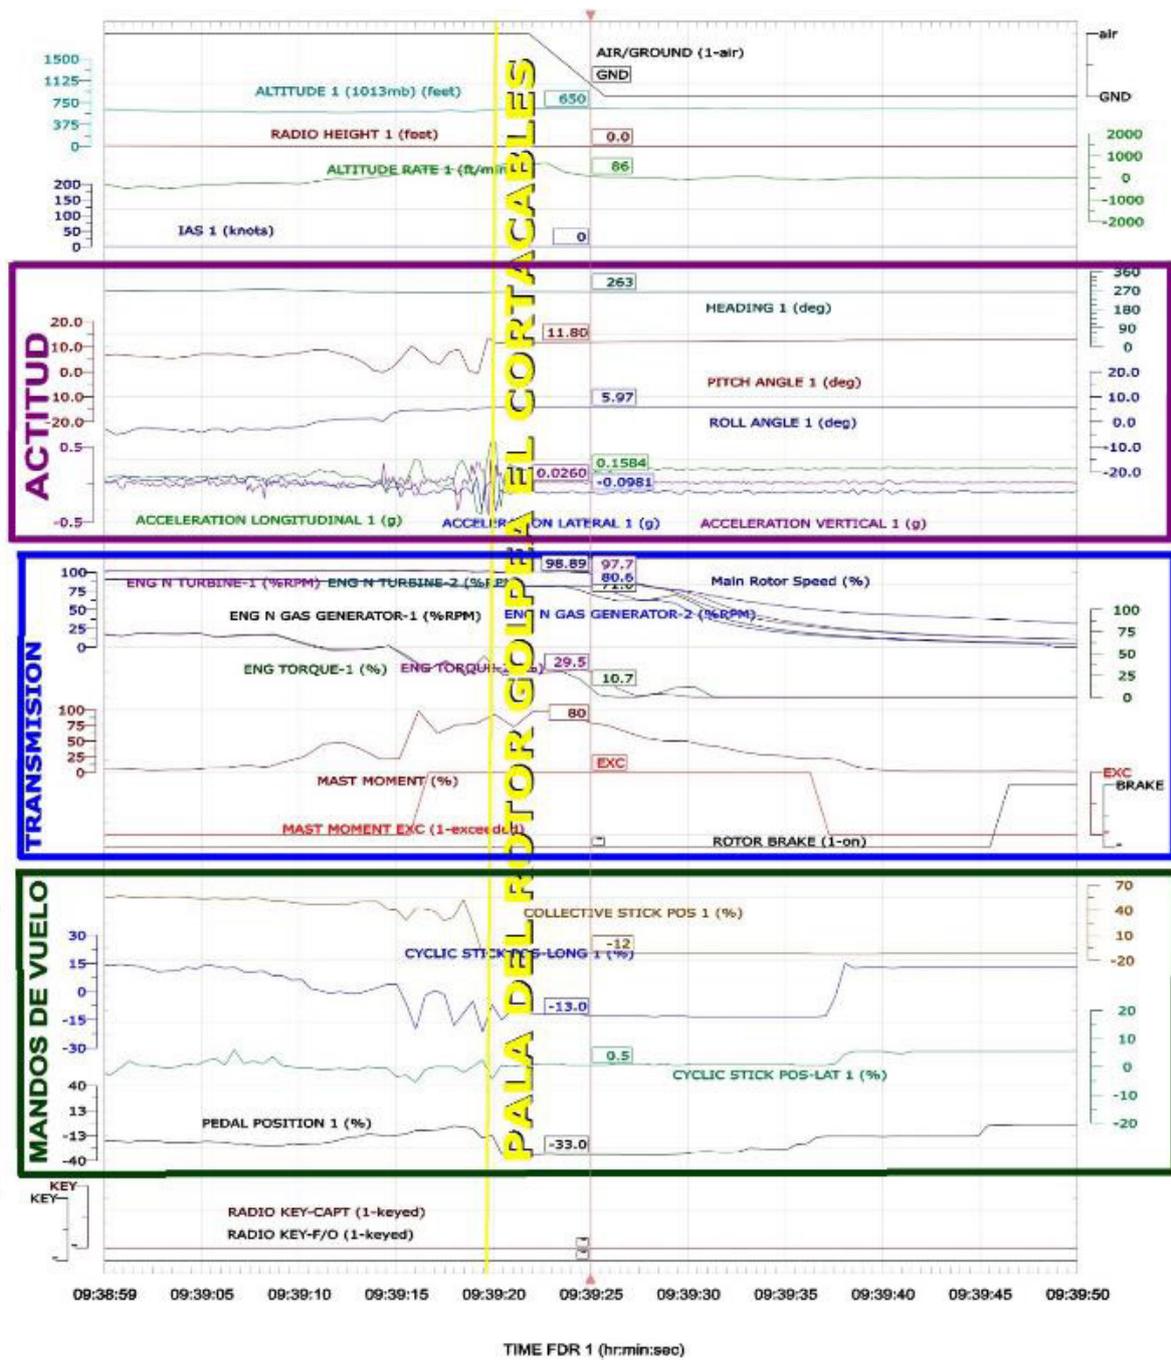
The helicopter then pitched two more times. The pilot kept the cyclic control in an advanced-forward position. The MAST_MOMENT ranged from 70% to 98%. The aircraft slipped backwards. When the pilot lowered the collective to settle the aircraft, one of the main rotor blades struck the helicopter's upper cable cutter (coinciding with the extreme values of the longitudinal, lateral and vertical accelerations), and the noise of the impact can be clearly discerned in the recording from the cockpit voice recorder. The impact causes the aircraft to slip backwards again.

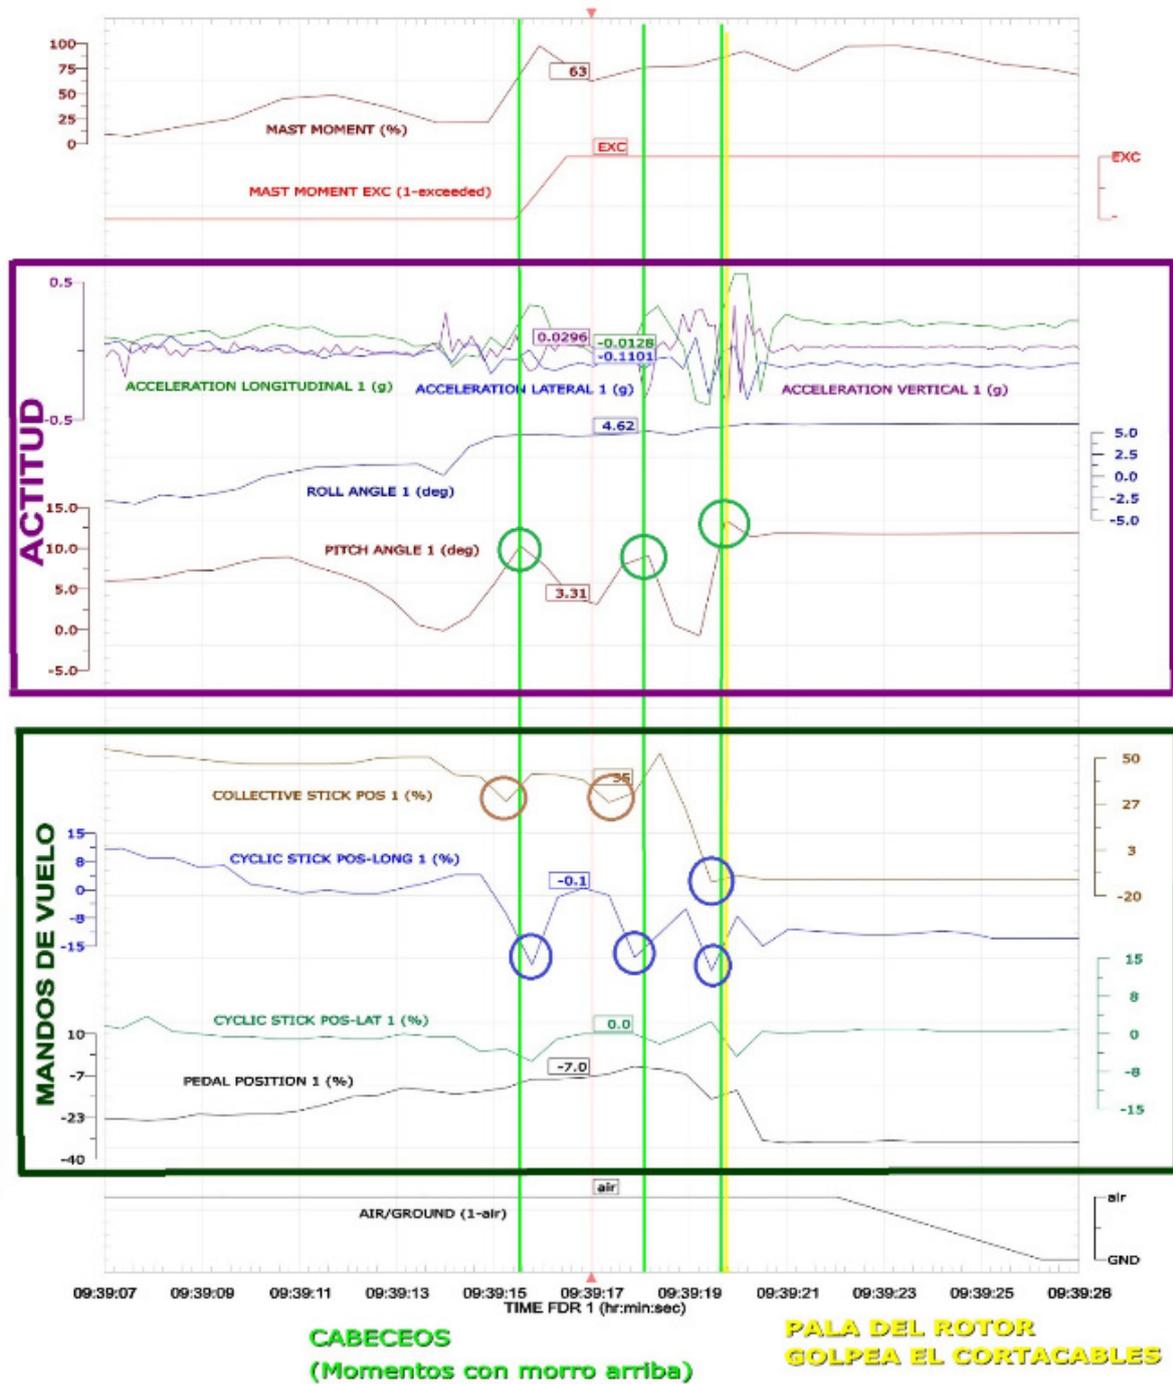
Illustration 10: Pitching movements during the accident

At 10:39:18 h, the “Mast Moment” warning sounded again, and the pilot can be heard saying: *No, now*. After this second warning, the collective was lowered to settle the aircraft with the longitudinal cyclic in an extremely forward position, which caused a main rotor blade to impact the upper cable cutter a second later. As the slope of the landing surface exceeded the limit, the fuselage lifted, and the rotor disc lowered when the pilot actuated the cyclic to level the aircraft.

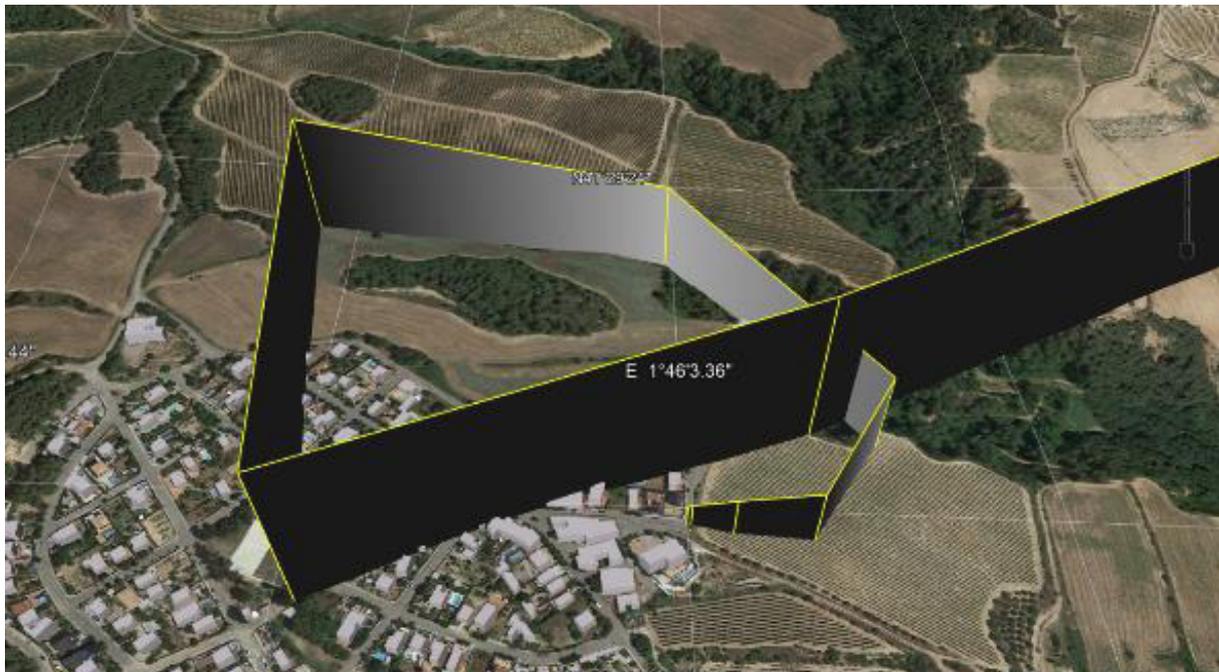
Illustration 11: Last moments of the flight before landing

The aircraft was equipped with a tracking beacon that recorded its trajectory. The following image shows the reconnaissance flight the pilot made to select an area for landing in the municipality of Piera:

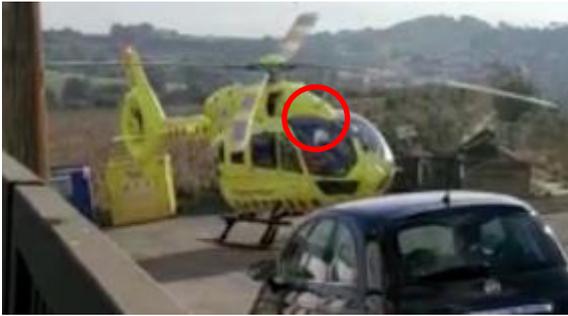
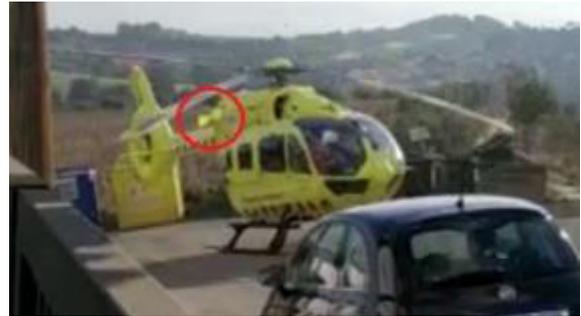
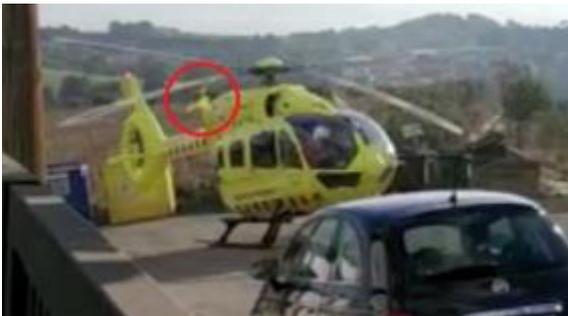
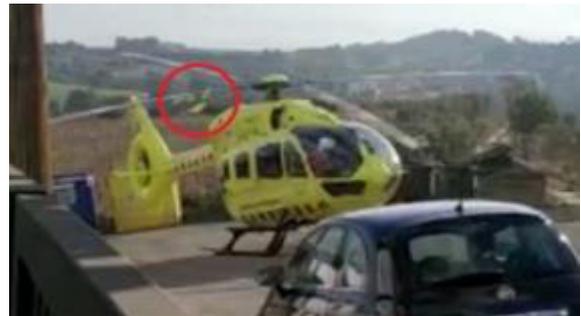
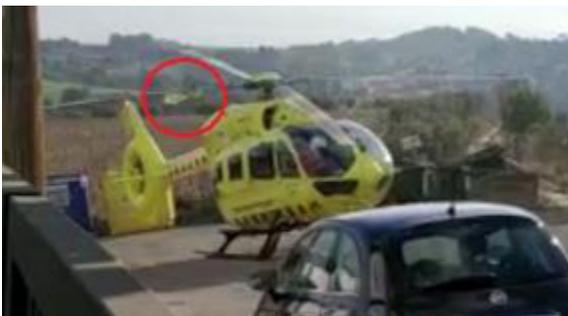
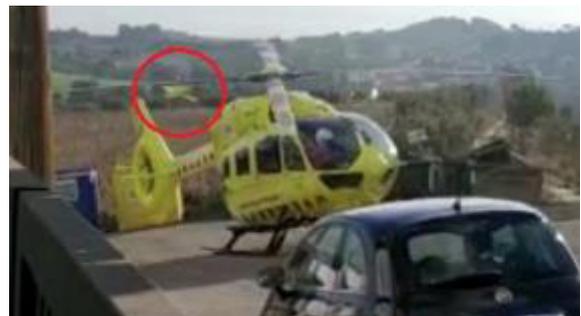
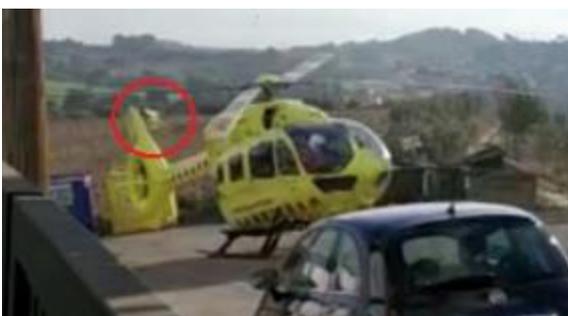
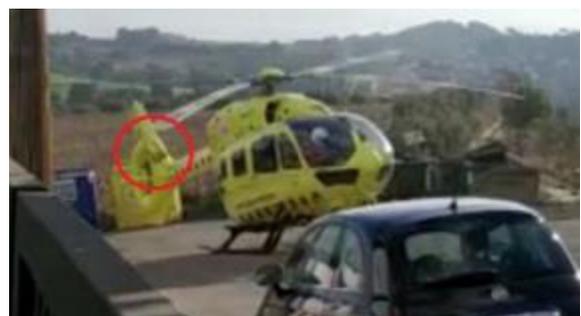
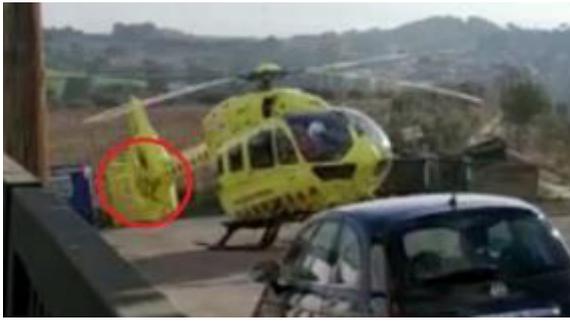
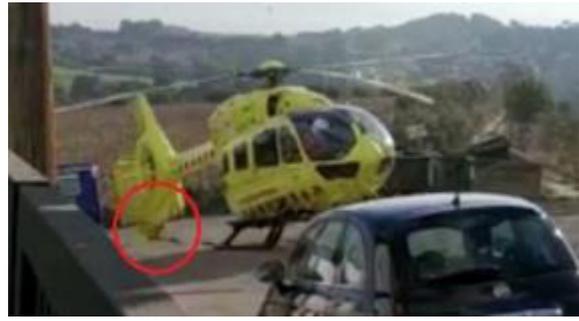
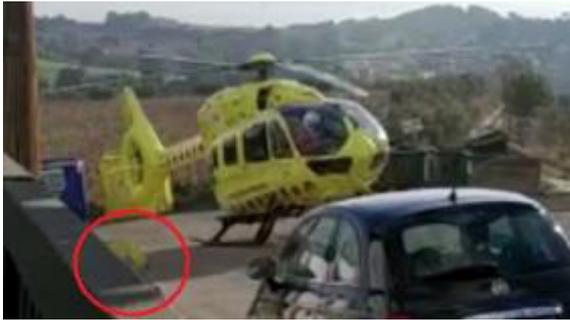
An individual recorded the helicopter landing with a video camera. The following images, taken from the video, show the rotor blade striking the upper cable cutter. The cable cutter was ejected by the rotor after turning approximately 270° with the blade that struck it. The red circle indicates the position of the cable cutter at different moments.

As can be seen in the recording, the pilot was unable to set the helicopter skid down correctly on the ground due to the sloping terrain during his first attempt.

On the next attempt, the helicopter pitches, and the pilot overrides the movement by lowering the collective. The rotor disc lowers, and the fuselage rises, causing one of the main rotor blades to impact the upper cable cutter. The following images show the magnitude of the damage:

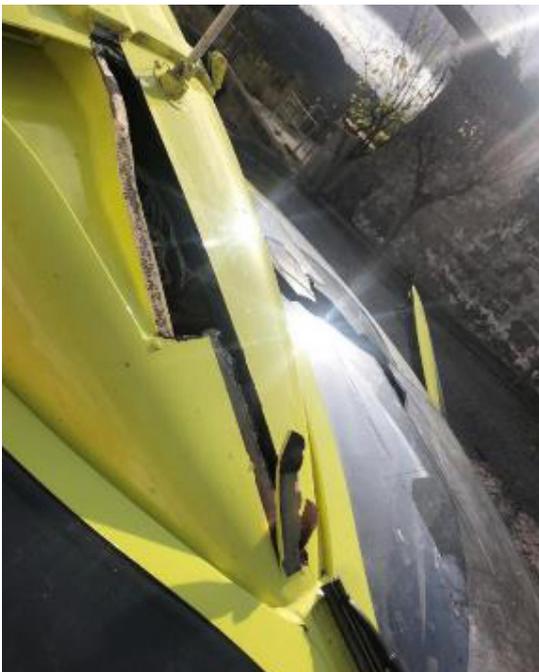
Illustration 13: Detail of the damage to the front window and cable cutter

The accident damaged the following components of the helicopter: the cable cutter system, a main rotor blade, the front copilot window and one of the skid struts.
