## Report A-055/2019

Accident happened on  
3 November 2019 to the BOEING  
B787-8 aircraft, registration  
N796AV, between VAKIN and  
DIRMU waypoints of the UN725  
airway (Barcelona FIR/UIR)

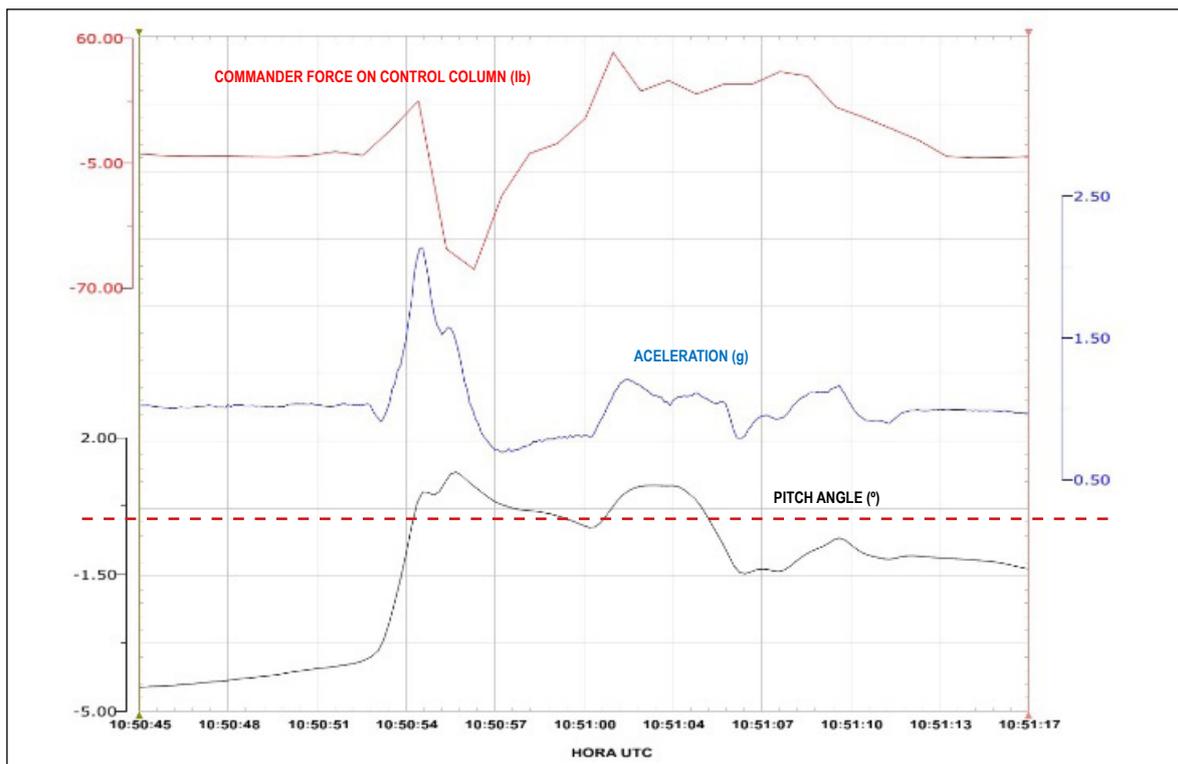
Figure 2: Parameters recorded in the flight data recorder

At 10:50:52 h, the pitch angle was -3.79°, the vertical speed was -4300 ft/min, and the CAS was 354 kt.

At 10:50:53 h, the extension of the speed brakes was recorded.

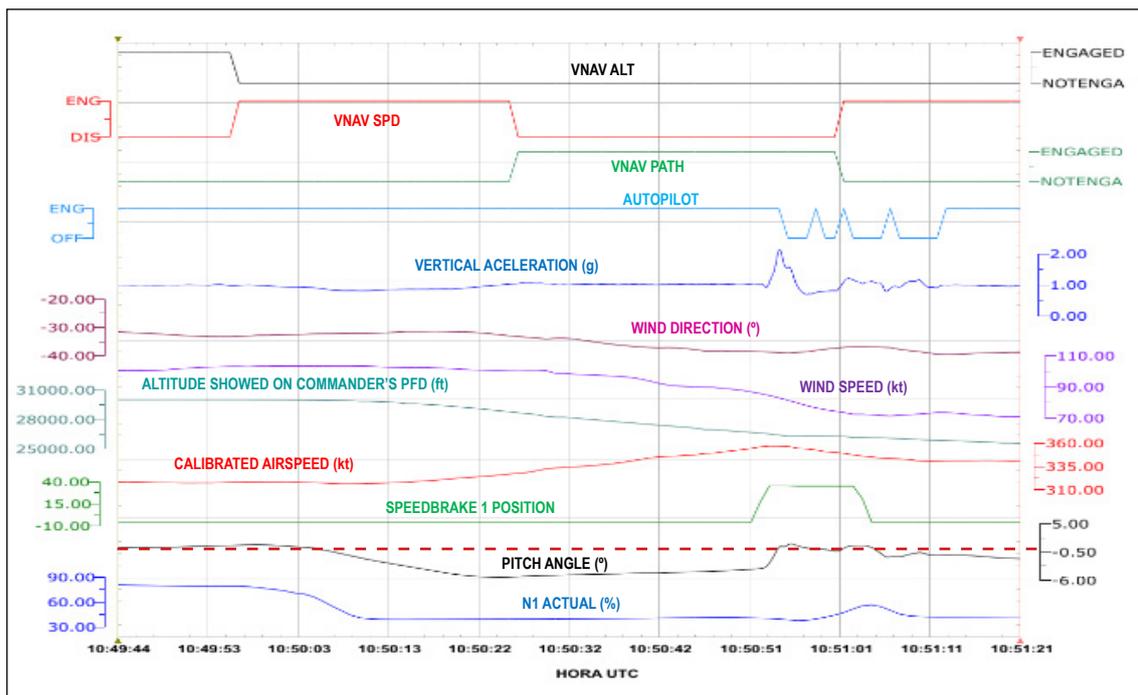
Figura 3. Parameters recorded in the flight data recorder

- The aircraft reached its maximum speed of 356.87 kt CAS (10:50:54 h). The GPS coordinates for the point where the maximum speed was reached are 41° 47'23.9"N and 000° 07'48" E, close to the DIRMU waypoint.
- An increase in control column force was recorded, varying between +52.78 lb and -60.26 lb.
- The vertical acceleration ranged between +2.14 g and +0.69 g. The highest vertical acceleration value of +2.14 g was recorded at 10:50:55 h, dropping to +0.69 g 3 seconds later.

- During the same period, at 10:50:55 h:
  - the pitch angle reduced to  $+0.6^\circ$ , having changed from  $-3.7^\circ$  to  $+0.6^\circ$  in the space of 2 seconds.
  - the activation of the master warning and disconnection of the autopilot was recorded<sup>12</sup>. The autopilot remained disconnected until 10:51:13 h.
- At 10:51:02 h, the autothrottle mode changed to IDLE and then HOLD. The pitch mode changed to VNAV PTH. The aircraft continued its descent in the HOLD/LNAV/VNAV SPD modes.
- After that point, the speed began to reduce, reaching 340 kt CAS at 10:51:10 h with a vertical speed of 2077 ft/min at 25959 ft of altitude.
- Three 1-second autopilot connections and subsequent disconnections were detected at 10:50:59 h, 10:51:02 h, and 10:51:07 h.
- At 10:51:13 h, the autopilot was permanently reconnected.
- The altitude varied between 26527 ft and 25866 ft.
