# CIAIAC

## Report A-064/2019

Accident involving a Beechcraft  
BE76, registration EC-INC, at  
La Axarquía Aerodrome (Málaga)  
on 25 November 2019

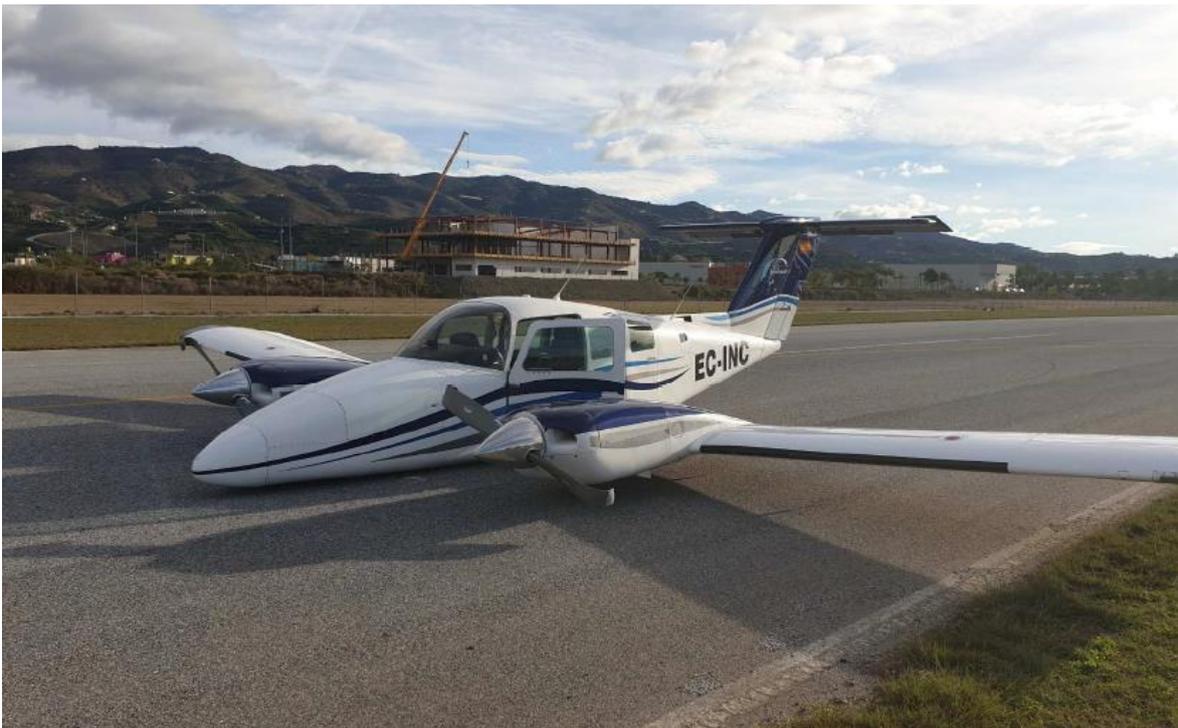
Photograph 1: Damaged aircraft at the accident site

The landing gear, propellers and the underside of the fuselage were damaged during the accident.

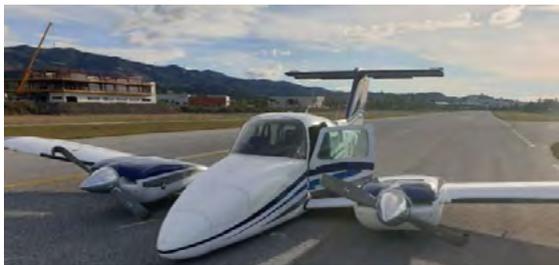
Photograph 4: General condition

The aircraft made a controlled and level landing on runway 30, aligned with the left half of the runway and with its landing gear up. It stopped a few metres from the end of the runway.

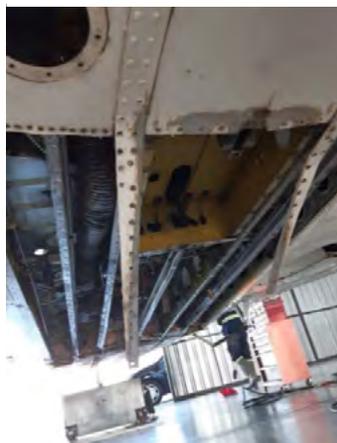
Photograph 5: Nose landing gear housing

The aircraft sustained damage when, without its landing gear deployed, the lower part of the fuselage came into direct contact with the runway asphalt and eroded as it slid along it before coming to a halt. Furthermore, the propellers, which were still rotating, suffered deformations as a result of impacting the ground.

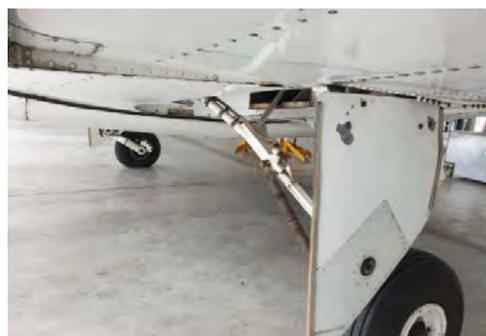
- Nose landing gear doors: significant damage.
- Main landing gear doors - deformed and eroded.
- Propellers of both engines: deformed and significantly damaged. On the right-hand propeller, one blade tip was doubled back on itself, and the other was folded forward. However, both blade tips were bent backwards on the left side, suggesting that the power being supplied by the left engine was inferior to that being supplied by the right engine.
- Lower fuselage area: underside eroded longitudinally in the direction of travel.
- Footboards: damaged at their attachment point.

Photograph 6: Main landing gear doors

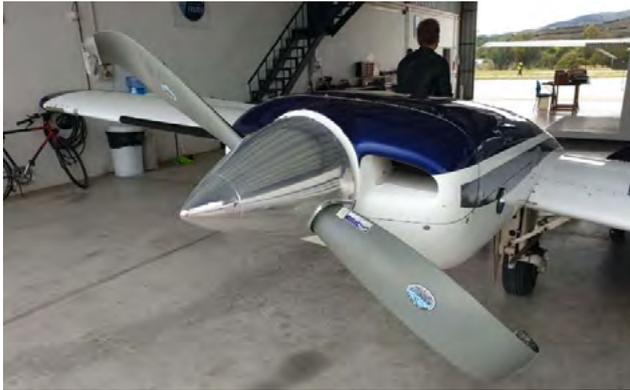
Photograph 7: Right engine propeller

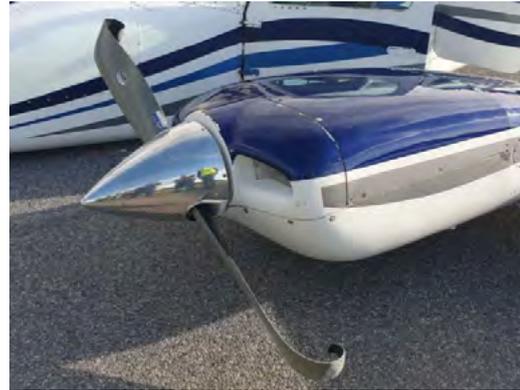
Photograph 8: Left engine propeller

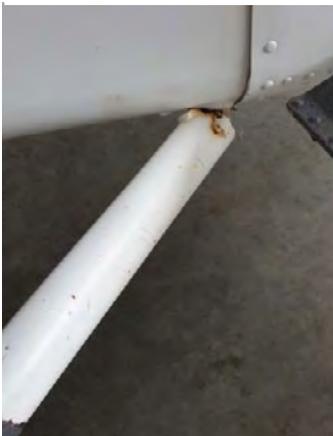
Photograph 9, left:  
Footboard

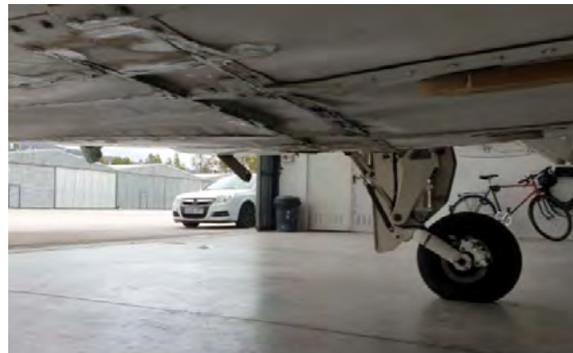
Photograph 10 right:  
Underside of fuselage
