THE DUTCH
SAFETY BOARD

Accident with hatch crane of mv Arklow Sky,
Bilbao, 21 September 2010

The Hague, July 2011

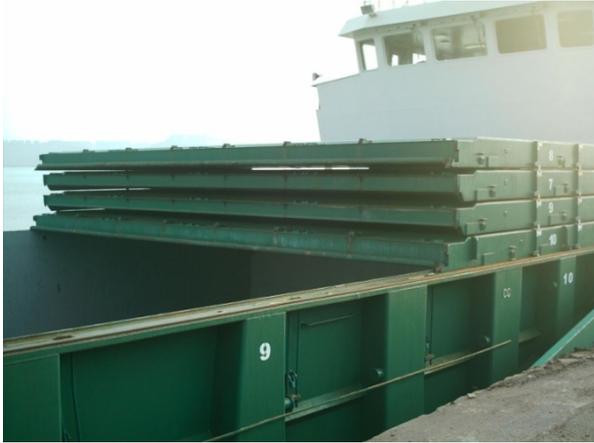
Photo 1: The piled hatch pontoons at the back of the hold, after hatch no. 6 had been driven away by the first mate.

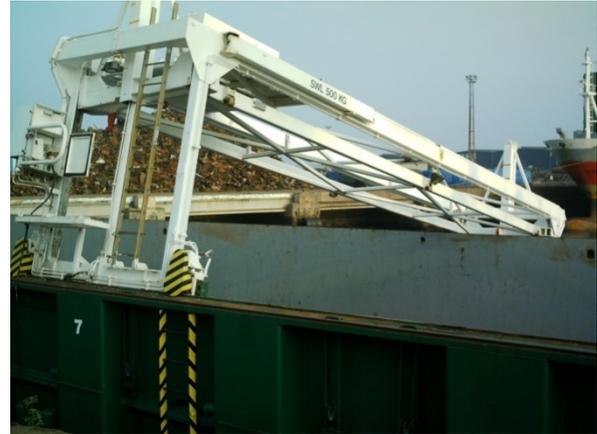
Photo 2: The situation shortly after the accident.

As a consequence of this fall into the hold the first mate suffered serious injuries and was admitted to hospital in a critical state. The material damage to the hatch crane and the ship was around € 25,000. This material damage consisted of, among other things:

- Indents¹⁸ and penetration of the tank top¹⁹ and side tanks in the hold.
- Displacement of the hydraulic plunger²⁰ of the hatch crane.
- Bending of the attachment hooks on the port side of the hatch crane.

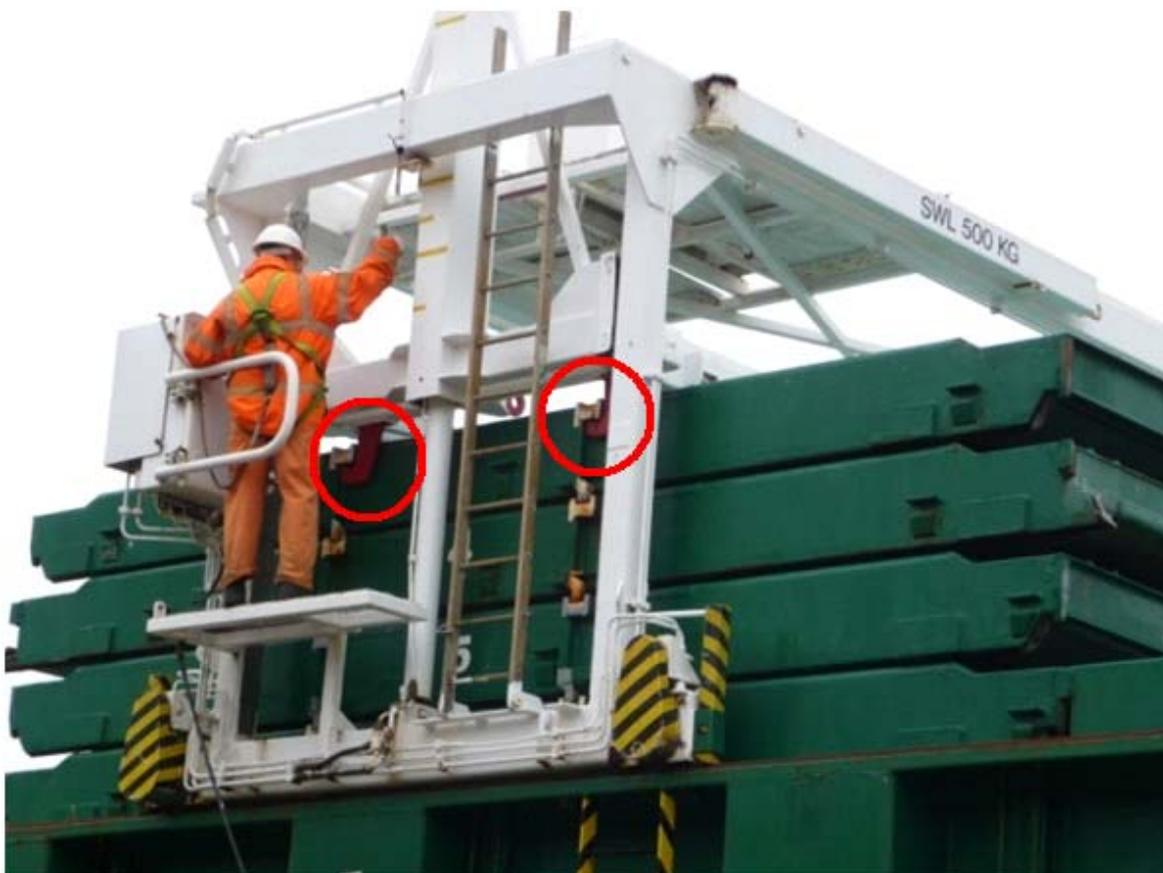
Photo 3: The hatch crane with hooked hatch (photo taken on the Arklow Sky in Sluiskil).

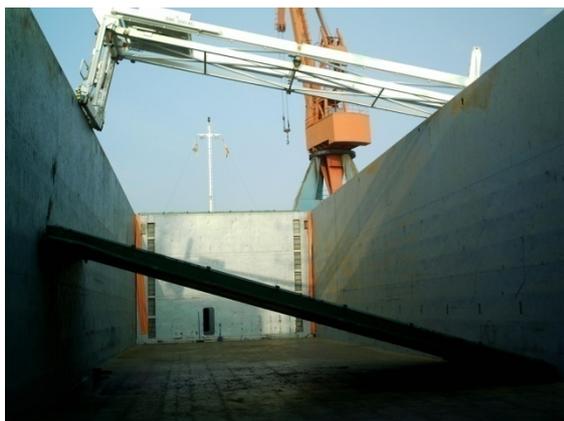
Photo 4: Situation after the accident viewed from the hold.

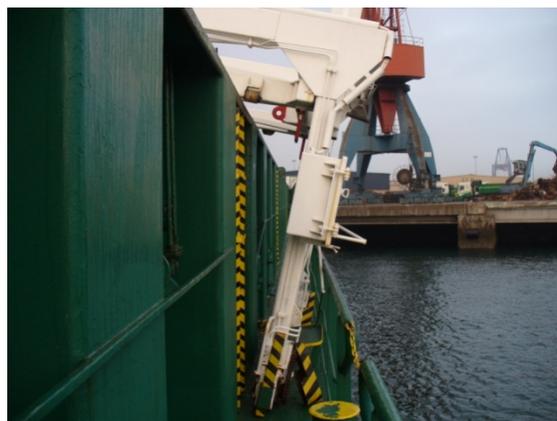
Photo 5: Position of the hatch crane on the starboard side in the gangway.

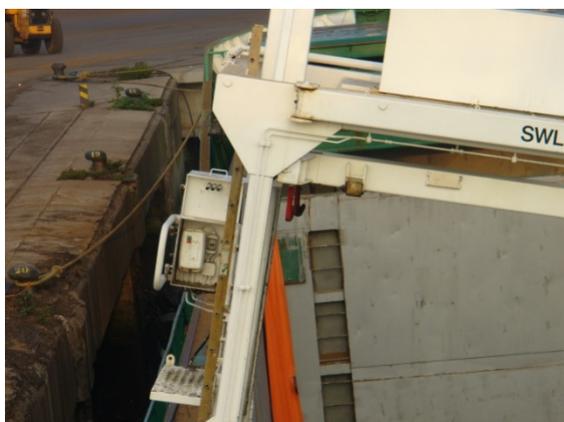
Photo 6: Bent hooks on the port side.

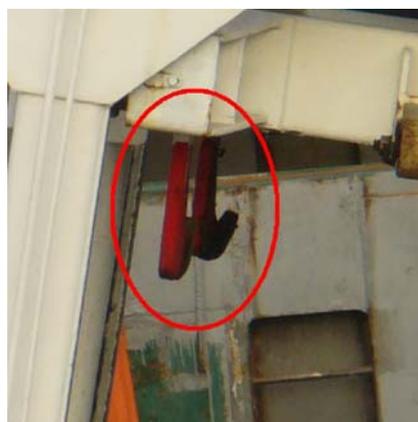
Photo 7: Enlargement of bent hooks.

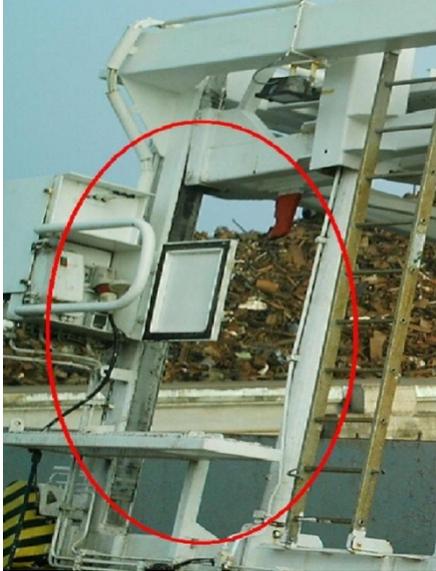
This was able to happen due to the lack of adequate anti-fall protection on the operating platform and due to the mate not wearing any personal anti-fall protection (safety harness)²².

The investigation did not provide any answer to the question of whether the door of the mains switch cabinet was open or closed during the operations. The shipping company regards an open door as the anti-fall protection for the operator on the operating platform.

Photo 8: Limited anti-fall protection on the operating platform with an 'open' door (see also photo 3).

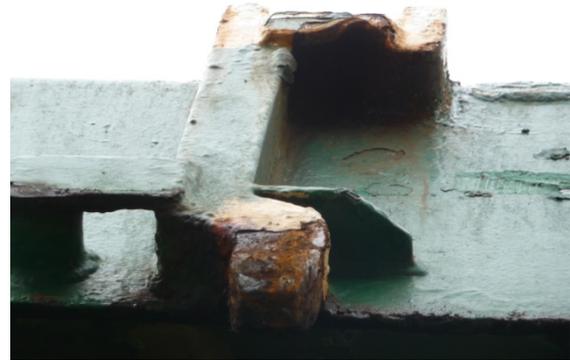
Photo 9: Damaged attachment point of the fallen hatch.

The accident could take place because the hooks of the hatch crane yoke on the starboard side did not connect to the hatch attachment points but to the rounded (outer) side of the attachment points. Contrary to the procedures, this was not checked by a second person. Again contrary to the procedures, the hatch was transported in a high position meaning that the hatch crane's centre of gravity remained high. The consequence was that a minor imbalance (for example when starting or stopping a movement) was sufficient to cause the incorrectly hooked-up hatch to slip off the rounded blunt sides of the attachment hooks. Moreover, the hatch's high position meant there was sufficient space for it to fall down past the hatchway coaming and into the hold. If the hatch had been moved in a low position, it would possibly have fallen onto the hatchway coaming.

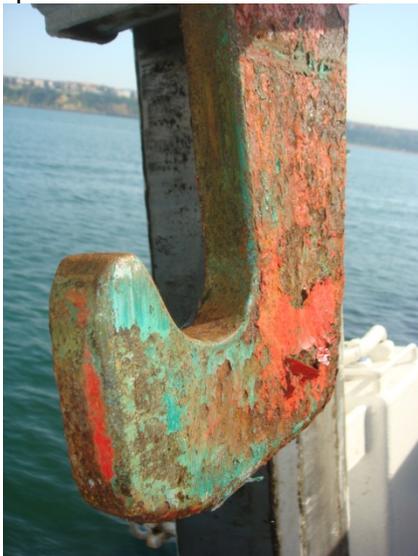
No 'hard' technical measures were implemented on board the Arklow Sky to prevent incorrect hooking. In the past one of the shipping company's vessels was fitted with a technical provision to prevent incorrect hooking using sharp-ended hooks. However, this provision was not fitted to any other vessel because the shipping company decided that it would not increase safety, given the crew's response that they would then be able to operate the hatch crane alone.

Photo 10: The hooks used on board with blunt end.

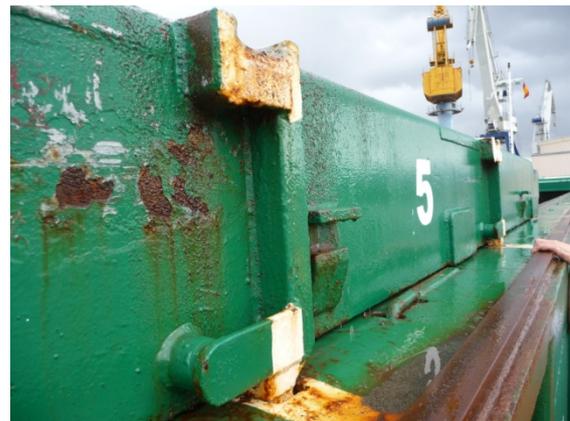
Photo 11: Hatch with two attachment points with rounded profile.

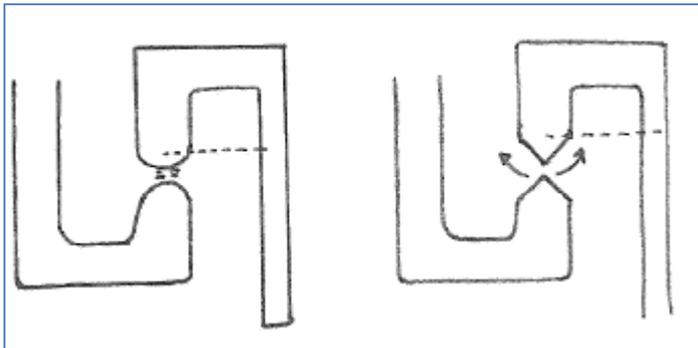
Figure 1: Difference between blunt ended and sharp ended hook and attachment point.

2. The use of sharp ended hooks and pockets, so that the hook cannot lift the hatch if not properly connected (see figure 1).

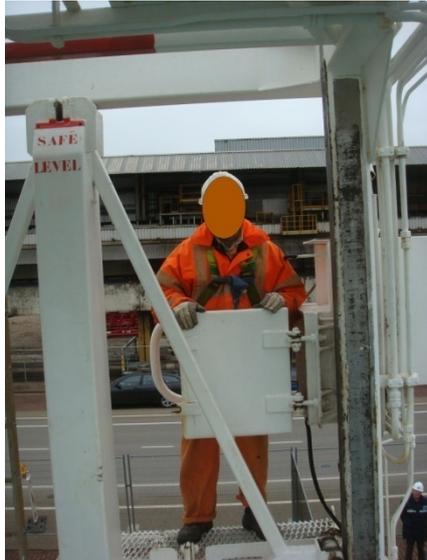
In combination with a correctly lowered spreader an anti-fall protection would seem adequate. (see picture attached - taken on board Arklow Sky in Sluiskil on 29/10/2010 with OVV representatives in attendance.
