CIAIM--16/2017 REPORT

Grounding of the vessel SEA DWELLER in the vicinity of the Port of Ceuta anchorage on 9 February 2015

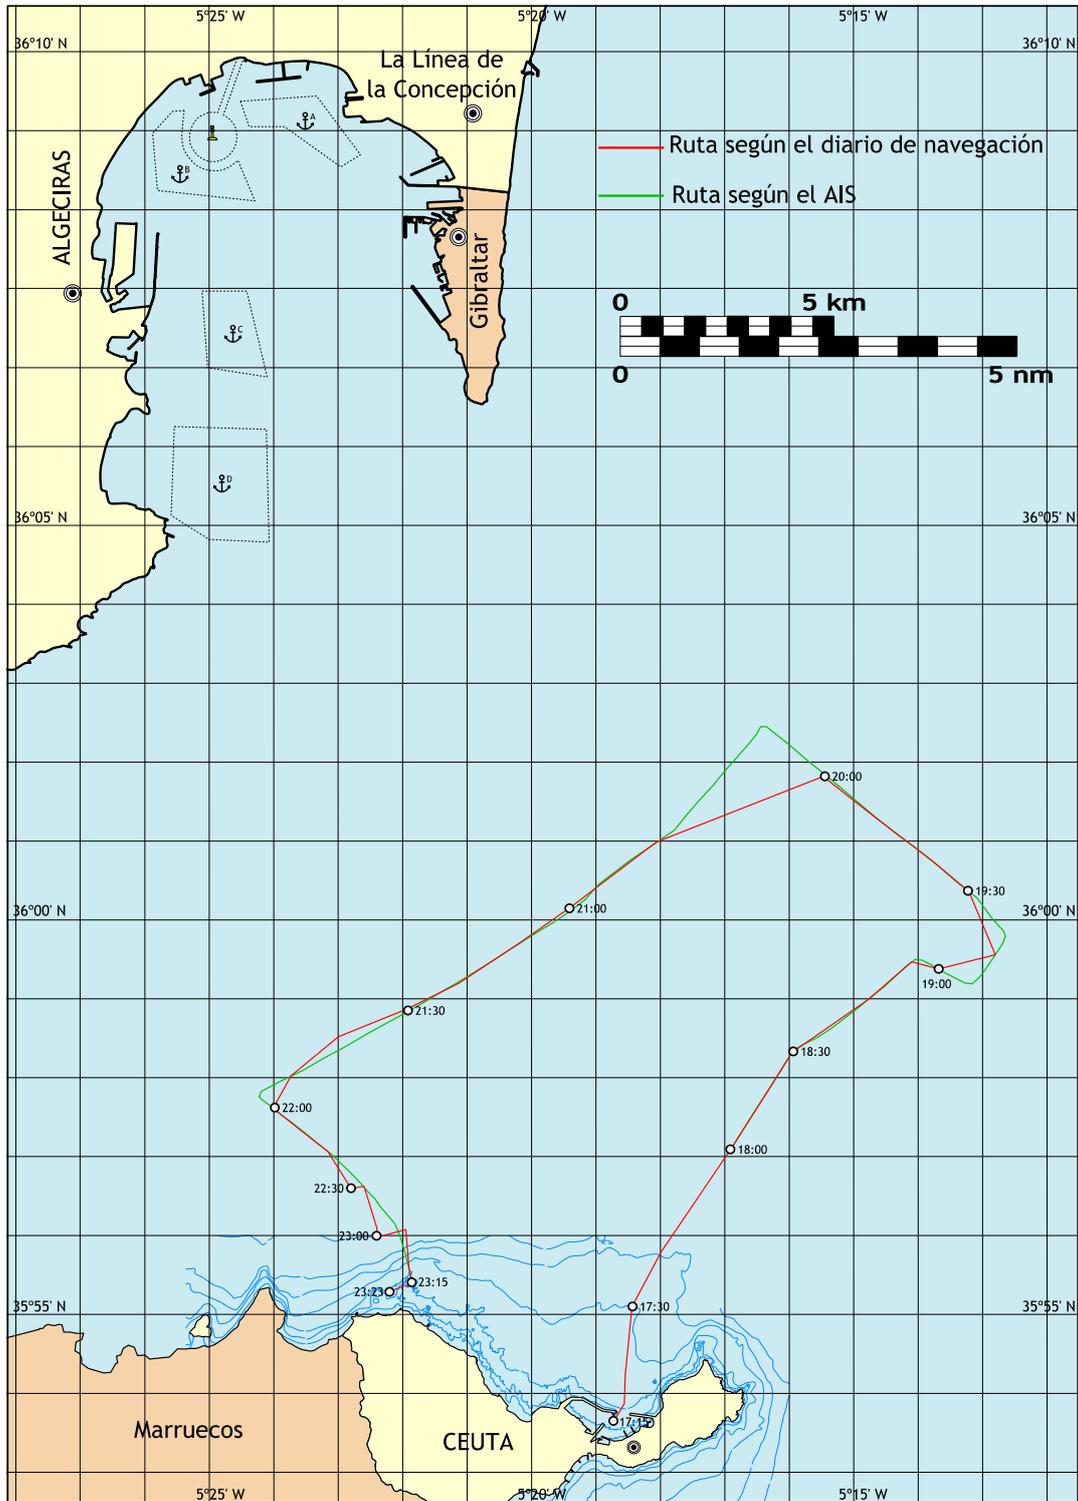
Figure 4. Ship's route before accident with time stamps

At 16:54, the Ceuta pilot boarded the SEA DWELLER to begin the maneuvers to exit the Port of Ceuta. After leaving the bay of Ceuta and once the pilot left the ship, the weather conditions they encountered were bad, with maximum wave heights of 7 to 8 meters and wind from the E gusting to over 40 knots. Given these conditions, the ship did not proceed directly to Algeciras and at approximately 17:30, it changed course to the NE (Figure 4).

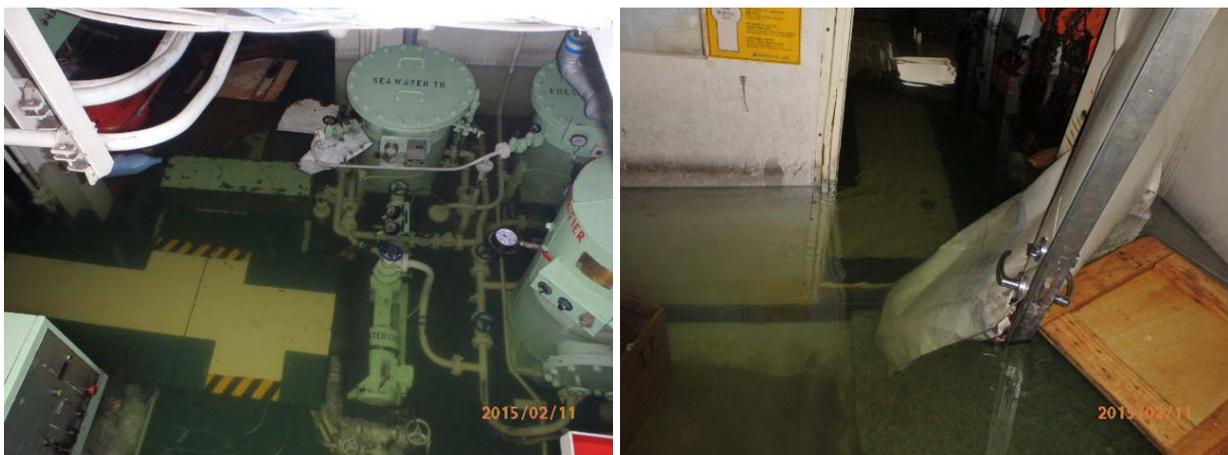
Figure 6. Flooding in the engine room.

On 10 February 2015 at 00:22, the crew reported that they were at anchor with the port anchor, which had four lengths of chain in the water. The engine room was also flooded to a depth of 6 m (Figure 6). They had no electricity.

The cracks in the bilge allowed water to enter and flood the engine room, which subsequently led to a loss of power.

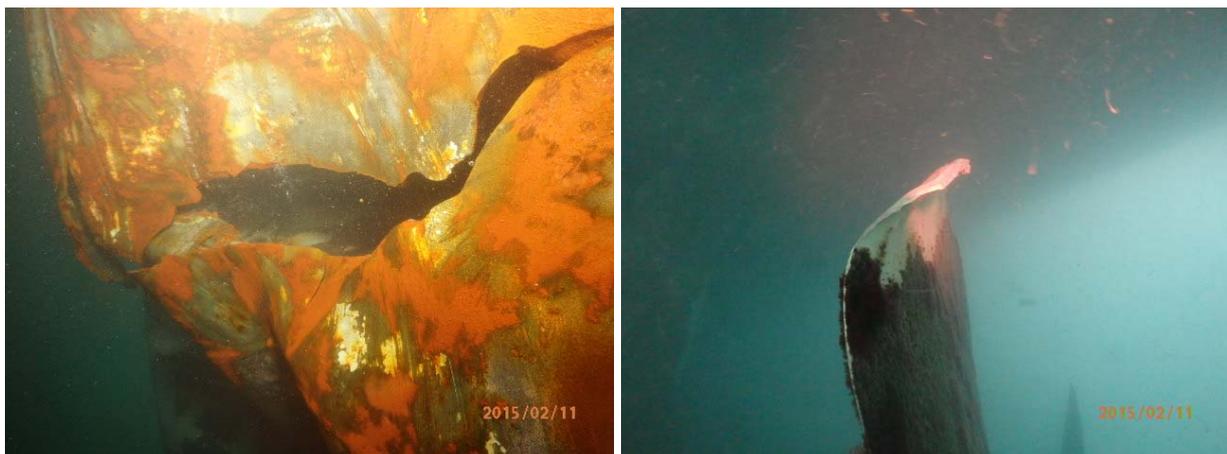
Figure 7. Damage to the hull and propeller

- Bending of the rudder with no apparent cracks.
- Bending of the four propeller blades with loss of material (Figure 7).
- Cracks and bending of the starboard bilge along the entire length of the engine room (between frames 7 and 51).
- Broken starboard bilge keel (between frames 43 and 51).
- Scratches to bow dome caused by the anchor chain.

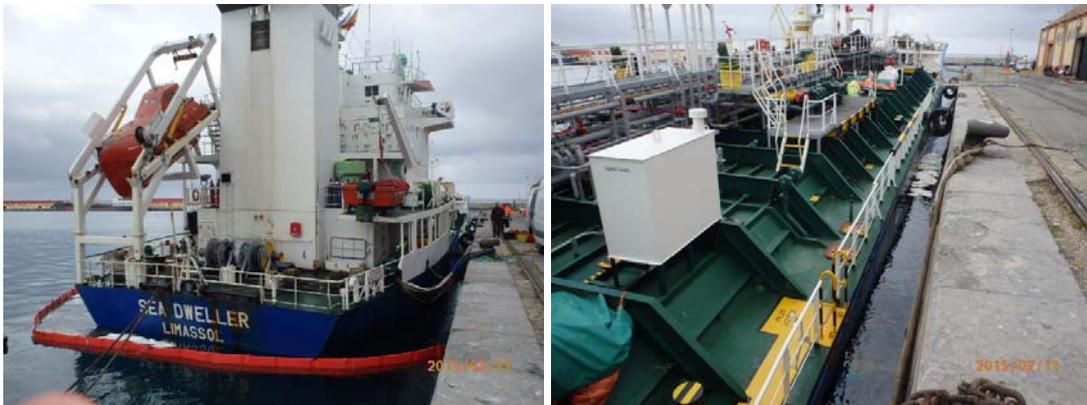
At 05:44, the SEA DWELLER was moored in Ceuta. The ship's engine room was partially flooded, but no losses were identified from the fuel, lubricant or other tanks.

At 06:00, after completing the mooring operation, the crew again checked the levels in the tanks. They confirmed that water had entered the number 5 starboard ballast tank, the starboard diesel tank and that the engine room was partially flooded.

Figure 8. Vessel moored in Ceuta after running aground.

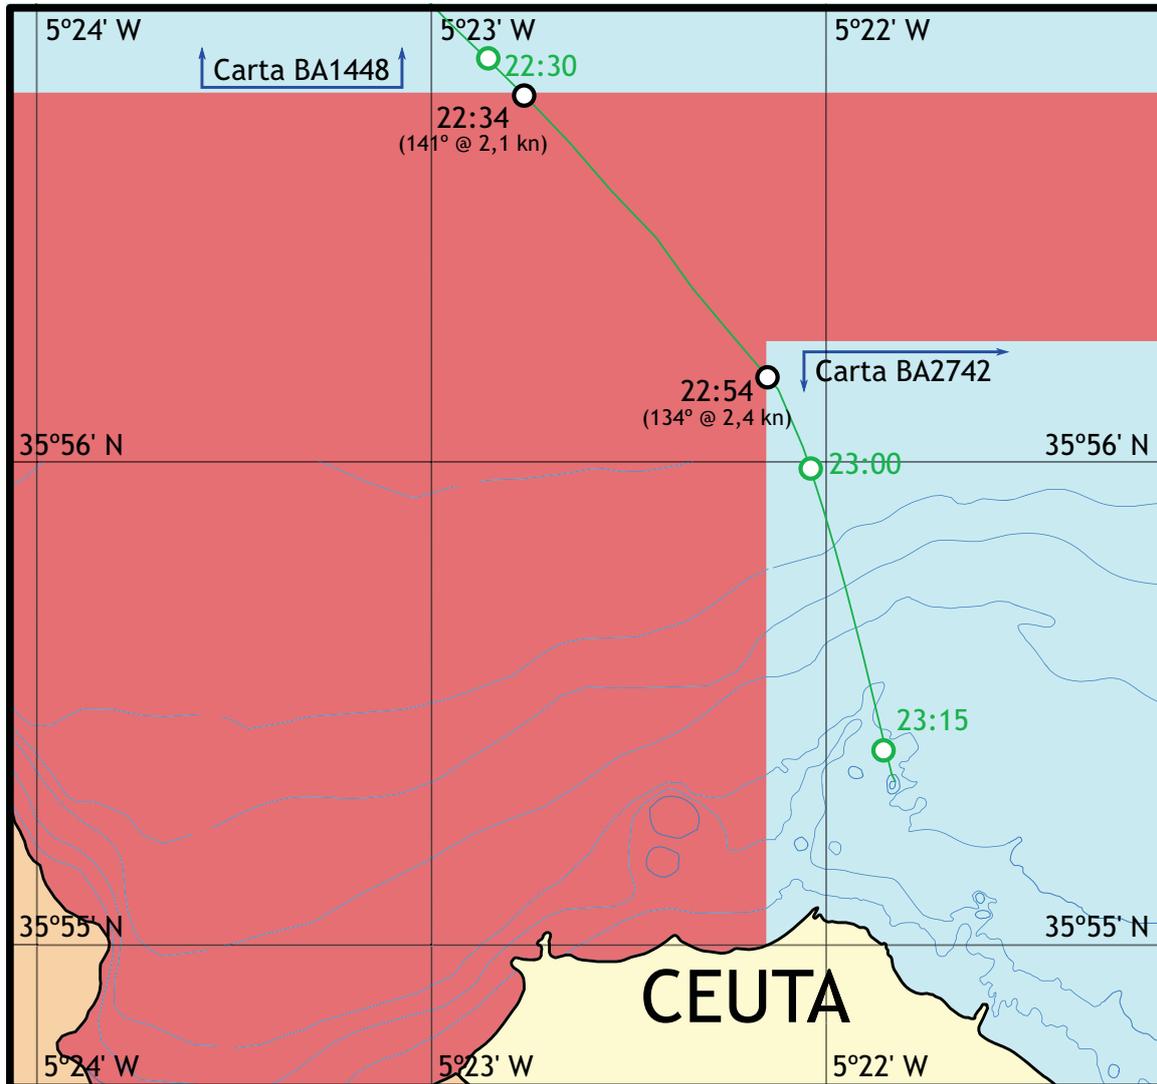
As Tabla 6 shows, the two detailed charts do not overlap and leave a small strip that is not covered by either. The width of this strip is approximately half a nautical mile in a north-south direction, see Figure 12.

Figure 12. Coverage of the nautical charts.

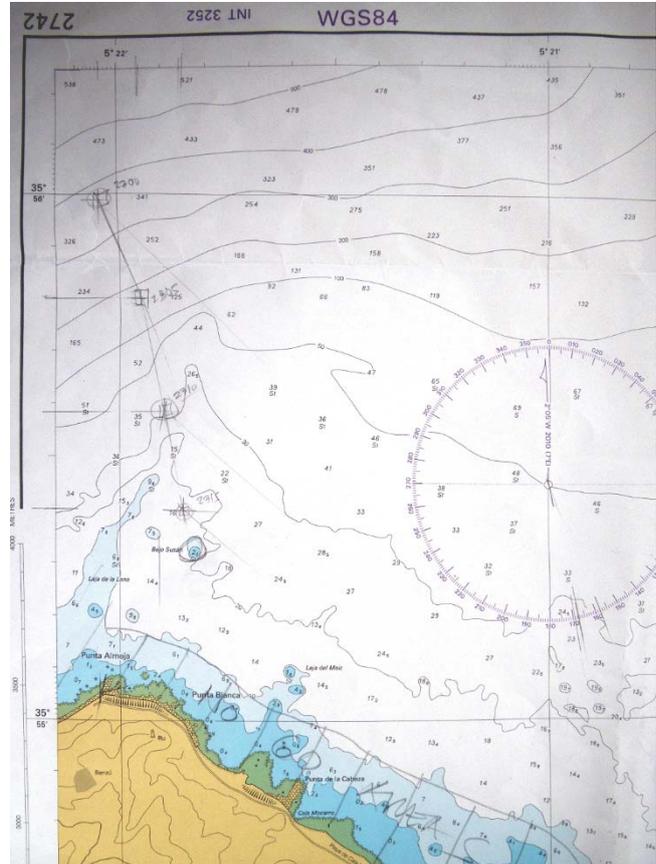
According to the crew's statements, the second officer was taking positions from the GPS received and plotting them on the paper chart, as shown in Figure 13. The captain was seeking to shelter the ship along the coast to protect it from the bad weather conditions. Despite being aware of their proximity to the coast and labeling an area on the chart to keep away from, it was not until two minutes before the accident that they noticed the existence of shoals just ahead of them. At that point, they still had 32 m under the keel. The captain ordered full port turn.

Figure 13. Detail of shoals on chart 2742.

Given the bad weather conditions, this action only managed to keep the bow from striking the shoal, but not the stern. The starboard part of the ship, from the midpoint to the stern, impacted the Susán shoal, causing considerable damage.
