# Technical report IN-005/2021

Incident on 21 February 2021 involving a CESSNA 525 aircraft operated by ProAir Aviation GmbH, registration D-IPOD, at A Coruña Airport (Spain)

### IN-005/2021

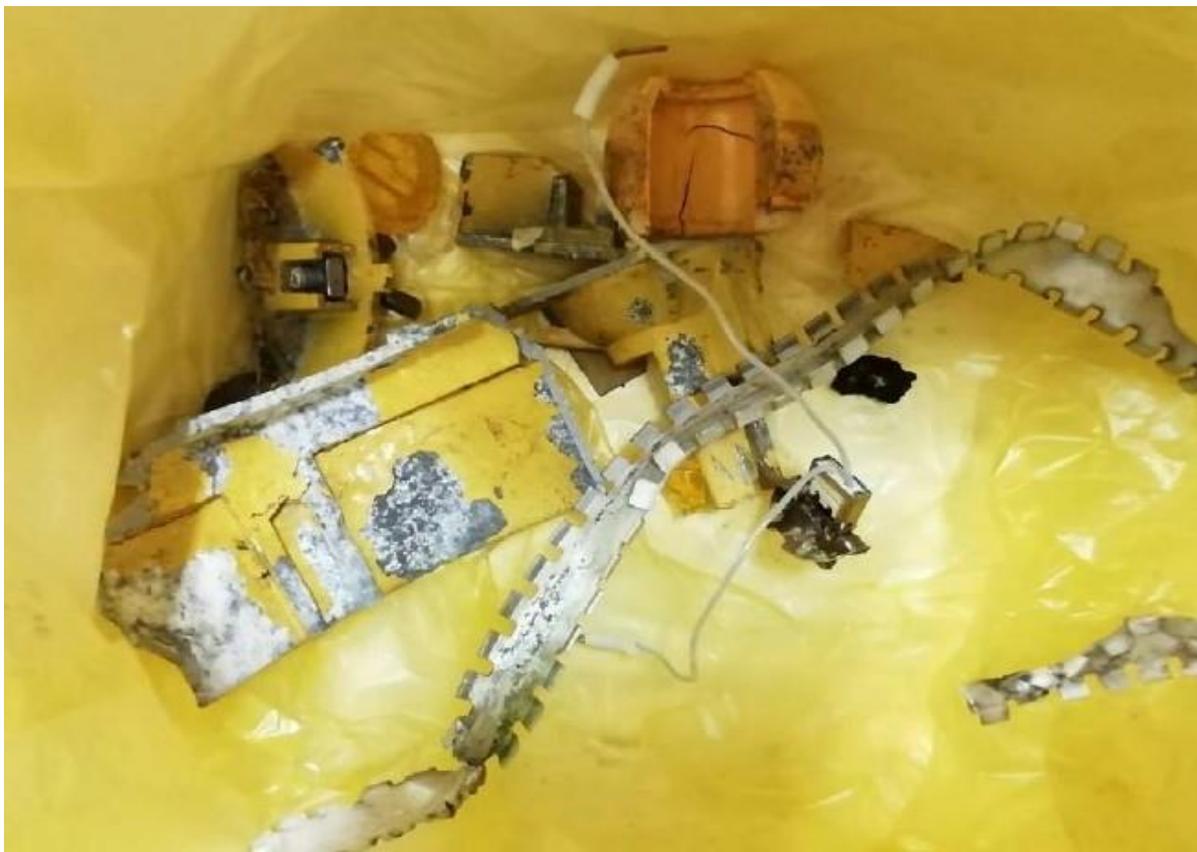
Two runway edge lights on the west side were left broken and unserviceable, with debris, such as pieces of steel and small and medium-sized pieces of glass scattered over a large area of the runway. Small pieces of glass were also found along the edge of the runway, which was cleaned with a pressure hose.

Photograph 4: FOD found on the runway

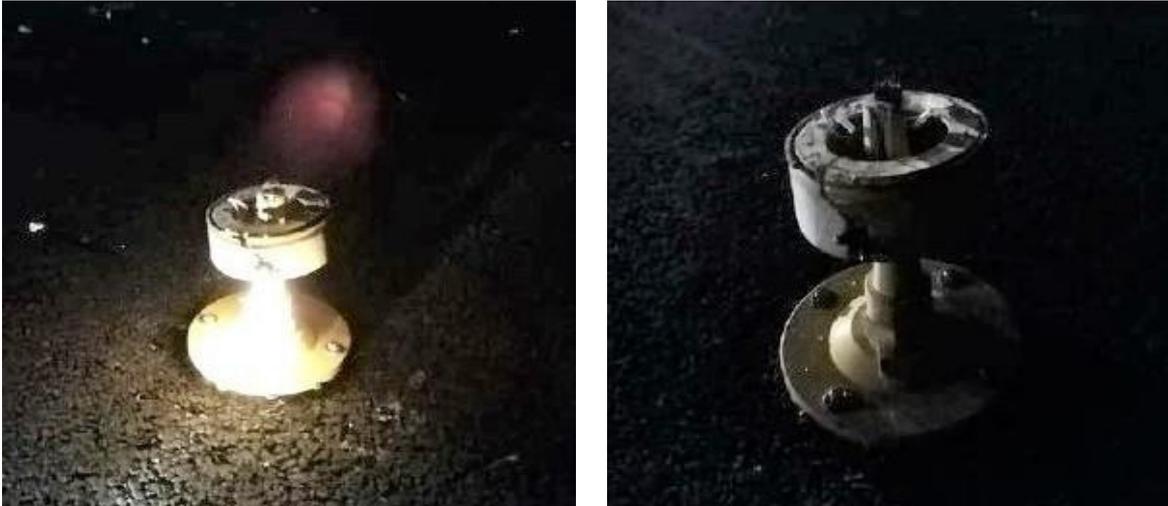
The TOAM personnel<sup>2</sup> who inspected the runway after the crew notified the tower found debris from two broken lights. The pieces came from two raised white/yellow lights on the edge of runway 21, at positions 83A and 85B.

Photograph 5: Damaged edge lights

- By 21:21 UTC, all the tasks had been completed, and the edge lights had been replaced.

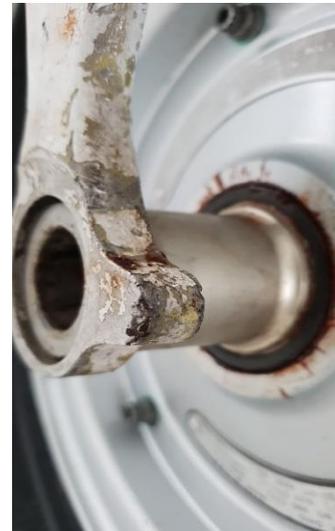
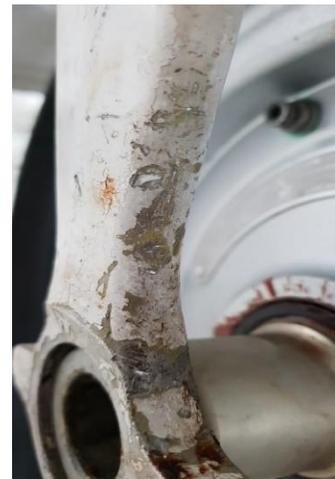
The damage reported by the aircraft operator was minor and restricted to scratches and small notches on the outer arm of the nose gear fork.

Right - Photograph 6. Damage to the nose wheel fork

The minor impacts and scratches on the outer metal arm of the fork and the remains of the broken lights are consistent with the crew's statements and with the nose gear impacting runway edge lights 83A and 85B, located approximately halfway along the runway, during rotation.

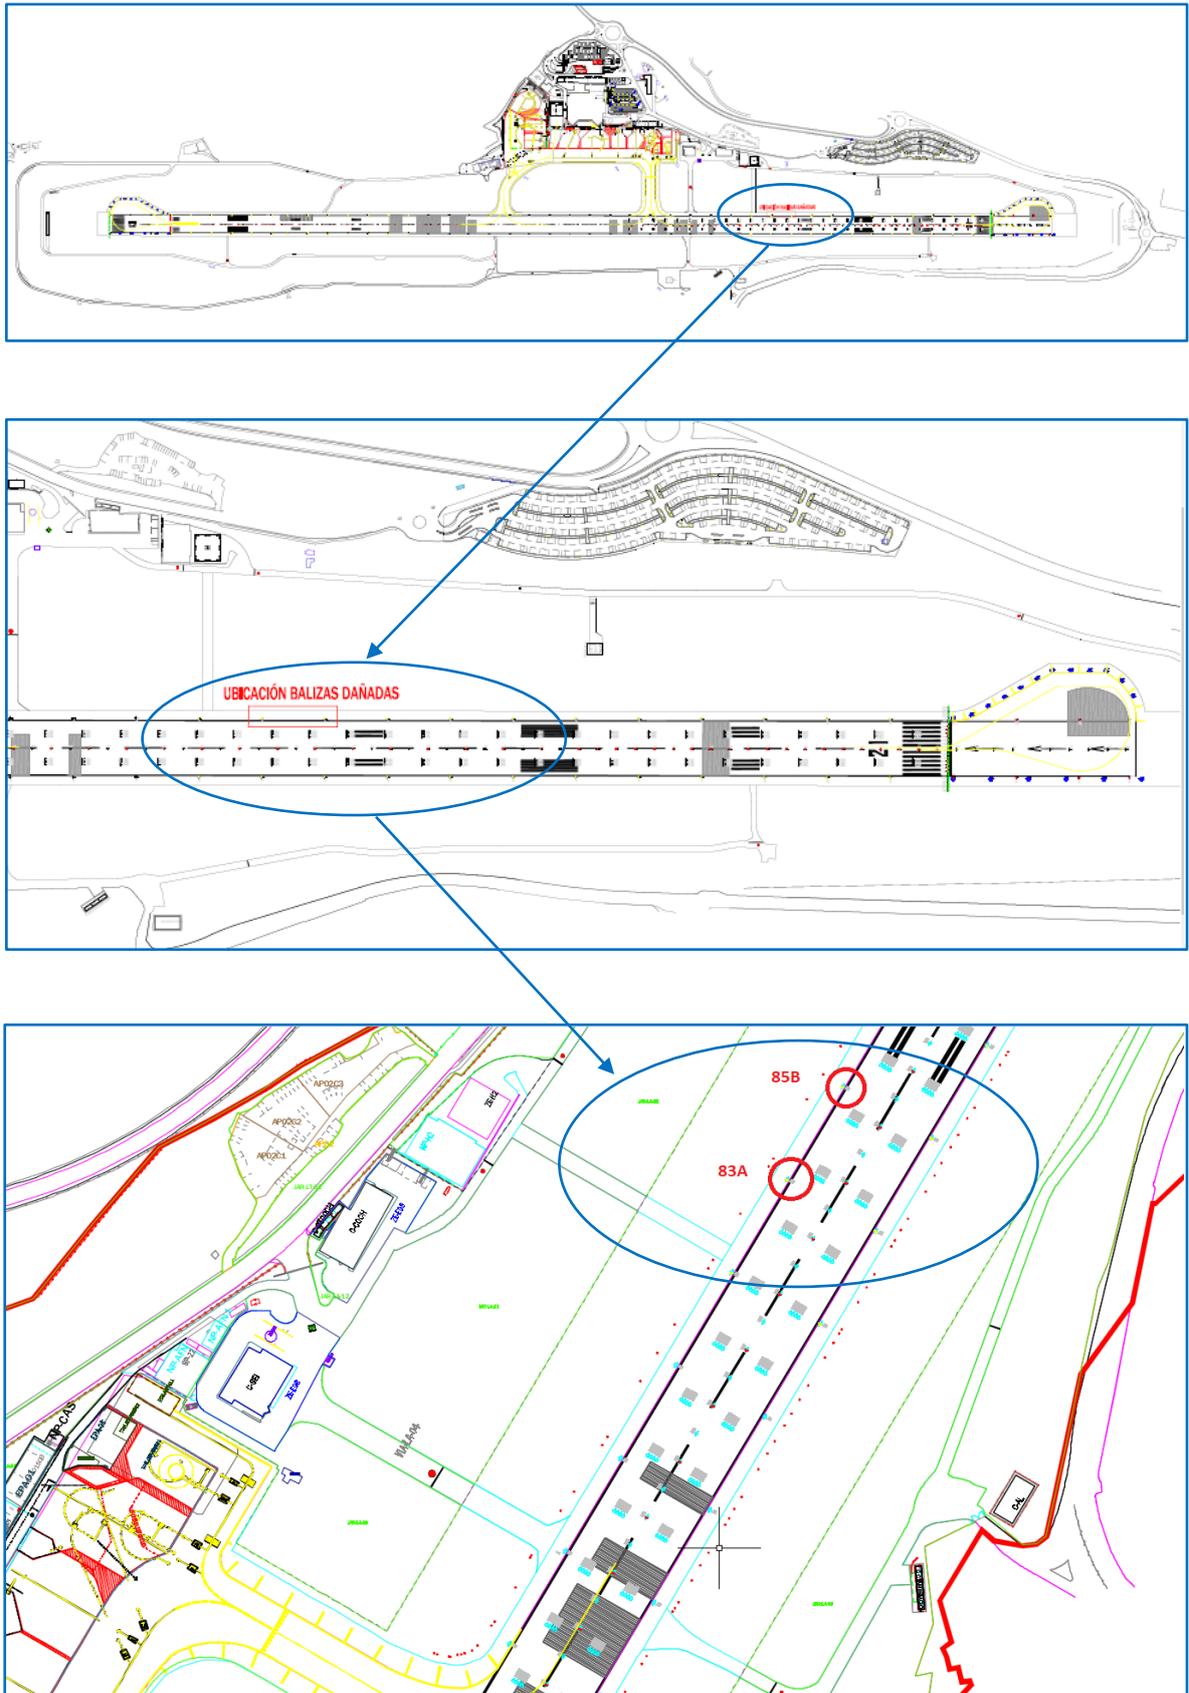
Figure 7. Location of the damaged lights
