**COMISIÓN DE  
INVESTIGACIÓN  
DE ACCIDENTES  
E INCIDENTES DE  
AVIACIÓN CIVIL**

## Report IN-006/2020

Accident involving a Boeing 767-375ER aircraft operated by Air Canada, registration C-GHOZ, at Madrid-Adolfo Suárez Airport (Madrid) on 3 February 2020

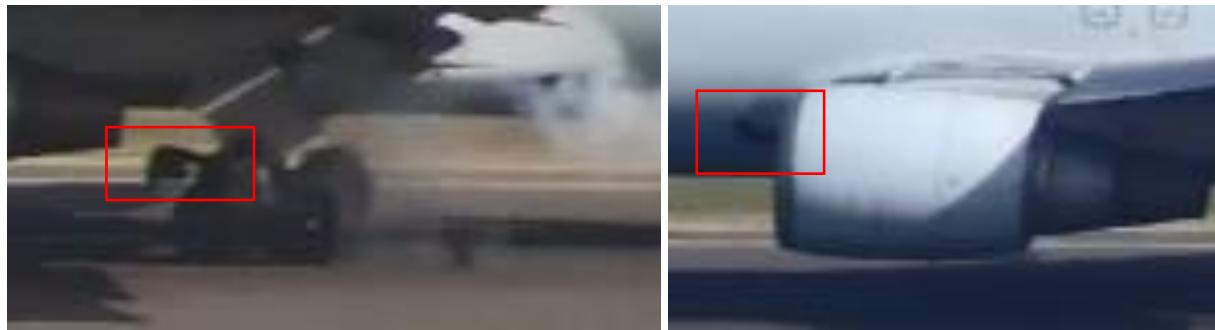
On Monday, 3 February 2020, the Boeing 767-375 aircraft, registration C-GHOZ, operated by Air Canada with flight number ACA837, departed from Madrid-Adolfo Suárez Airport (Spain) destined for Toronto Pearson Airport. (Canada). At 14:58:03, two seconds before lift off, the wheel number 5 (the left rear wheel on the left main landing gear) experienced a tyre burst and thrown tread. During the incident, several tyre fragments were ingested by the left engine (number 1), causing internal damage.

Figure 2. Tyre number 5 piece and ingestion by the engine (14:58:03, t=+0 s)

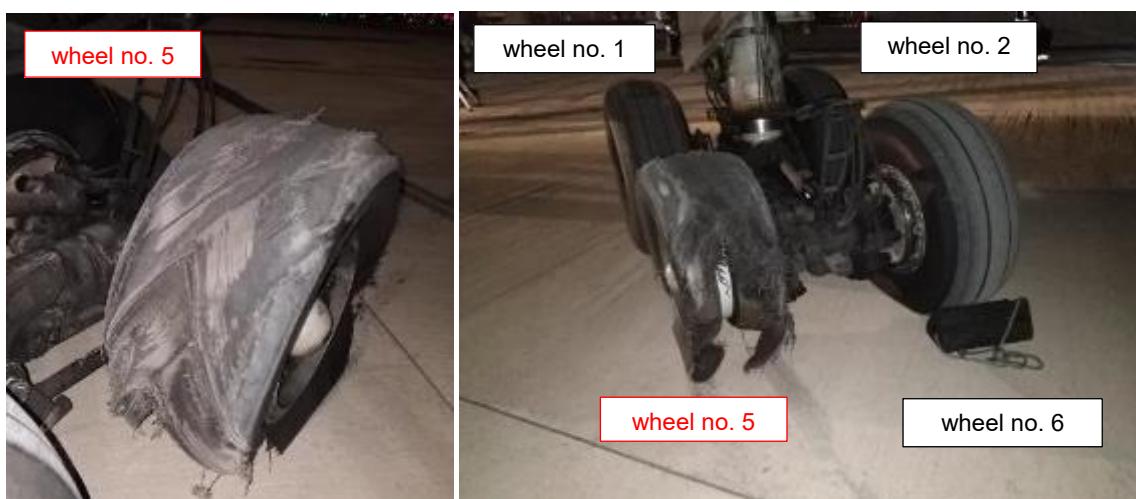
Figure 5. Left main landing gear (seen from behind) after the landing

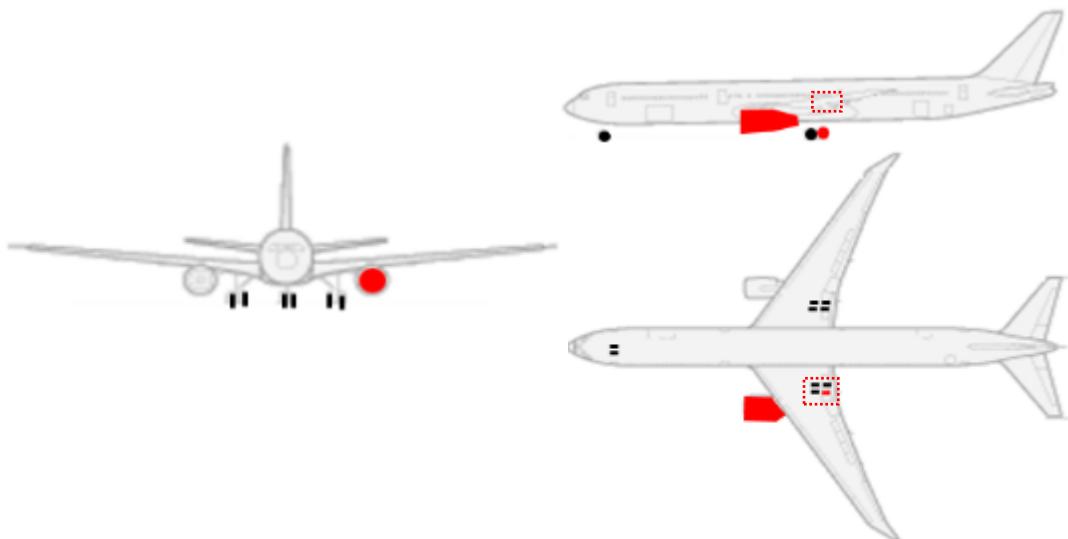
The aircraft sustained significant damage to the left main gear (wheel number 5, panel and tilt sensor) and left engine (engine interior and exterior fairings). The fairing of flap number 3 and various panels located above the left main gear sustained minor impacts.

Figure 6. Damage to the aircraft

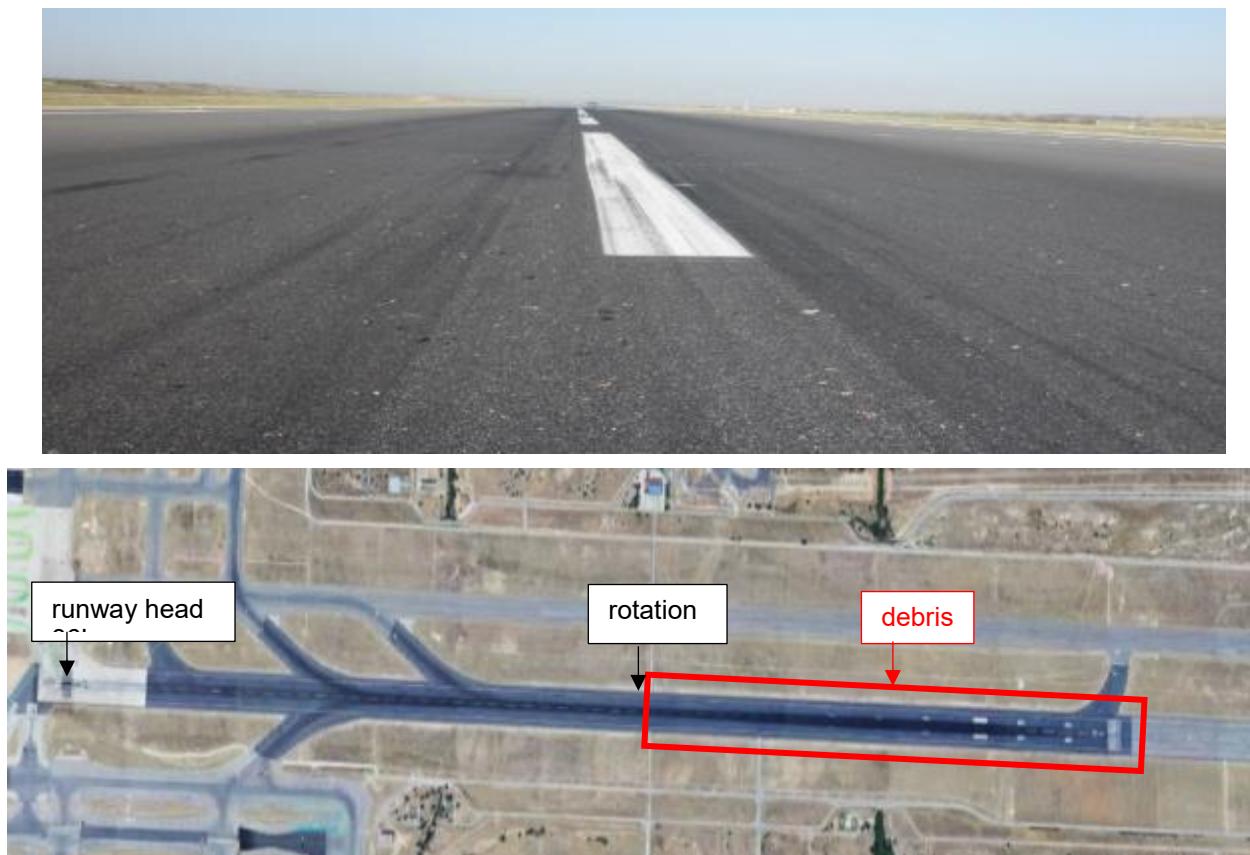
The debris was scattered over approximately 1400 m of the runway, along the area shown in figure 10, and consisted of:

- a multitude of wheel fragments of different sizes: the smallest measuring a few centimetres in thickness and length and the largest being over a metre in length.
- material (honeycomb) that was later identified as belonging to the engine cowling (nose cowl inlet).

Figure 10. Dispersion of debris on runway 36L

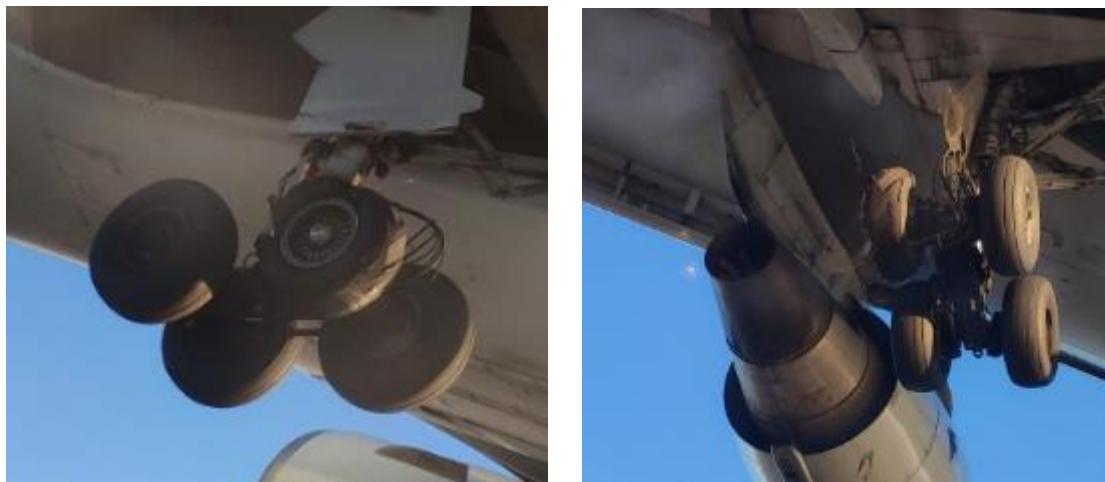
The inspection, conducted between 17:49 and 18:03, required the ACA's gear and flaps to be extended. The military aircraft positioned itself under both sides of the ACA aircraft and inspected the main and nose landing gear. He confirmed the damage to one of the left-landing-gear wheels and that the remaining three left wheels and the right and forward landing gear appeared to be fine. The EF-18A pilot took several photos, two of which are shown in figure 12. After completing the inspection, the landing gear was retracted and locked correctly.

Figure 12. Photographs taken by EF-18A

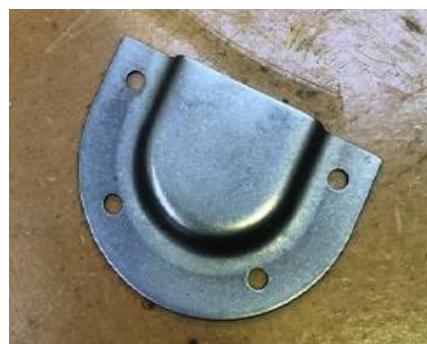
Of all the pieces collected, only one was identified as not belonging to the aircraft. This piece, shown in the image, was metallic and measured 45\*35\*6 mm. Its condition was unaltered and shiny, ruling out its involvement in the event.

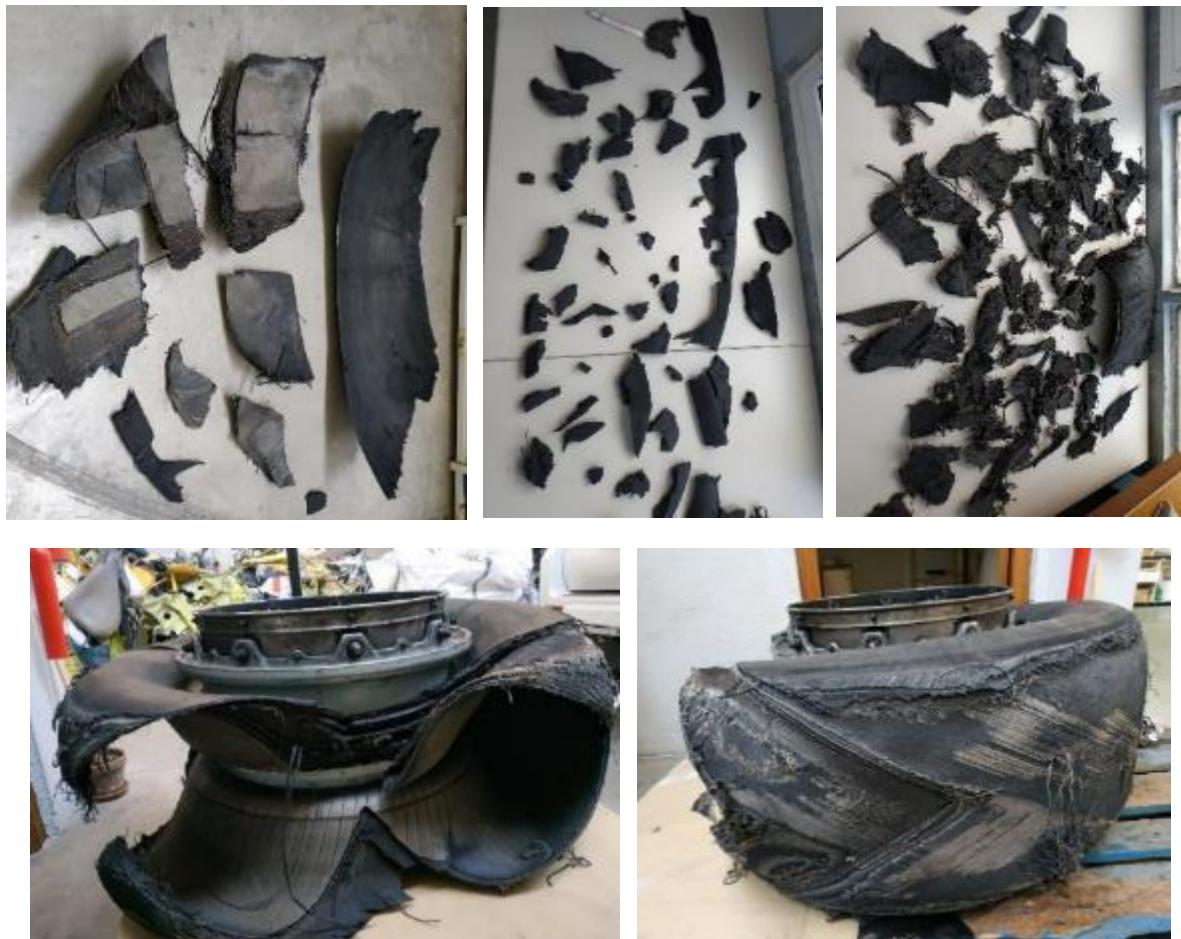
The sizes of the recovered fragments varied: the largest was 132x40 cm, and the smallest was 1x1 cm. The thickness of the pieces also varied: some were made up of just the tread or casing, and others contained the entire tyre section. Some of the fragments had cuts that would have been caused by the engine blades. All the recovered items were preserved for further investigation (section 1.16). The remaining wheels on the left main gear (numbers 1, 2 and 6) were fully intact.

Figure 13. Remains of wheel no. 5

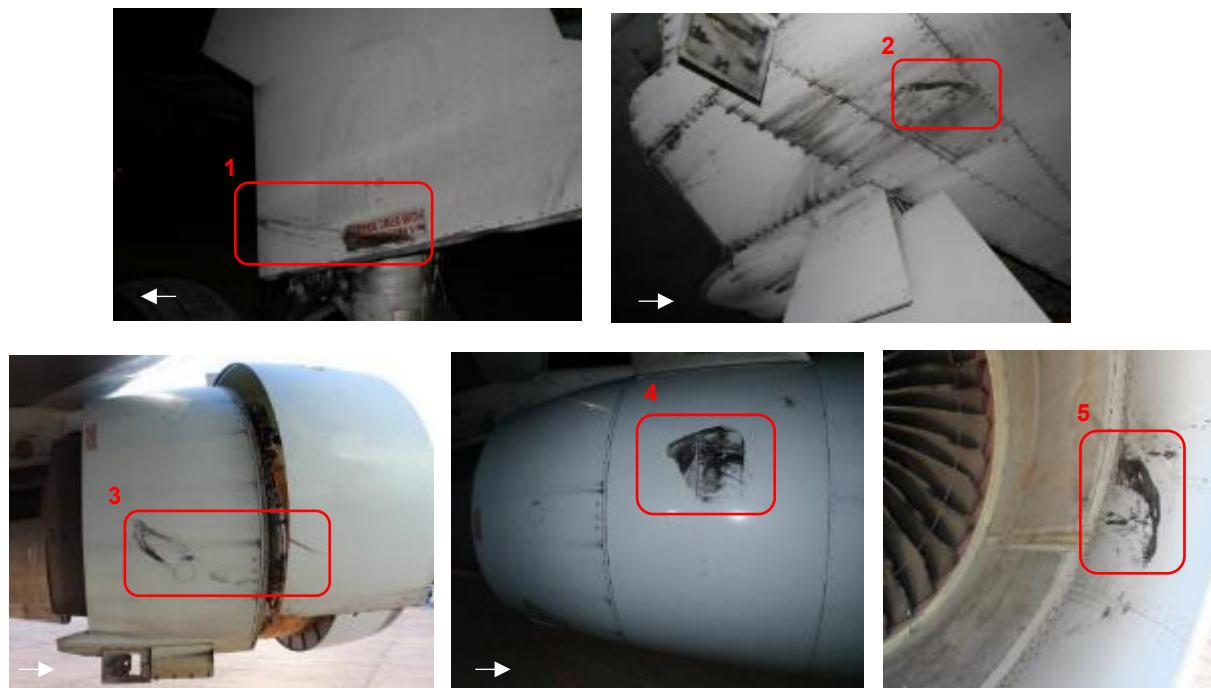
1. left main gear panel
2. underside of the left wing
3. right panel of the thrust reverse
4. right fan cowl
5. nose cowl inlet

Figure 14. Rubber marks (travelling in the direction of the white arrow: towards the front of the aircraft)

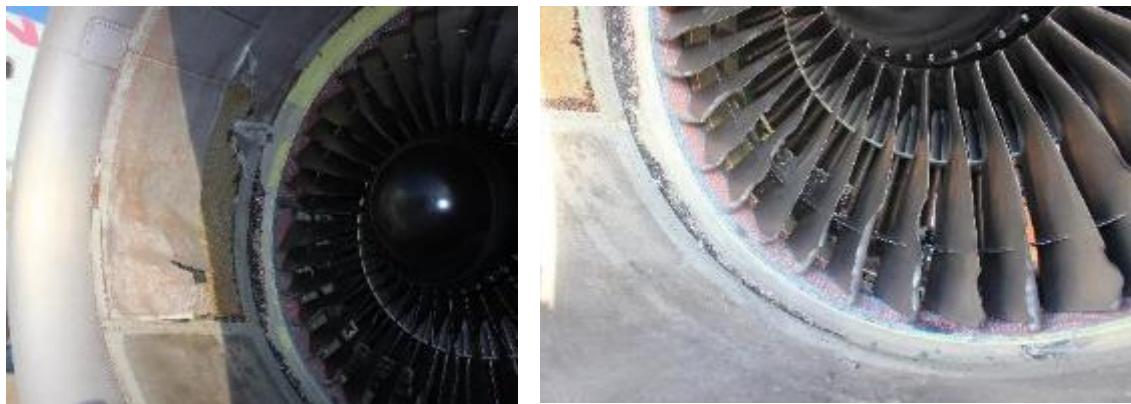
- Fan/booster module: the fan and fan track were significantly damaged, with the coating material having disappeared from the fan inlet and damage all the fan blades. The 2nd stage blades of the low-pressure compressor (LPC) displayed minor scratches and traces of ingested material. The 5th stage LPC blades displayed markings indicating the displacement of ingested material, and one of them had a dent on the trailing edge. Further remains of ingested material were found in the booster, and there was minor damage (minor tip curl) to some blades.

Figure 15. Damage to the fan

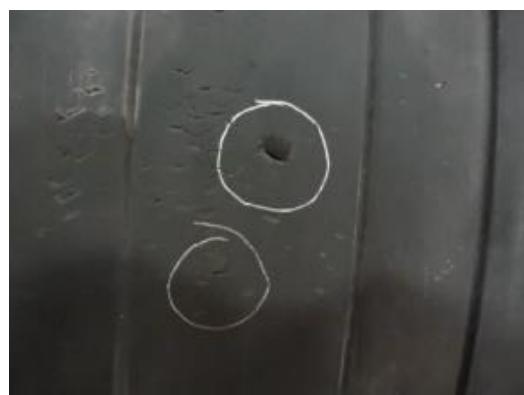
It was reviewed the history of the left main gear wheels, identifying that wheel number 6 had been replaced on 30/01/2020, three days before the event. It was removed due to the presence of two cuts. To determine whether these cuts could have also affected wheel number 5, it was retrieved the information on wheel number 6. However, due to the size of the cuts (approximately 1 cm), it was ruled out the possibility that they could have affected wheel no.5.

Figure 16. Cuts on wheel number 6 (paired with no. 5), produced on 30/01/2020

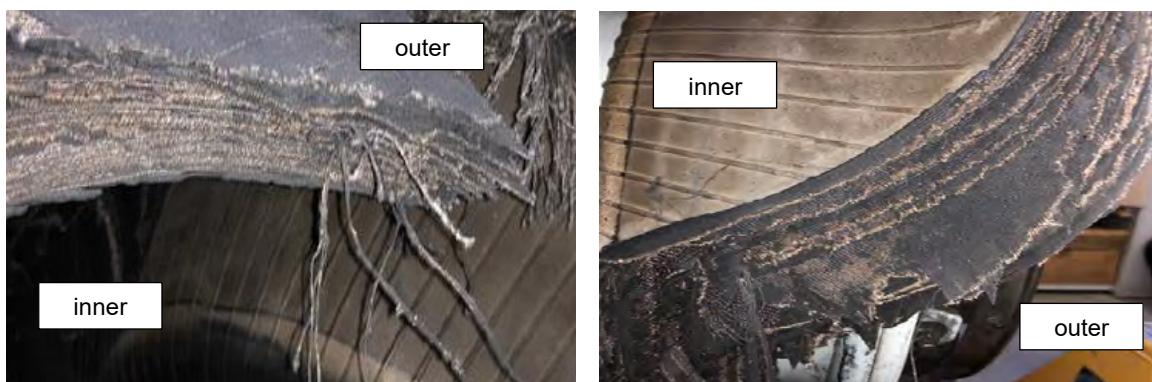
- The fragments belonging to sector 7 displayed direct ruptures in all the plies. In these breakages, all the ruptures were perpendicular to the tyre surface.
- The fragments belonging to sectors 4, 5, 6, 8, 9, 10, 11 and 12 displayed tapered ruptures. In these breakages, the plies had ruptured in a staggered and gradual way, showing a progression from ply to ply.

Figure 18. Direct ruptures (left) and tapered (right) in the casing of tyre no. 5

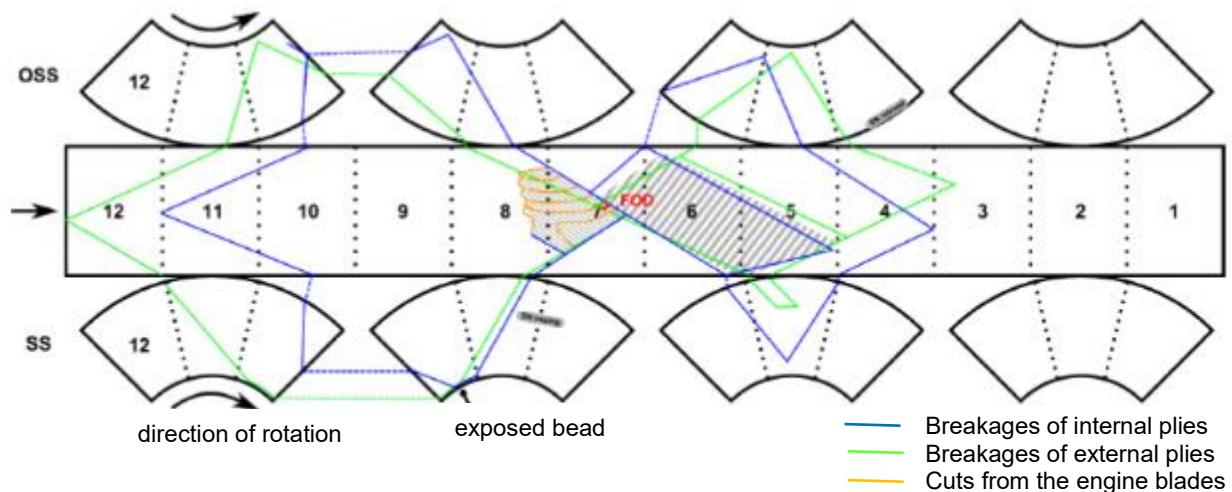
The following graphic representation of the fragments' rupture layers (internal in blue and external in green, in figure 20) and their position on the tyre, shows that in the direct rupture zones, the fracture lines between the pieces were closer together, whereas in the staggered fracture zones, the fracture lines were separated.

Figure 19. Reconstruction of tyre number 5

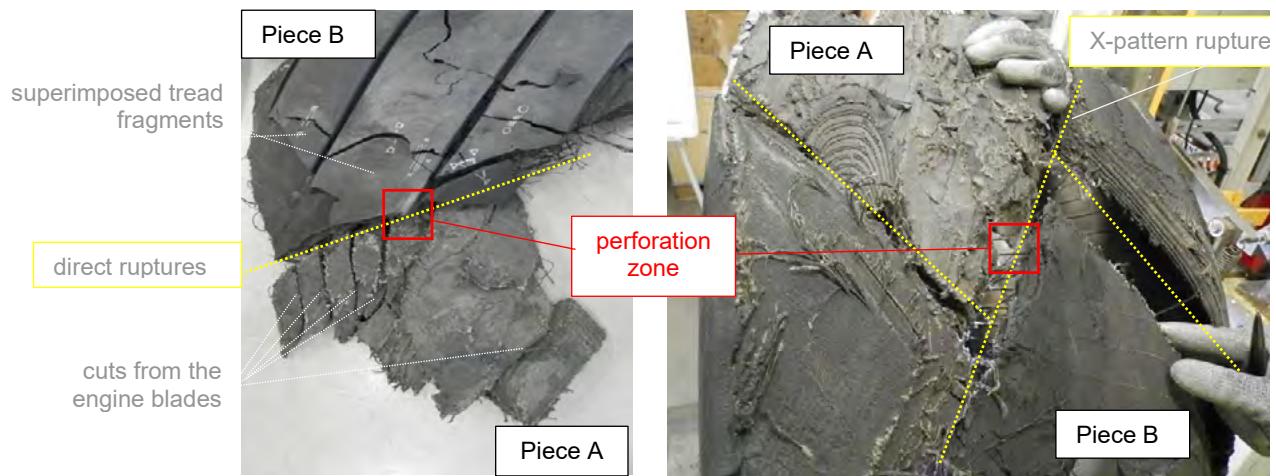
- Piece A: belonged to sector 7 and a small portion of sector 8. It was made up of eight small fragments with very sharp cuts in a different direction to those that followed the path of the plies. These eight pieces fitted together to form a single piece that had been ingested by the engine and cut by its blades.
- Piece B: belonged to sectors 7, 6 and a small portion of 5. This piece had no cuts and hadn't been ingested by the engine. Associated with piece B were four tread fragments, which have been superimposed over piece B in the left-hand image in figure 21.

Figure 20. Pieces A and B from sector 7 viewed from the exterior

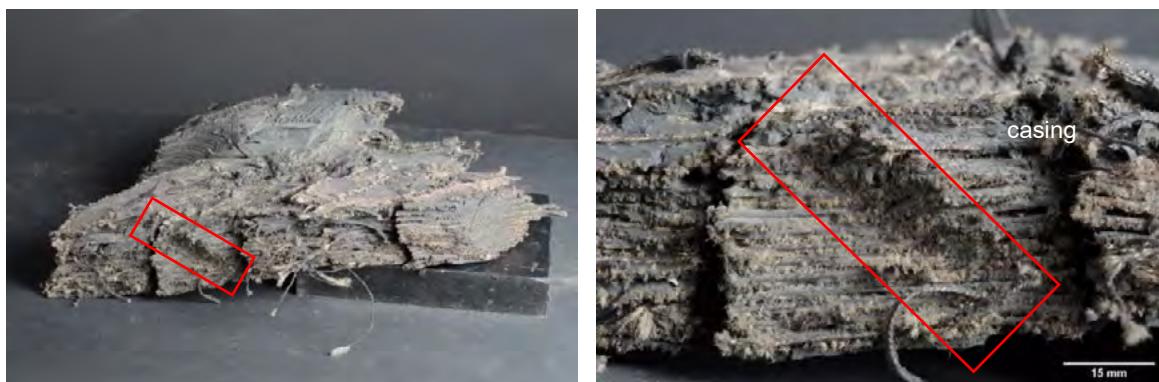
A detailed observation of the pieces revealed perforation marks in the tread and almost all the plies of the tyre casing around the join between pieces A and B. These perforation marks were found in pieces A and B and in one of the tread fragments that had separated from part B.

Figure 21. Perforation in piece A (casing)

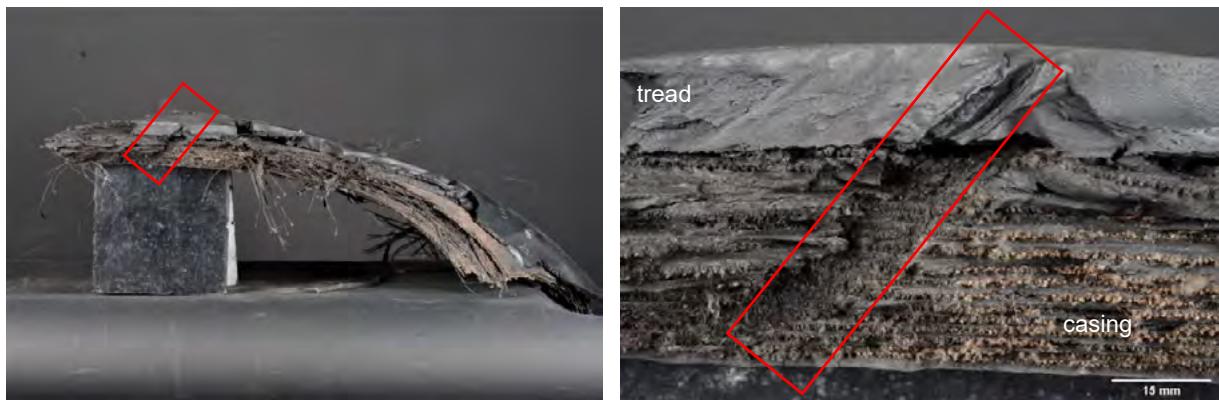
Figure 22. Perforation in piece B (casing and tread)

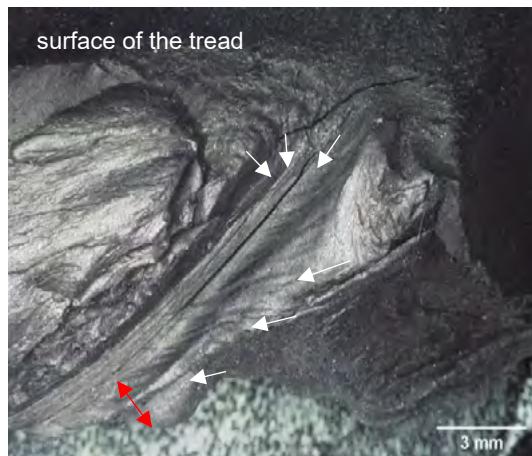
Figure 23. Deformation of the material in the tread of piece B
