# Technical report

## **IN-006/2021**

Incident on 19 February 2021 involving an ATR 72-212 aircraft operated by Swiftair, registration EC-LYJ, at Palma de Mallorca Airport (Balearic Islands)

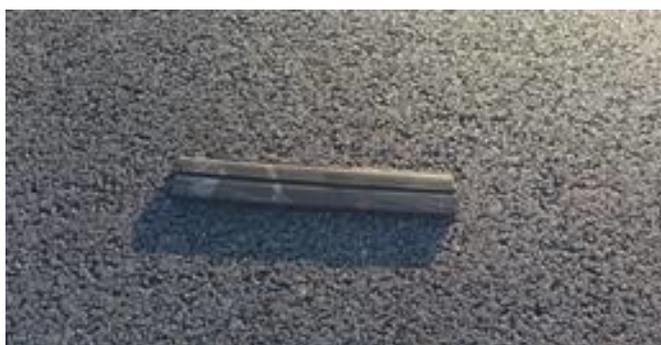
According to the Wildlife Control Service, the similarity between the tyre colour and the asphalt made it difficult for the marshalls to spot the debris on the runway at night.

Fig.1.- Illustration showing the contrast between the FOD and asphalt

REC08/21. It is recommended that AENA, as the provider of the Runway and Apron Service at Palma de Mallorca Airport, study the possibility of improving the detection of FOD on the runway.

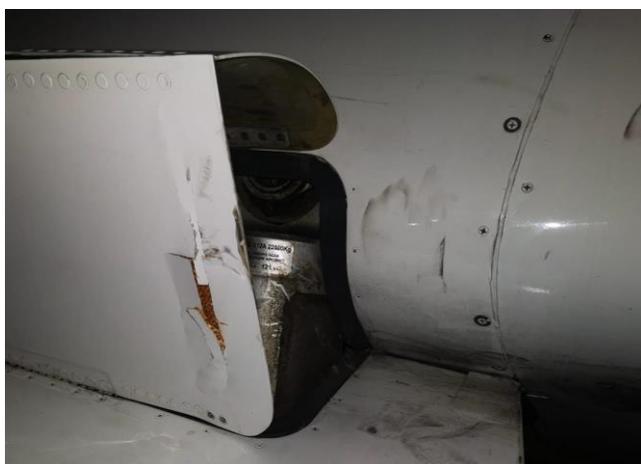
The aircraft landed normally and managed to taxi to its final parking position. Damage was identified to the left main landing gear, a flexible hose from the main landing gear actuator, the wheel-speed transfer assembly, the left main landing gear folding door, and an inspection panel.

Fig.2.- Landing gear folding door

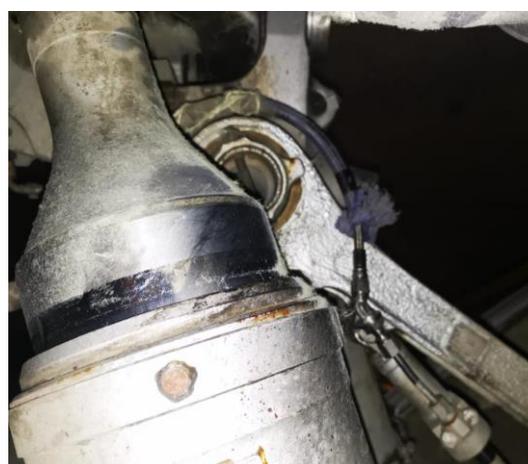
Fig.3.- Actuator flexible hose

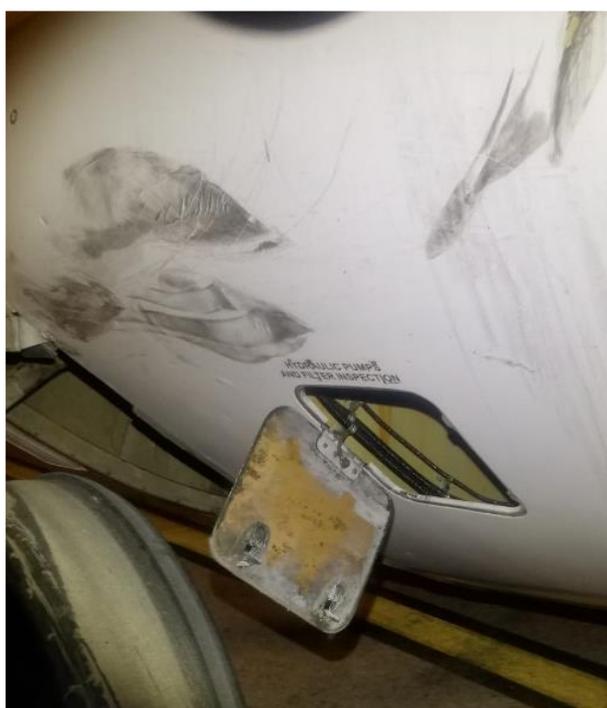
Fig.4.- Inspection panel y rubber marks

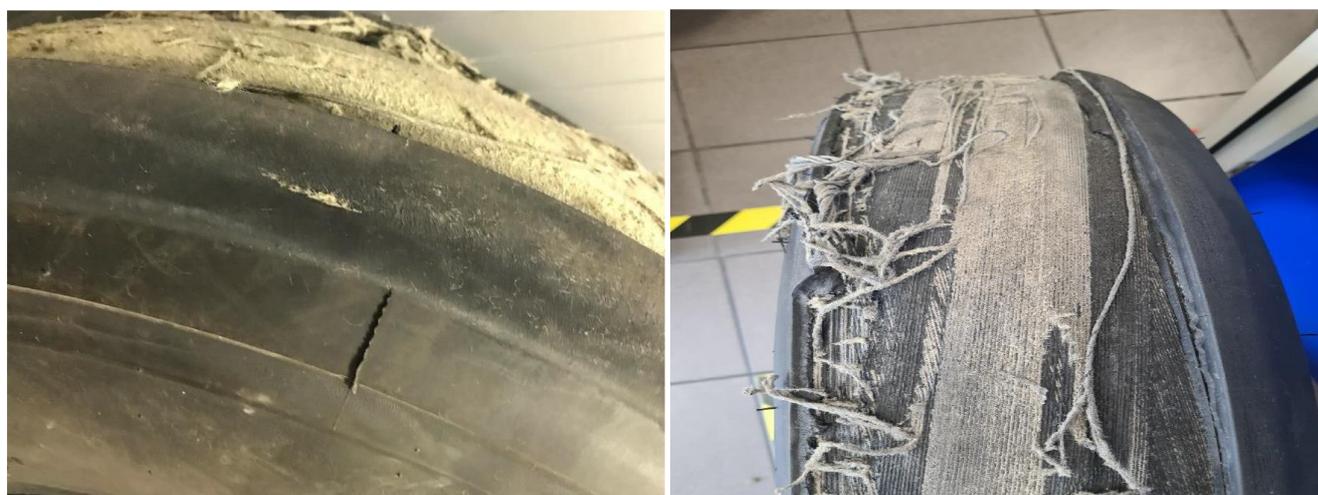
Wheel no. 2 was still attached to the landing gear frame. It had complete tread loss and slight wear on one sector of the serial number side. In addition, frayed cords were observed along the entirety of its circumference.

**Fig. 5.- Wreckage of wheel number 2**

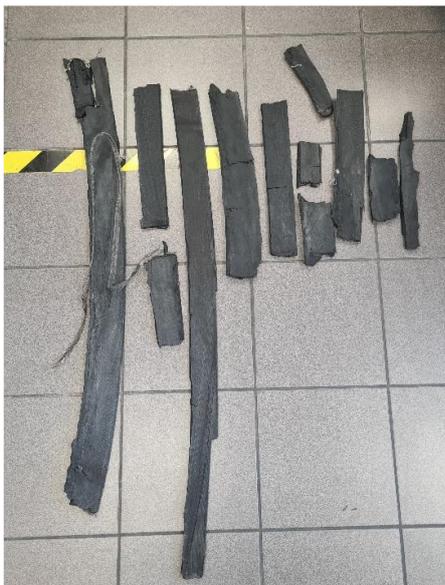
On 20 February 2021 at 8:15 h, an additional unscheduled inspection was carried out on runway 24R at Palma de Mallorca Airport, as a result of which approximately 30% to 40% of the tyre tread was recovered. No non-wheel debris was collected.

Fig. 6.- Recovered fragments of tyre tread

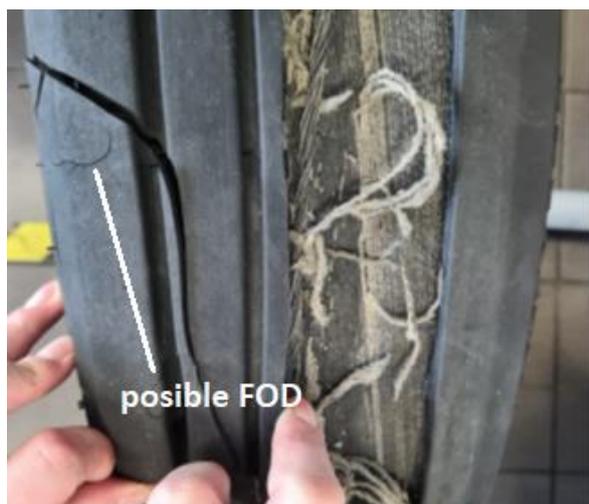
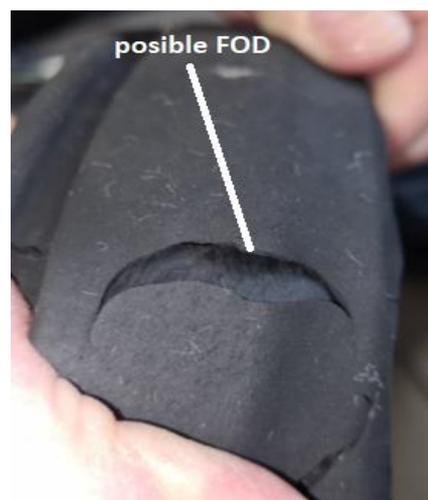
Once the recovered tread fragments had been reconstructed, a cut whose origin is compatible with the presence of Foreign Object Damage (FOD) was identified in sector 4 on the side of the tyre without the serial number.

The probable cause of the incident is considered to be the perforation of tyre number 2 on the left main gear by an external object (FOD), which caused the tread to detach.

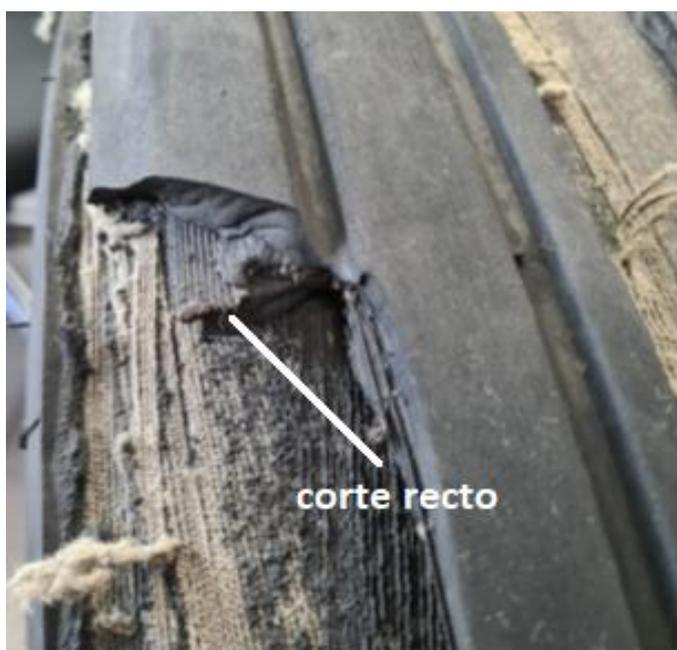
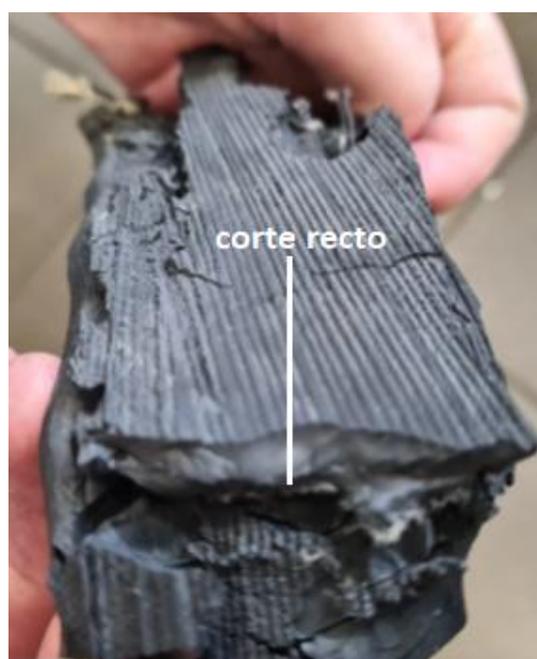
A straight one-layer cut was visible on the inner-facing part of this area, which could have been made by a pointed object.

Based on these observations, we can establish that the tyre probably rolled over a foreign object that sliced through the tread's reinforcing layer in sector 4 and that the resultant centrifugal and radial forces caused its subsequent detachment.
