Report IN-008/2019

Incident involving a Piper
PA-34-200T, registration EC-EPR,
at the Córdoba Airport on 12
February 2019

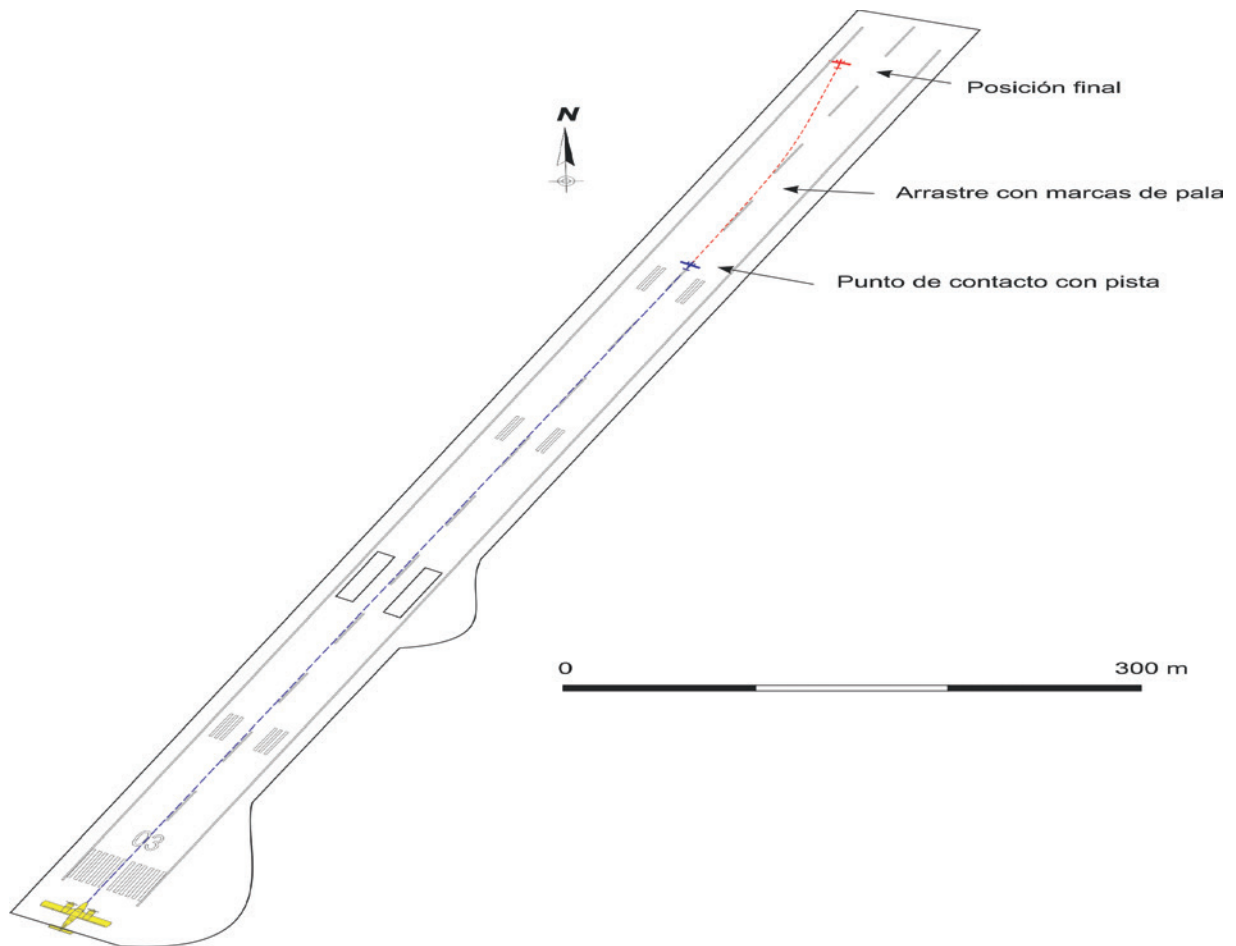
Fig. 1 – Diagram of path taken by aircraft

The aircraft touched down on the runway centerline some 600 m away from the threshold. After this point, it skidded about 200 m, leaving contact marks on the asphalt,

made by the underside of the fuselage, as well as impact marks left by the tips of the propeller blades.

As it skidded, the aircraft deviated slightly to the left before coming to a stop inside the runway limits.

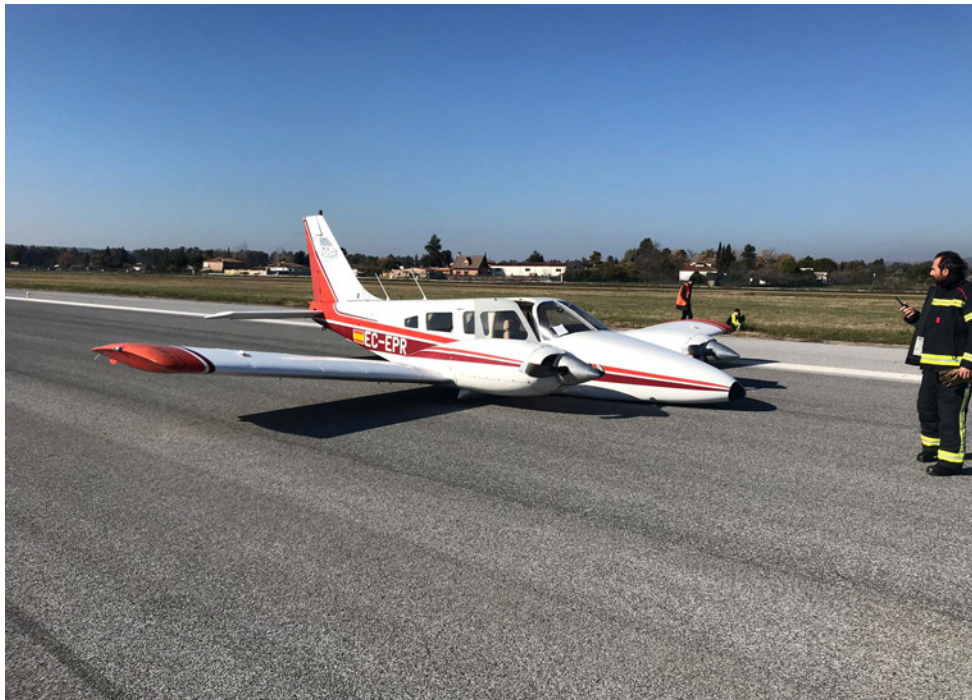
Fig. 2 – Condition of the aircraft

The aircraft sustained localized damage to the propeller and underside of the fuselage.

The aircraft sustained damage to its propeller and the underside of its fuselage.
