## IN-008/2019

Incident involving a Piper PA-34-200T, registration EC-EPR, at the Córdoba Airport on 12 February 2019.

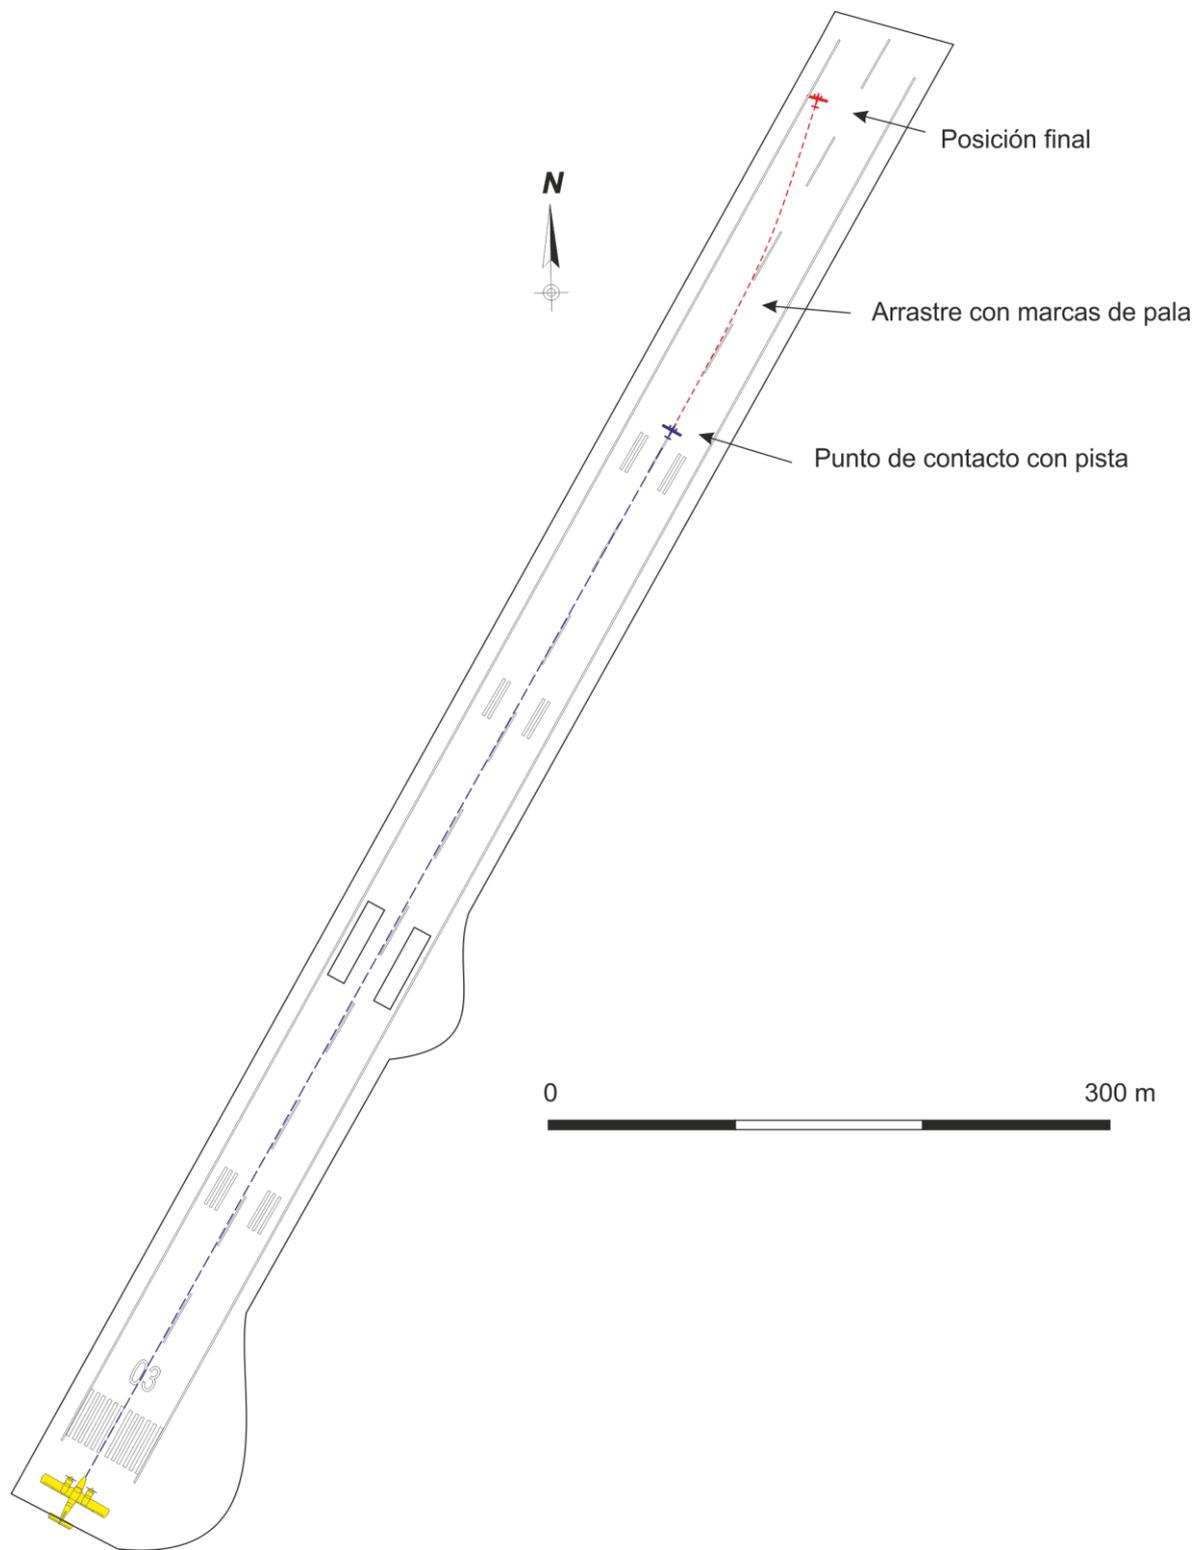
**Fig. 1 – Diagram of path taken by aircraft**

The aircraft touched down on the runway centerline some 600 m away from the threshold. After this point, it skidded about 200 m, leaving contact marks on the asphalt,

made by the underside of the fuselage, as well as impact marks left by the tips of the propeller blades.

As it skidded, the aircraft deviated slightly to the left before coming to a stop inside the runway limits.

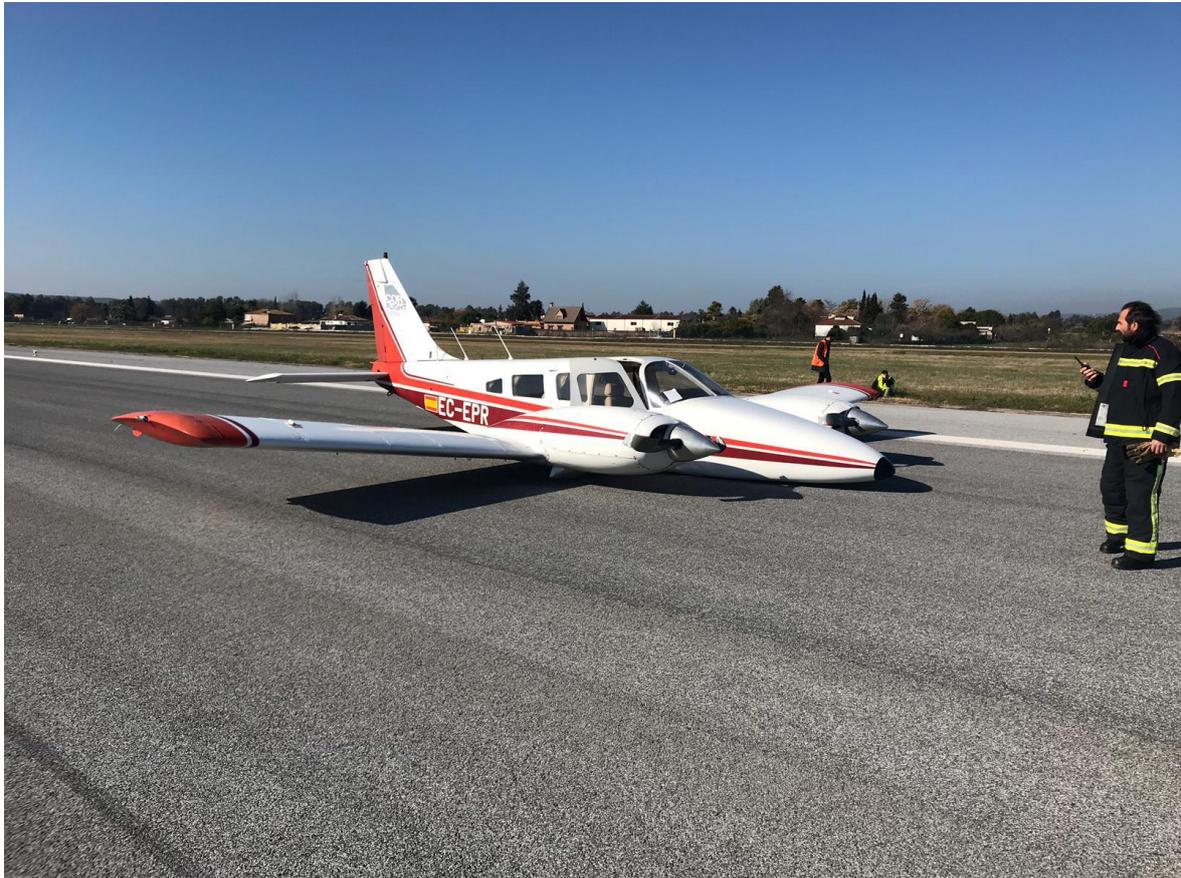
*Fig. 2 – Condition of the aircraft*

The aircraft sustained localized damage to the propeller and underside of the fuselage.

The aircraft sustained damage to its propeller and the underside of its fuselage.
