Report IN-011/2019

Incident involving a Tecnam
P2006T aircraft, registration
EC-LHB, in Torre de Claramunt
(Barcelona) on 1 March 2019

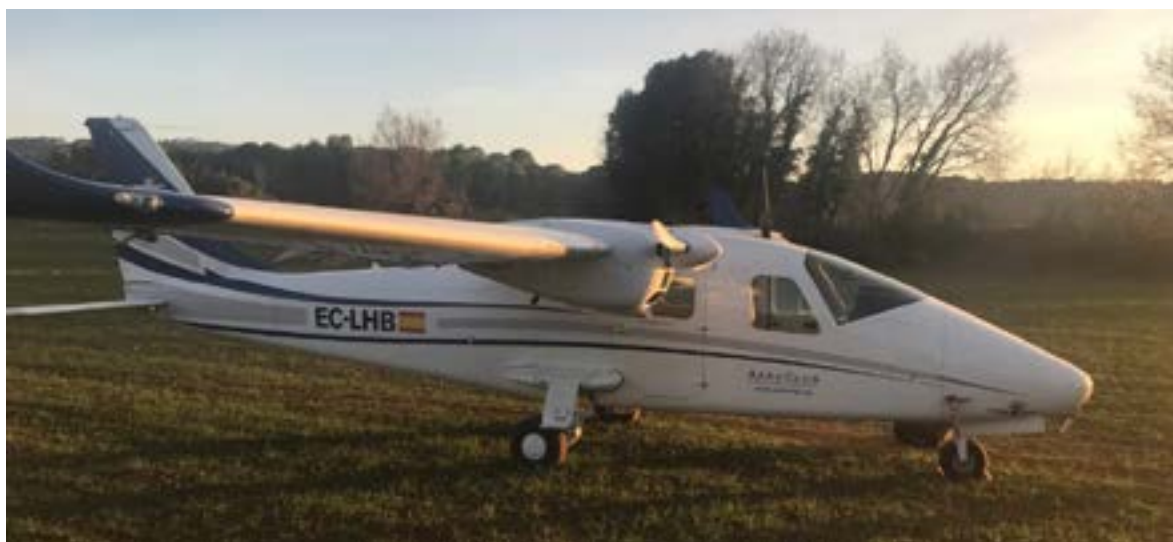
The landing took place in a crop field without further incident. Neither occupant was injured and the aircraft was not damaged.

Figure 1. Condition of the aircraft after the emergency landing

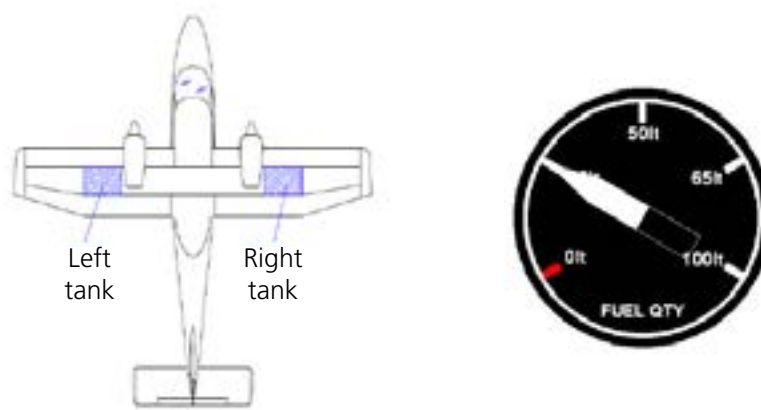
The aircraft can hold 200 l of fuel (between the two wing tanks, with a 100-l capacity each), of which 194.4 l is usable. The amount of fuel is shown on two analog gauges (one for each tank) located in the right panel in the cockpit. Each gauge has marks for 0-30-50-65-100 l.

Figure 2. Fuel tanks and gauge in the cockpit

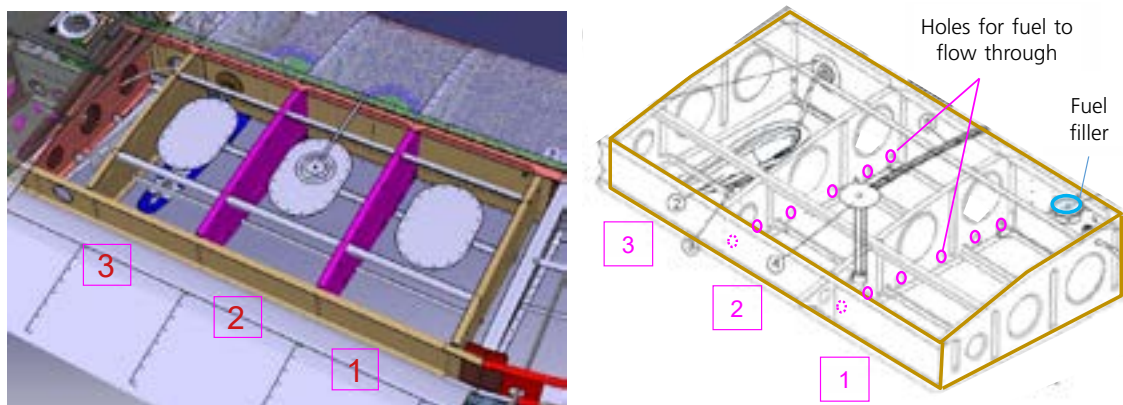
The fuel tanks (outlined in brown in Figure 5) are built into the aircraft's wings. Tecnam was asked for information on the internal structure of the tanks (Figure 5). There are two internal ribs (shown in pink) that divide the tank into three compartments (labeled here 1, 2 and 3 for reference). The fuel is pumped into compartment 1 through the fuel filler at a flow rate (deemed constant) of 1.83 l/sec. To allow fuel to flow from one compartment to another, there are six holes at the bottom of each rib. These are shown in Figure 5 right. For calculation purposes, each hole is assumed to be circular, with a radius of 1.1 cm.

Figure 5. Inside of the fuel tanks (right tank shown)

In order to determine if the six orifices restrict the fuel flow when the three compartments are filled, calculations were done involving the process of refueling the three compartments in series. The results of these calculations show that the compartments are filled simultaneously and that the orifices do not impose any restrictions on the refueling process.

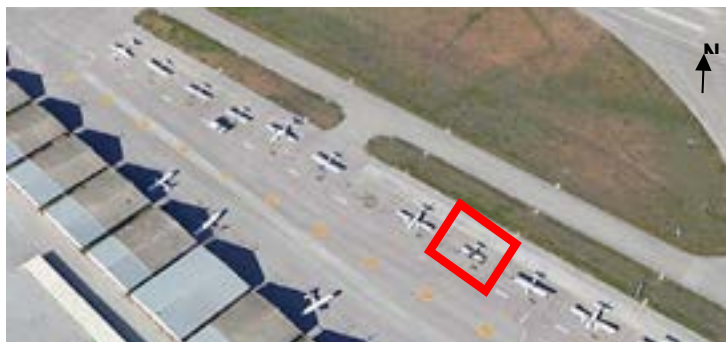
The parking stand where the aircraft was refueled before takeoff was number 209. At this stand, the aircraft is facing southwest (approximately 220°), according to information in the AIP.

Based on information provided by the Sabadell Airport (maps showing the inclination of the aprons), and considering the gear-down arrangement of this aircraft and assuming that the aircraft was properly parked during the refueling, the calculations show that the aircraft was leaning 2% to the left, meaning that with the aircraft parked in the expected position, the right wing is higher than the left⁷.

Figure 6. Parking stand 209
