Technical report

IN-034/2019

Incident involving a Boeing 787-9 aircraft with registration LN-LNI operated by Norwegian Air Shuttle Asa, and an AIRBUS - A319 aircraft with registration VP-BHJ operated by Siberia Airlines, on approach to runway 07L at Barcelona Airport (LEBL) on 07 July 2019.

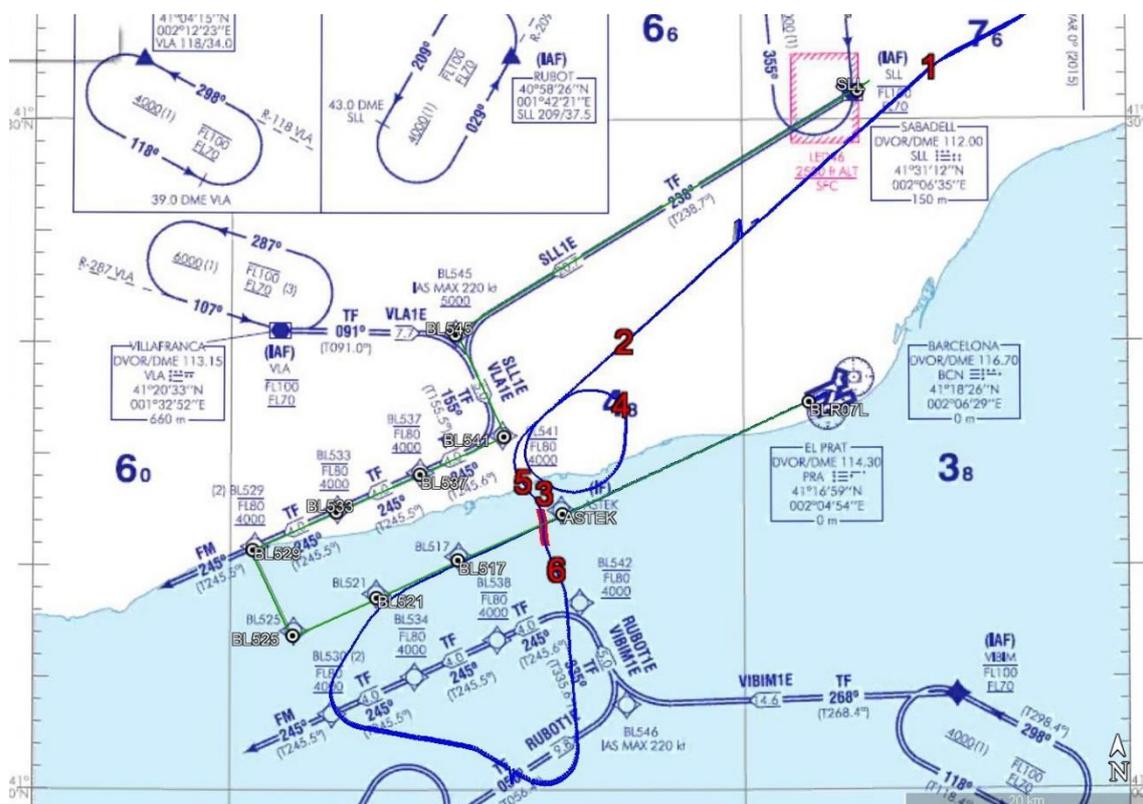
Figure 29; Trace of aircraft VP-BHJ and significant moments

Based on the records, we have drawn up a chronological description of the aircraft's operating modes at different points along its radar trace, which has been superimposed onto the Barcelona approach chart. Thus, the points marked in red in figure 29 are described below:

At 10:41:57 (point 6), the aircraft had climbed to 4,150 ft, and the autopilot had re-engaged; 10 seconds later, the TCAS alert was cleared.

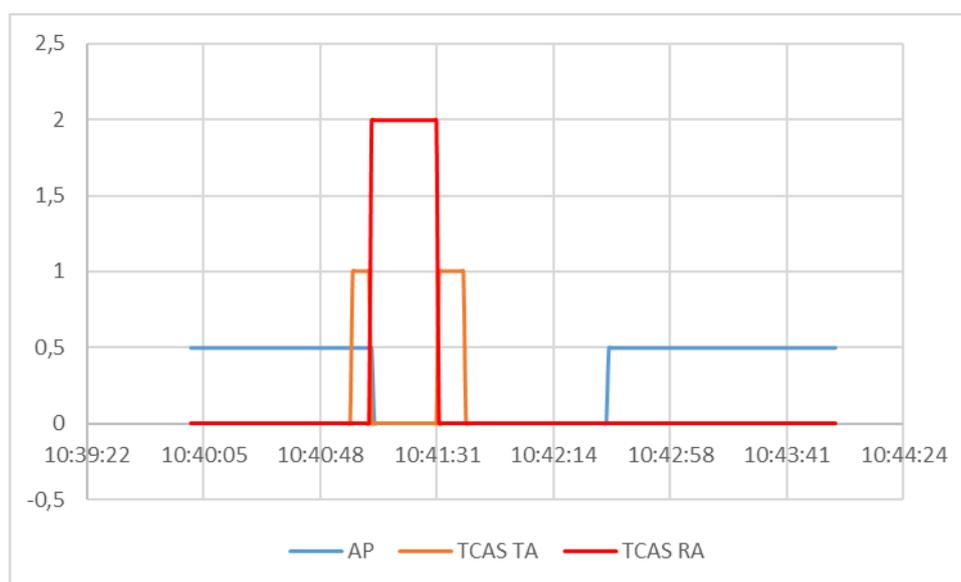
Figure 32; TCAS alerts and autopilot configuration of the LN-LNI aircraft

The aircraft's descent rate begins to increase, and its heading changes from 80 degrees to 130 degrees.

At 10:41:20, the aircraft stops descending, and the TCAS RA alert disappears. Ten seconds later, the TCAS TA alert also disappears.

The aircraft slows down and at 10:42:34, the autopilot is reactivated and the initial heading is restored.

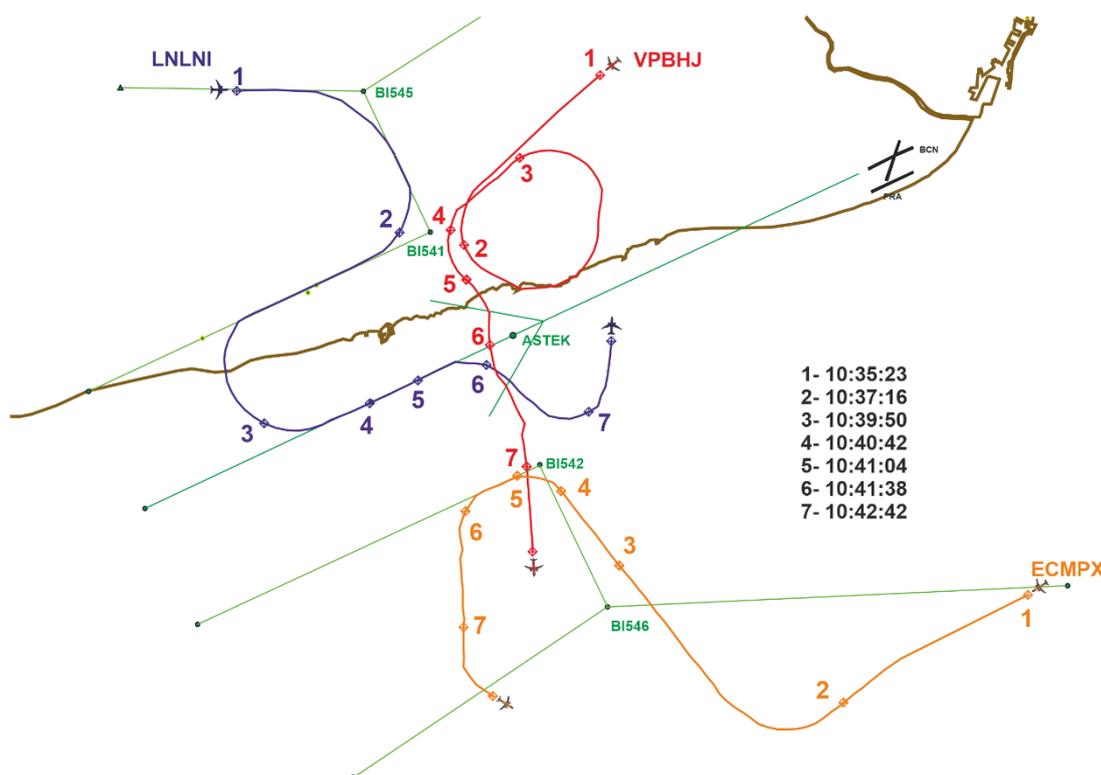
Figure 38; Aircraft traces and chronological description

This section integrates and summarises the information from the flight data recorders installed on the aircraft, the radar surveillance from the ATC units, the ATC communications and the testimonies of the controllers and crews involved in order to provide an overall chronological description of the incident. The incident occurred at 10:40 UTC, but the most relevant events are outlined below due to their influence.
