Technical report

IN-034/2021

Incident on 04 July 2021 involving a Vulcanair P.68TC Observer aircraft operated by SAETA, registration EC-KQV, at Seville Airport (Seville, Spain)

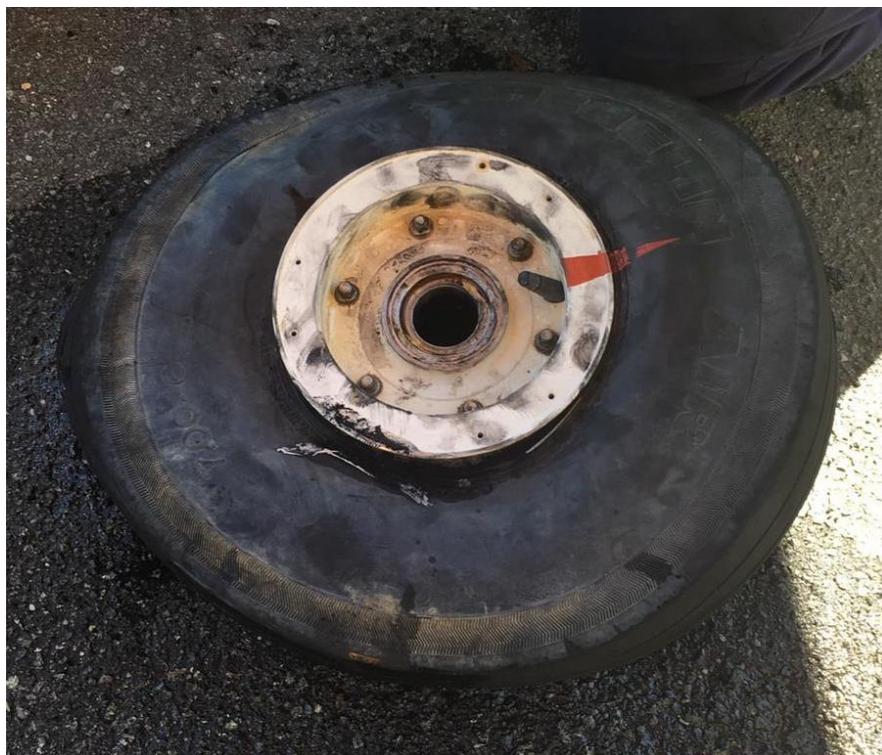
Illustration 3: Tyre on the incident aircraft

After taxiing to the holding point prior to entering the runway, the tyre on the aircraft's right main landing gear wheel burst and subsequently caught fire.

Damage to the aircraft was limited to the right main gear tyre.

During the investigation, photographs of the state of the aircraft's brake system at the time of the incident were requested. However, the only photograph that is available is how the tire and wheel rim were after the event:

The investigation has not been able to determine what caused the right main gear tyre to burst and subsequently catch fire. However, the possibility that inadequate tyre pressure and/or excessive braking could have contributed to the incident has not been ruled out.

REC 11/22: The aircraft operator is recommended to review and update its procedures according to the aircraft manufacturer's requirements for tire pressure measurement.
