TECHNICAL REPORT

IN-041/2022

Incident on 13 July 2022 involving an AIRBUS A-330-343X aircraft operated by AIR CANADA, on registration C-GHLM, and a CESSNA CITATION 550 aircraft operated by the Spanish Navy, on registration U20.03, in the vicinity of Adolfo Suárez Madrid - Barajas Airport (Madrid, Spain)

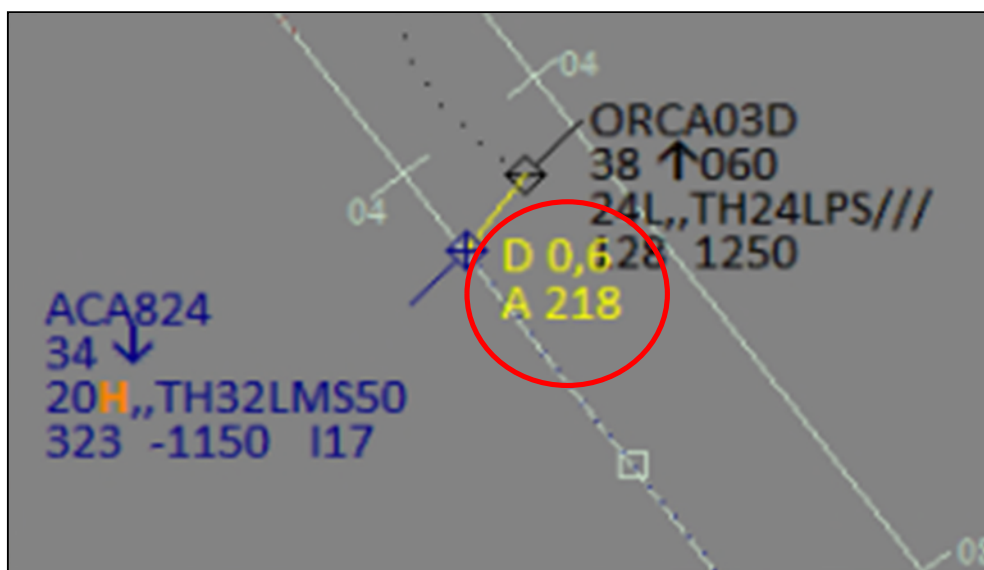
Figure 3. Position of the aircraft at 11:03:31 h

At 11:03:31 h, ORCA03D was continuing its climb through 3,800 ft between the two localisers, and ACA824 was descending through 3,400 ft on the localiser for runway 32, with a separation between them of 0.6 NM horizontally and 400 ft vertically.

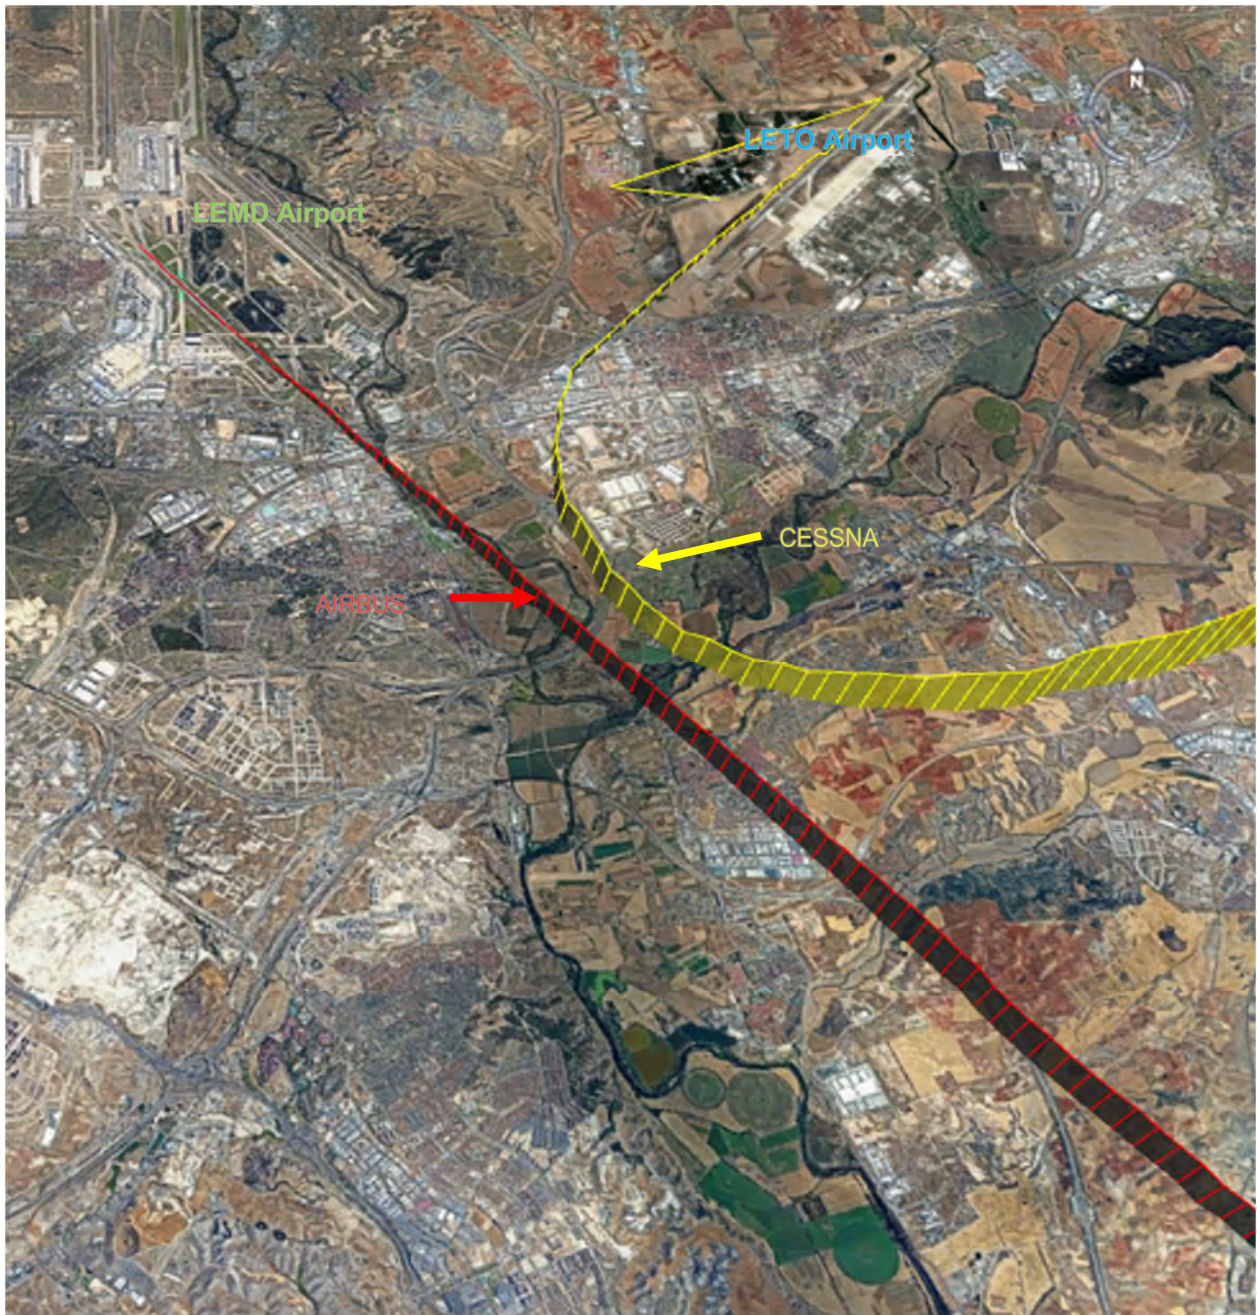
Figure 6. Trajectories of the two aircraft

Twelve (12) seconds later, the TCAS RA warning sounded for fifteen seconds, during which time the instruction it received was "DON'T CLIMB".

During that time, the aircraft's altitude varied from 3,253 ft to 3,038 ft, and its ground speed decreased from 196.1 kt to 194.4 kt.
