CIAIAC

Report IN-049/2019

Incident involving two Boeing
737-8AS aircraft, registrations
EI-ENH and EI-DYR, on 11 September
2019 at Málaga Airport

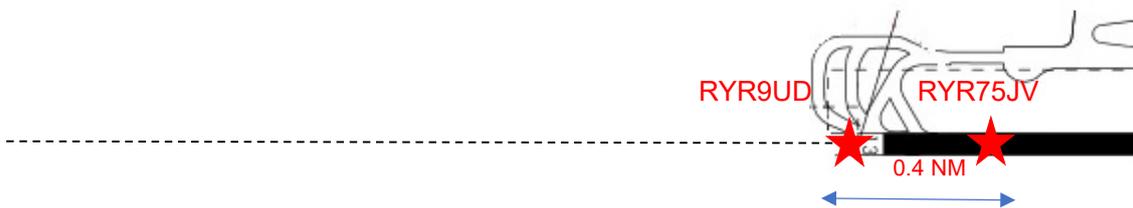
Illustration 7 Position of aircraft at 19:53:59 UTC

At 19:53:59 UTC, the trace shows aircraft RYR9UD established on short final at an altitude of 200 ft AMSL, and aircraft RYR75JV on its take-off run on RWY 13 at a speed of 94 kt (GS). The distance between the two aircraft was 0.4 NM.

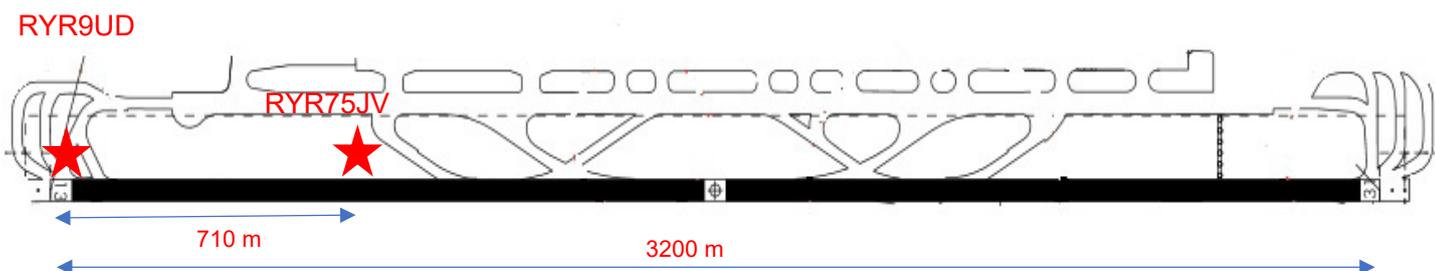
Illustration 8 Position of aircraft at 19:54:03 UTC

At 19:54:03 UTC, the trace shows aircraft RYR9UD over the threshold of RWY 13, travelling at an altitude of 100 ft AMSL and a speed of 150 kt (GS), and aircraft RYR75JV on its take-off run from the same runway at a speed of 111 kt (GS). The distance between the two aircraft was 710 m (0.38 NM).

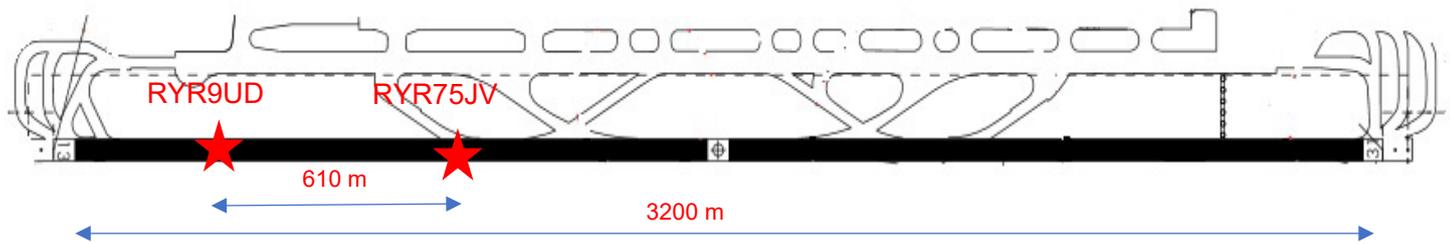
Illustration 9 Position of aircraft at 19:54:08 UTC

At 19:54:08 UTC, the trace shows aircraft RYR9UD over RWY 13 with its main landing gear not yet having made contact with the runway, and aircraft RYR75JV on its take-off run, not yet having commenced rotation. The distance between the two aircraft was 610 m (0.33 NM).

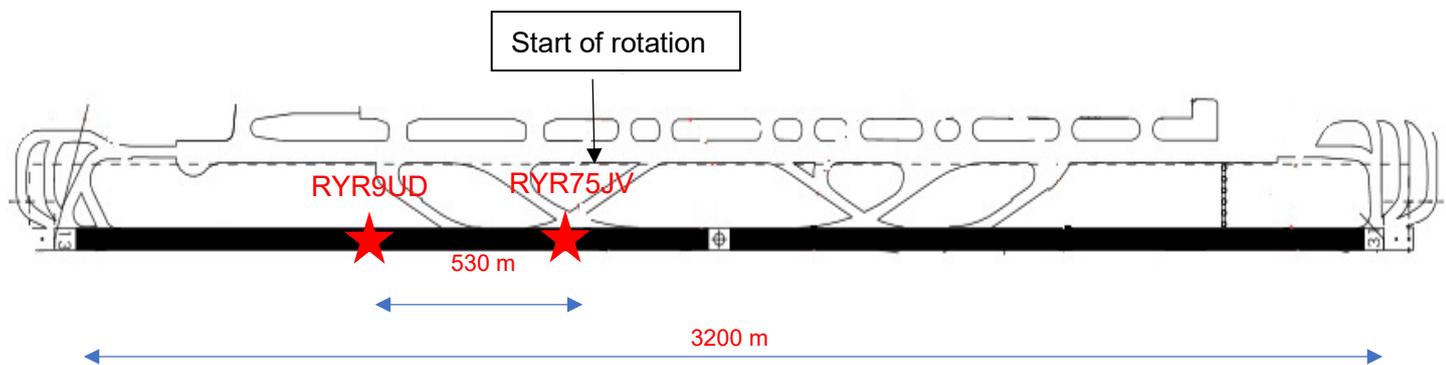
Illustration 10 Position of aircraft at 19:54:11 UTC

At 19:54:11 UTC, the trace shows aircraft RYR9UD over RWY 13 with its main landing gear not yet having made contact with the runway, and aircraft RYR75JV on its take-off run initiating the rotation manoeuvre (forward landing gear in the air and main landing gear on the ground). The distance between the two aircraft was 530 m (0.29 NM).

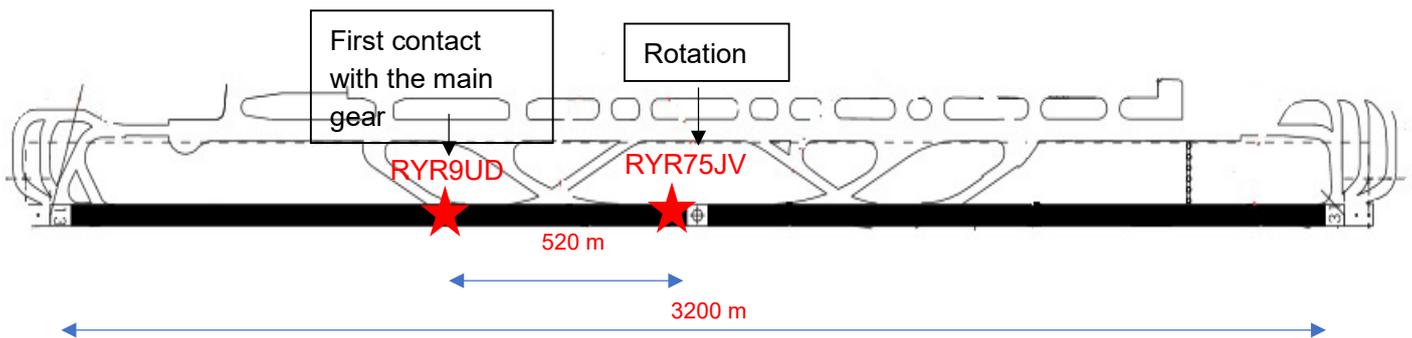
Illustration 11 Position of aircraft at 19:54:15 UTC

At 19:54:15 UTC, the trace shows aircraft RYR9UD over RWY13 with its main landing gear on the runway, and aircraft RYR75JV finishing the rotation manoeuvre on its take-off run (forward landing gear in the air and main landing gear on the ground). The distance between the two aircraft was 520 m (0.28 NM), the shortest separation recorded between them.

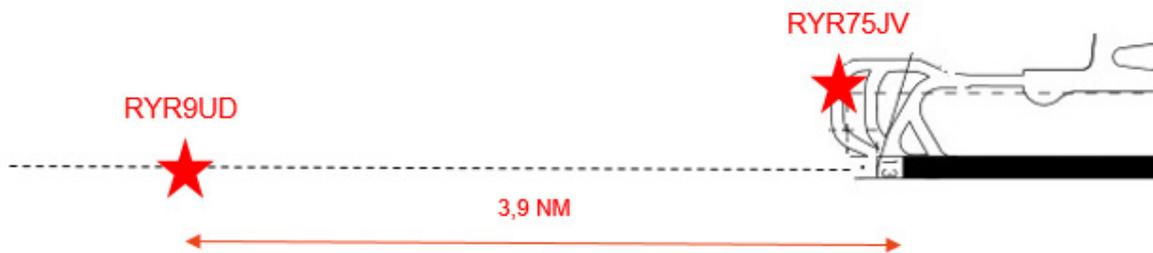
At 19:52:27 UTC, he instructed aircraft RYR75JV to line up on the runway and hold, when, at that moment, the approaching RYR9UD aircraft was established on final at a distance of 3.9 NM from the threshold of RWY 13. The following image shows the relative positions of the aircraft.

The crew of the RYR75JV aircraft took six seconds to acknowledge the instruction to line up and another seven seconds to select the power to taxi. Because of the time it takes for the aircraft to begin moving after the power selection, the N1 and GROUND SPEED parameters did not become active until 19:52:49 UTC. This data does not signify the delay in the actions carried out by the crew is considered significant or excessive.

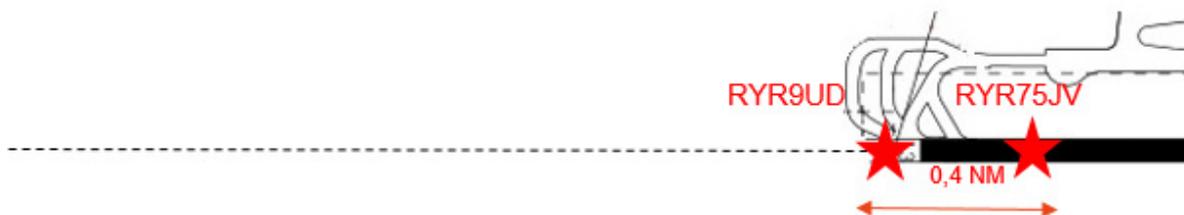
However, at 19:53:59 UTC, the LCL TWR LEMG controller cleared the RYR9UD aircraft to land with the preceding traffic in view on runway 13 when it was established at 200 ft of altitude AMSL, and aircraft RYR75JV was on its take-off run on RWY 13 at a speed of 90 kt (GS). The distance between the two aircraft was 0.4 NM.

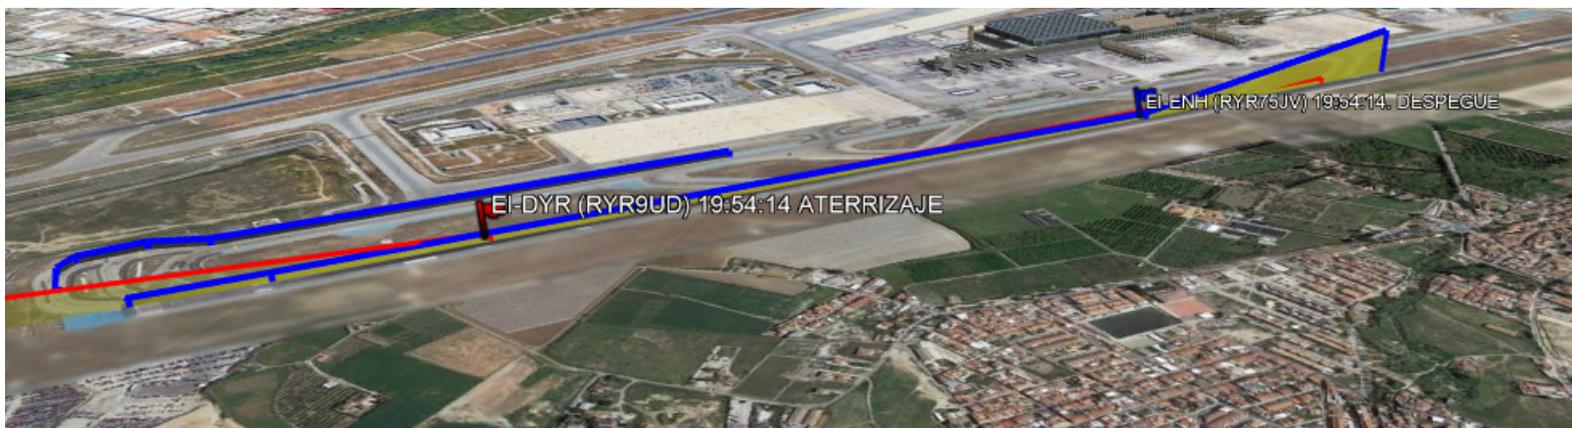
Illustration 18 Aircraft trajectories at the moment of touchdown

From the data obtained from the flight recorders we have been able to determine the exact moment at which the landing aircraft, with registration EI-DYR, makes contact with the runway for the first time with its main landing gear. This instant (19:54:14 UTC) has been represented in the following graphic, where the trajectory of the inbound aircraft is indicated in red, and that of the outbound aircraft is indicated in blue.

The landing EI-DYR aircraft touched down on the runway with a ground speed of 141 kt. For its part, the EI-ENH aircraft was on its take-off run executing the rotation manoeuvre, with a ground speed of 157 kt. The distance between the two aircraft was 520 m (0.28 NM). This was the point of minimum separation between the two aircraft.
