Technical report

IN-053/2021

Incident involving a Boeing 737-8AS aircraft, registration number EI-DLH, on 10 December 2021 at Santiago Airport (La Coruña, Spain)

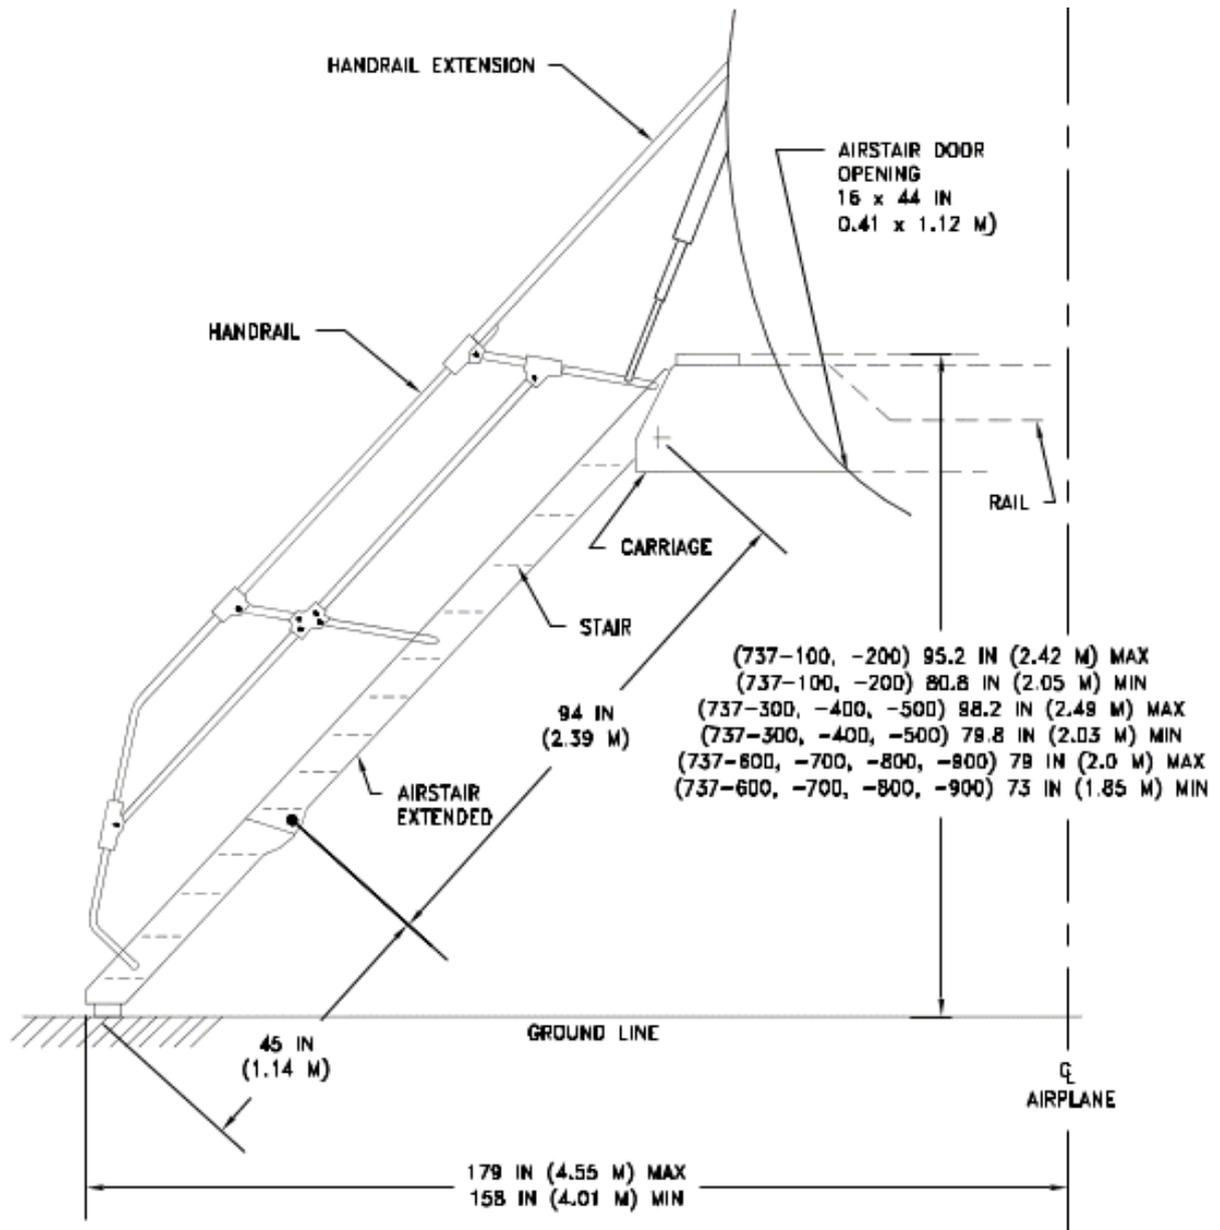
Figure 1: Dimensions of the stairs on the Boeing 737 aircraft

The following figure, taken from the Boeing document titled “Airplane Characteristics for Airport Planning”, shows the dimensions of the stairs. The height of the stairs on the 800 model ranges from a minimum of 1.85 m to a maximum of 2 m, with a length of 3.53 m. Thus, the slope varies from 69% to 62%, respectively. The width of the stairs is approximately 0.62 m.

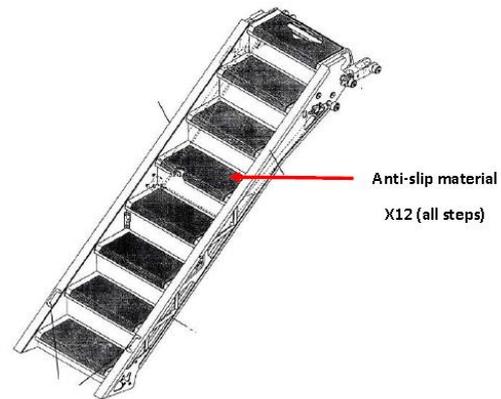
1. The stair treads are covered with a non-slip material: specifically, 3M Safety Walk 710 - Coarse⁴.

Although Ryanair's manuals also allow the use of the 3M Safety Walk 610 - General Purpose non-slip material⁵, the stairs of the aircraft in question are equipped with the former.

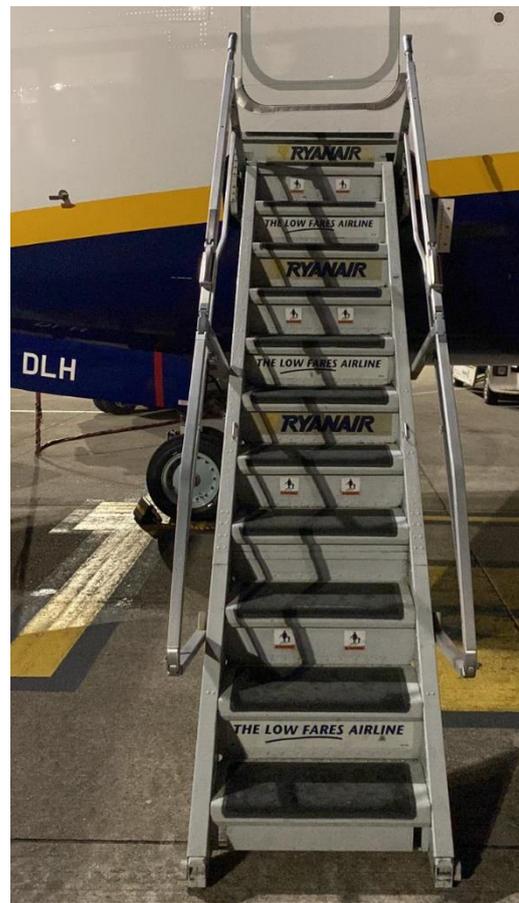
2. The aircraft involved in this event (see the photograph on the right) had warning signs advising that passengers travelling with small children should hold their hands when walking up or down the stairs, as per Special Airworthiness Information Bulletin (SAIB) NM-07-47⁶ issued by the FAA in September 2007.

These warning signs also advised passengers to hold onto the handrail with their other hand.

In the photograph, the warning signs can be seen on the step risers.

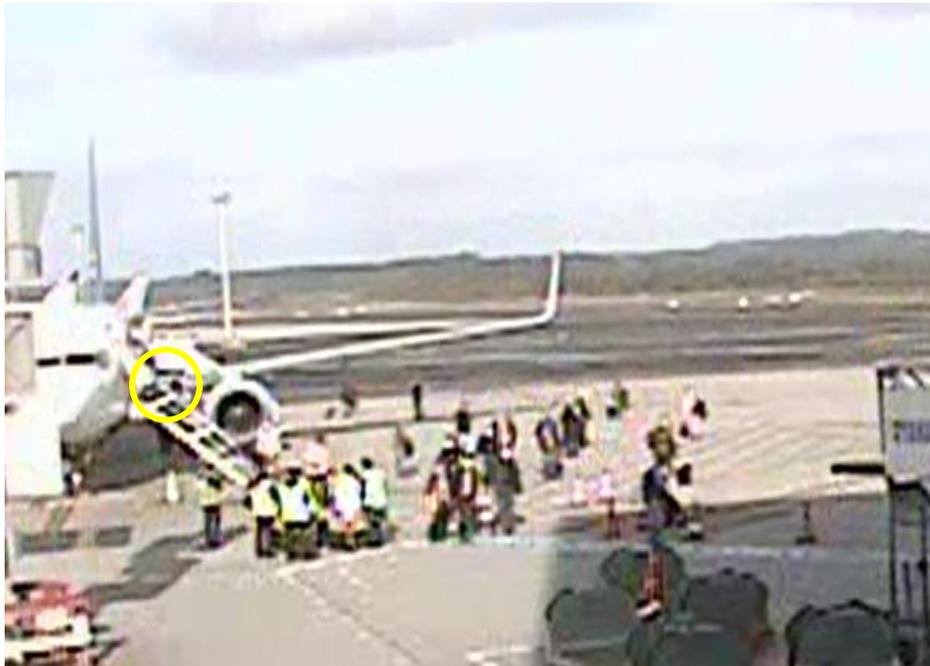
Figure 2: Passenger descending the stairs moments before the fall

The incident was captured by the airport's cameras. However, it is not clear from the footage exactly how the passenger fell:

Even though the aircraft has warning signs on the stair risers and door frame advising passengers to hold onto the handrail when walking down the stairs, and despite the fact that Ryanair communicated this advice in English before proceeding to disembark the passengers, the injured passenger - who is of Spanish nationality - walked down the stairs while holding a suitcase in one hand and a coat in the other, and therefore did not hold onto the handrail.

As both of his hands were full, he was unable to grasp the handrail upon losing his balance.
