# **MINISTRY OF INFRASTRUCTURE AND TRASPORT**

**Directorate General for Rail and Marine Investigations**

**Fire on Board Ro-Ro Pax *SORRENTO***

**Final Report**

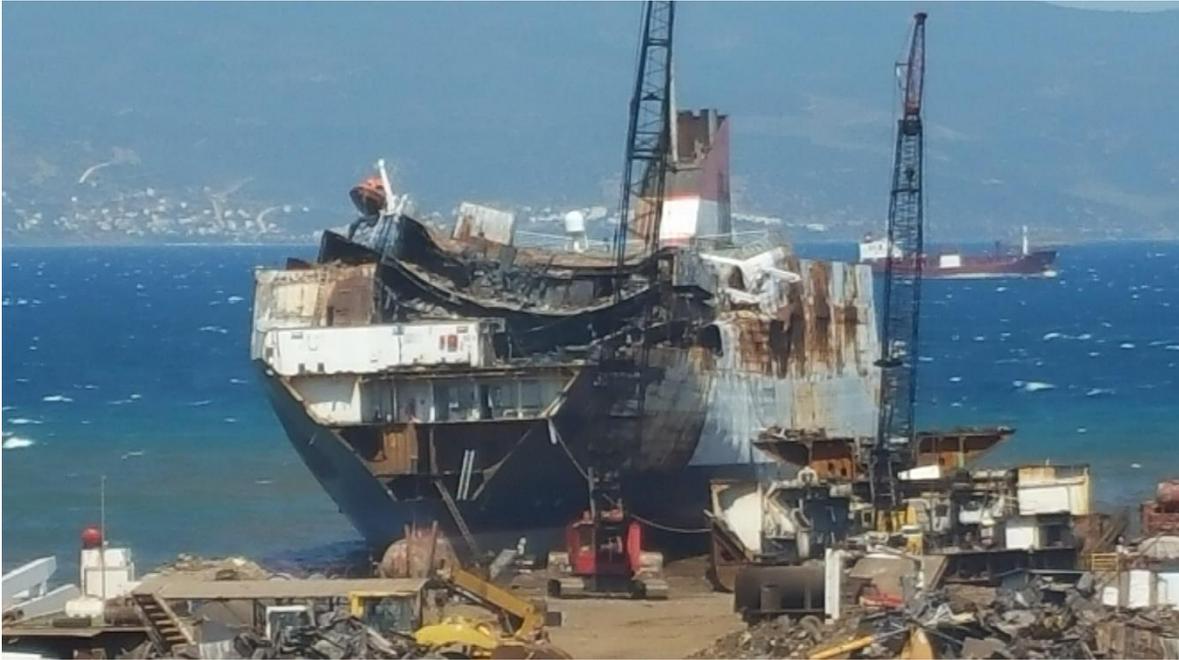
**Pic 1: M/V SORRENTO – Initial phases of demolition (21 apr 2016)**

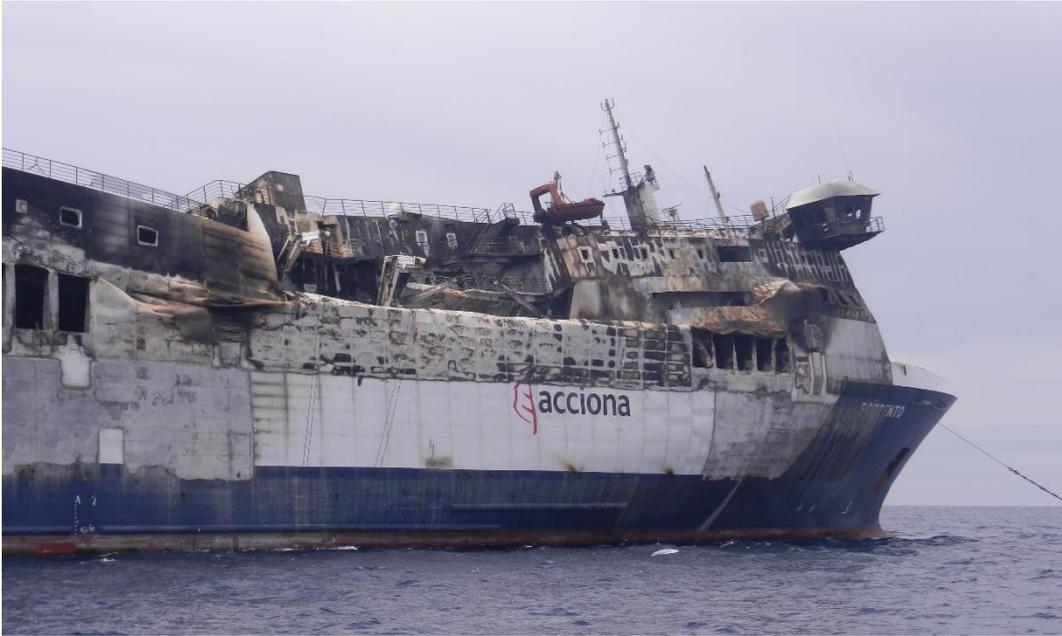
**Photo 2: Right side view (01/05/2015)**

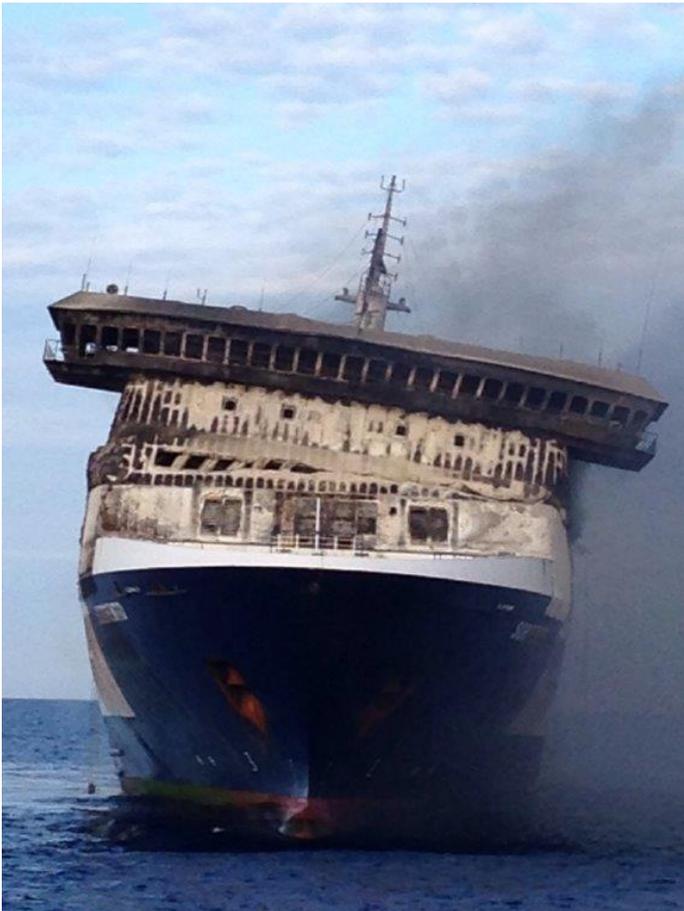
**Photo 3: Front view (01/05/2015)**

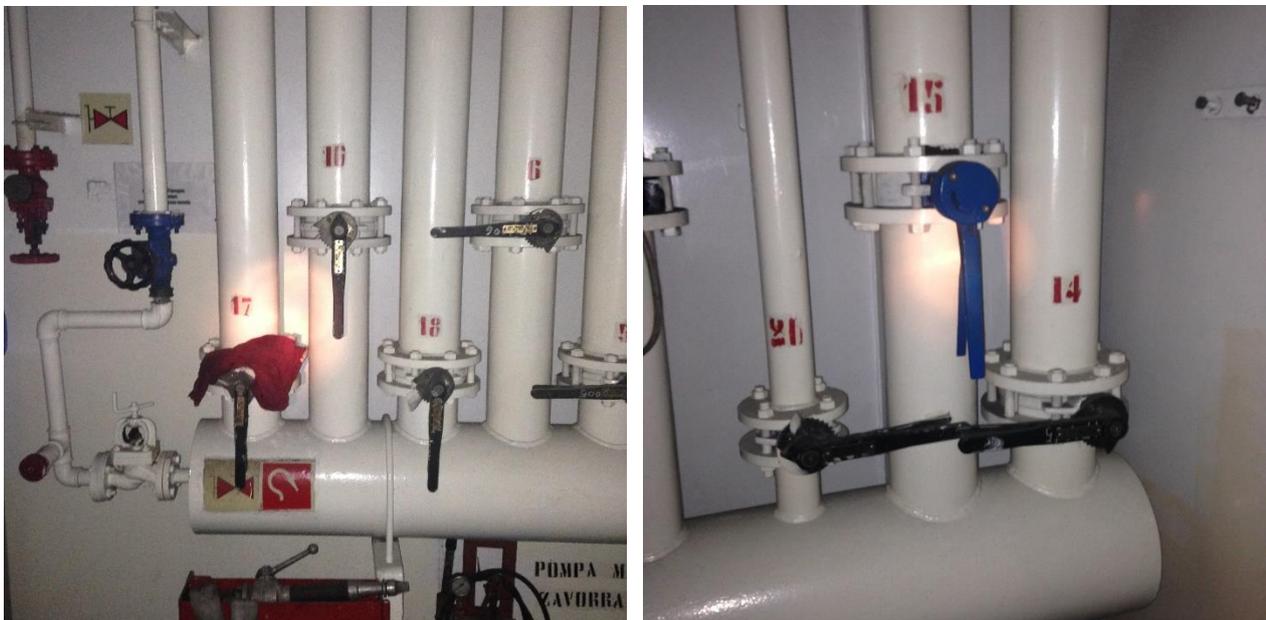
Close to the ECR there is also the Drencher room, from where – according to the interviews and the proof collected – the valves number 15, 16, 17 and 18, which had been opened to extinguish the fire and correspond to the forward area of Deck 4, were activated manually.

**Photo 4: State of Drencher valves.**

The Drencher was opened in the wrong area and for four areas, furthermore, after few minutes it became unusable, as the main power supply disconnected – probably because of the damage caused by fire to the exposed cables on the ceiling of deck 4. In such conditions, the Drencher system could be powered only by the fire-emergency pump, which, however, didn't provide enough water to effectively extinguish fire.

- For the existing ships, evaluate the redundancy of electric systems supplying the pumps for the fixed extinguishing system of “Drencher” type so as to ensure the full operation of the system also in emergency conditions;

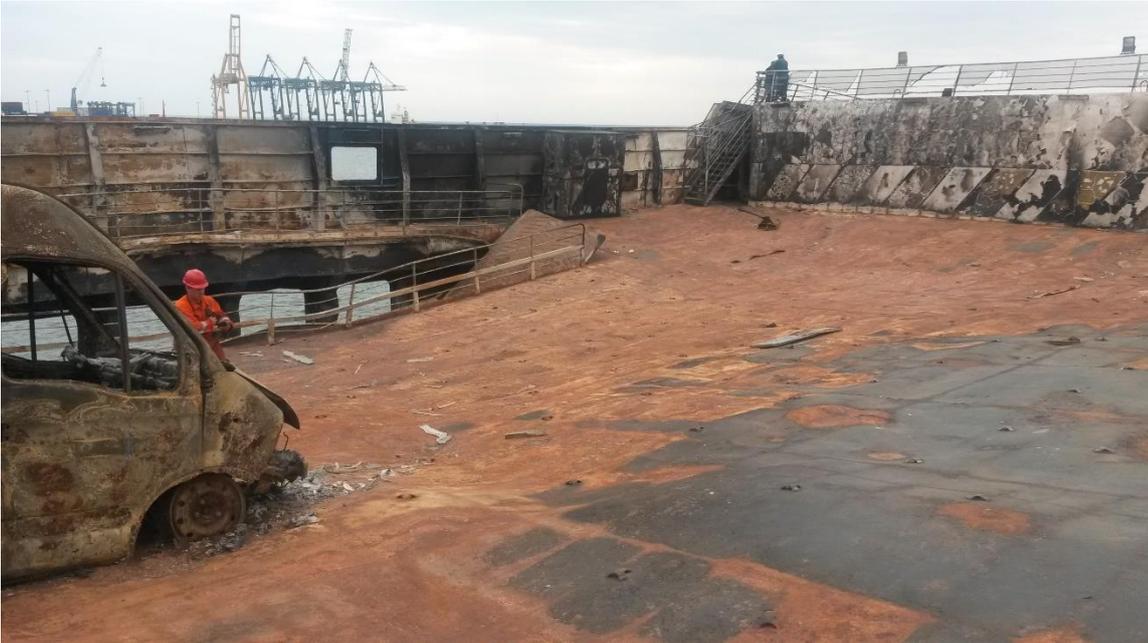
Entering Deck 4 from the stern ramp (back), it is possible to verify how the degree of the damage due to the heat showed by the walls and the roof, as well as the vehicles parked inside the garage, slowly increases as we move toward the bow area, by observing how in the front third of the garage deck (bow area) the higher sections of the frames show an intense deformation due to the heat, to the point that they reach the floor of the deck and even split in the centre. The deformation of the structures caused the collapse of the deck's ceiling in this front third of the garage, therefore crashing the vehicles parked in this area, whose structures had to be pretty weakened at the moment of collapse as a consequence of the fire.

**Photo 5: View of the collapsed area**

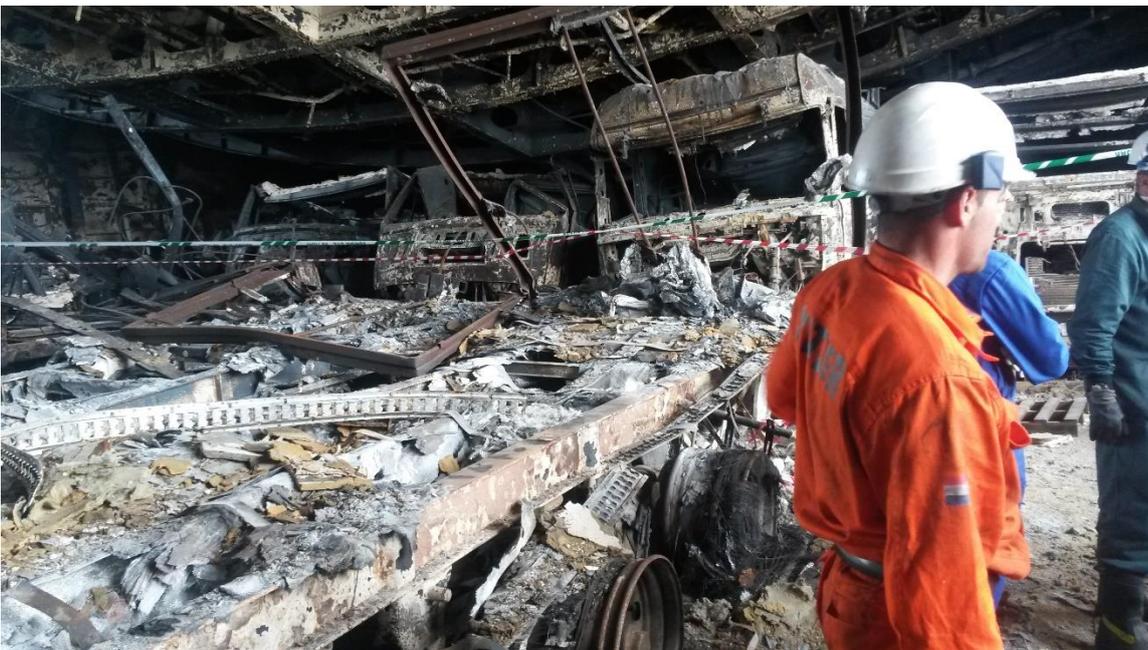
**Photo 6: Inside Deck 4**

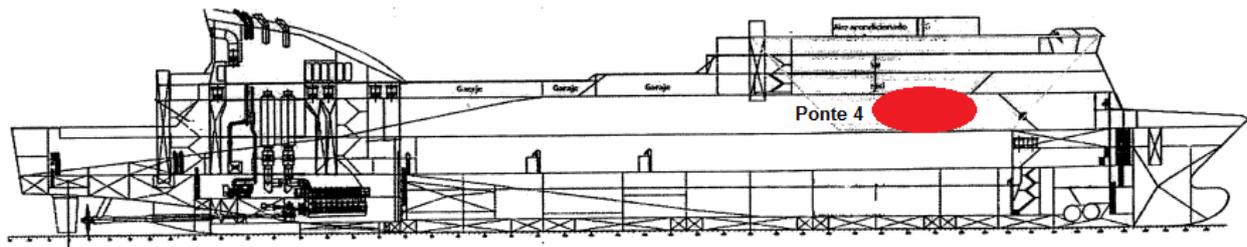
**Figure 3: Right-side view indicating the area where the fire developed**

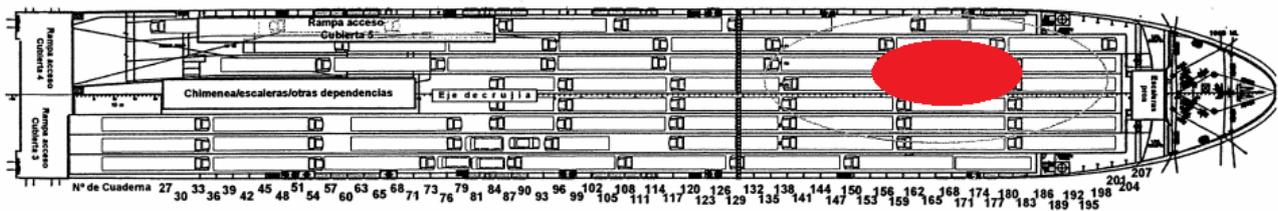
**Figure 4: Deck 4 – Top view (the possible fire's point of origin is marked in red)**

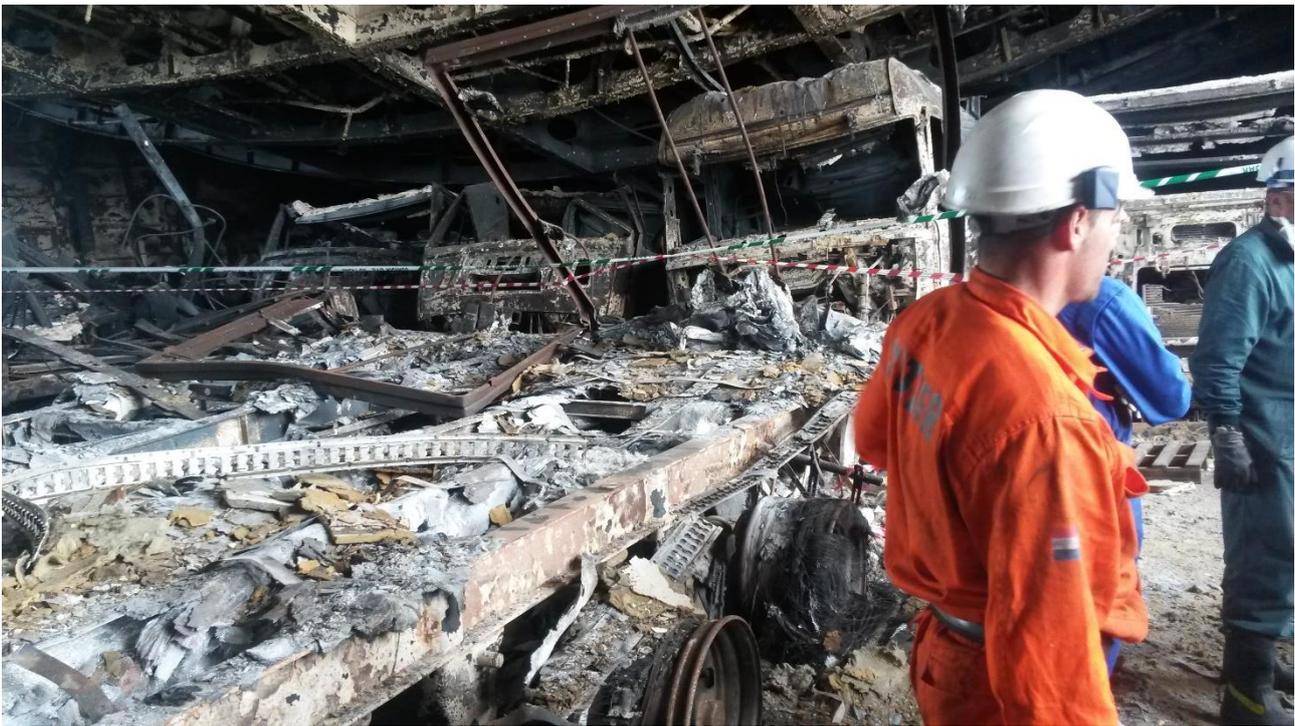
**Photo 7: trucks damaged by the fire**

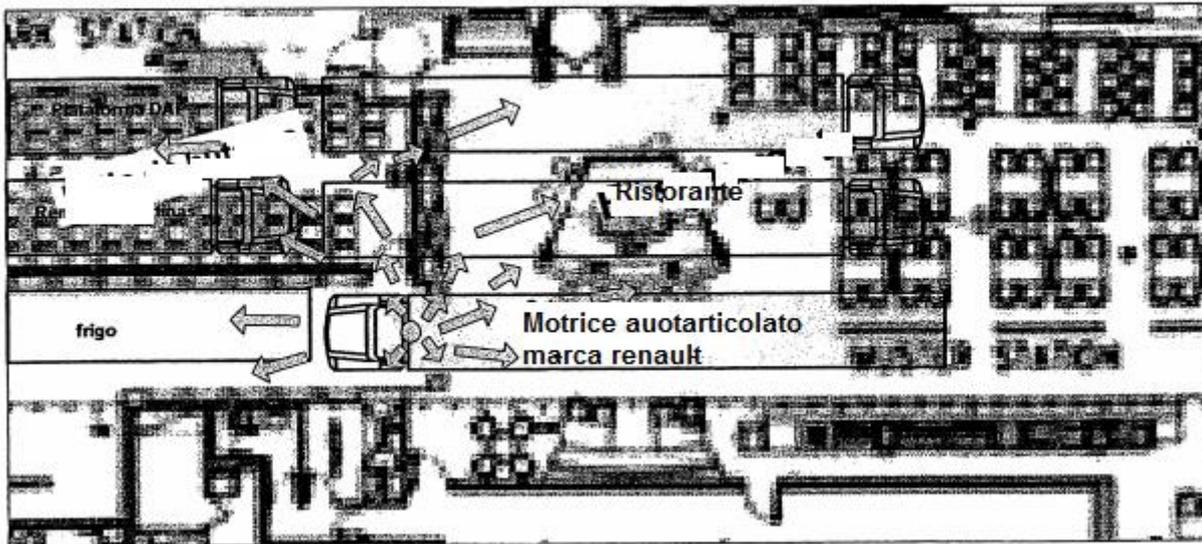
Once the area that has been touched by the fire the most had been found within Deck 5, it was then cleared out and cleaned; this allowed us to find how the floor of Deck 5 shows intense fusions due to the heat, with loss of material of the steel plates that form it, at the level of the entrance to the restaurant (bow area) and the front side of the courtyard with chairs (close to the ship's entrance hall); this allowed us to see, through the holes caused by the fusion of the floor's plates, the fire-damaged remains of the vehicles parked in the front rows of aisles 2, 3 and 4 of the car park in the ship's Deck 4.

**Figure 5: Position of the cab of the reefer by the brand Renault, with respect to the floor of Deck 5.**

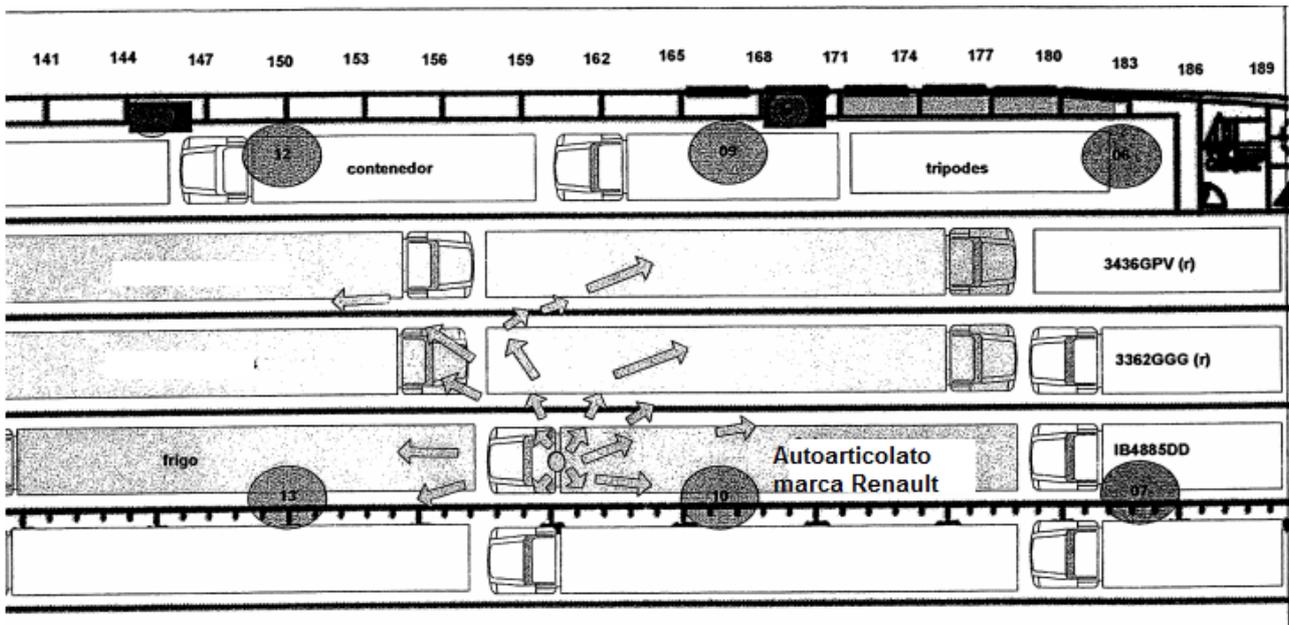
The works and studies carried out have allowed for the restriction of the origin area, now limited to the space bound by the back facade of the cabin of a cab parked facing the bow, in row 2, aisle 4 of the car park in Deck 4 and the front facade of the refrigerated semi-trailer hooked to it.

**Figure 6: Position of the reefer, brand Renault on Deck 4**
